# The Resurrection of St. Augustine

The story of a hundred-year fix

The mission St. Augustine at Isleta Pueblo, NM was built in 1613 and has, over the centuries, undergone many modifications. This image shows the building as it appeared in 2005, as the Pueblo began its drive to restore the historic church. In 2010 Crocker Ltd was selected as the contractor and Neil Carter Associates was the project manager.

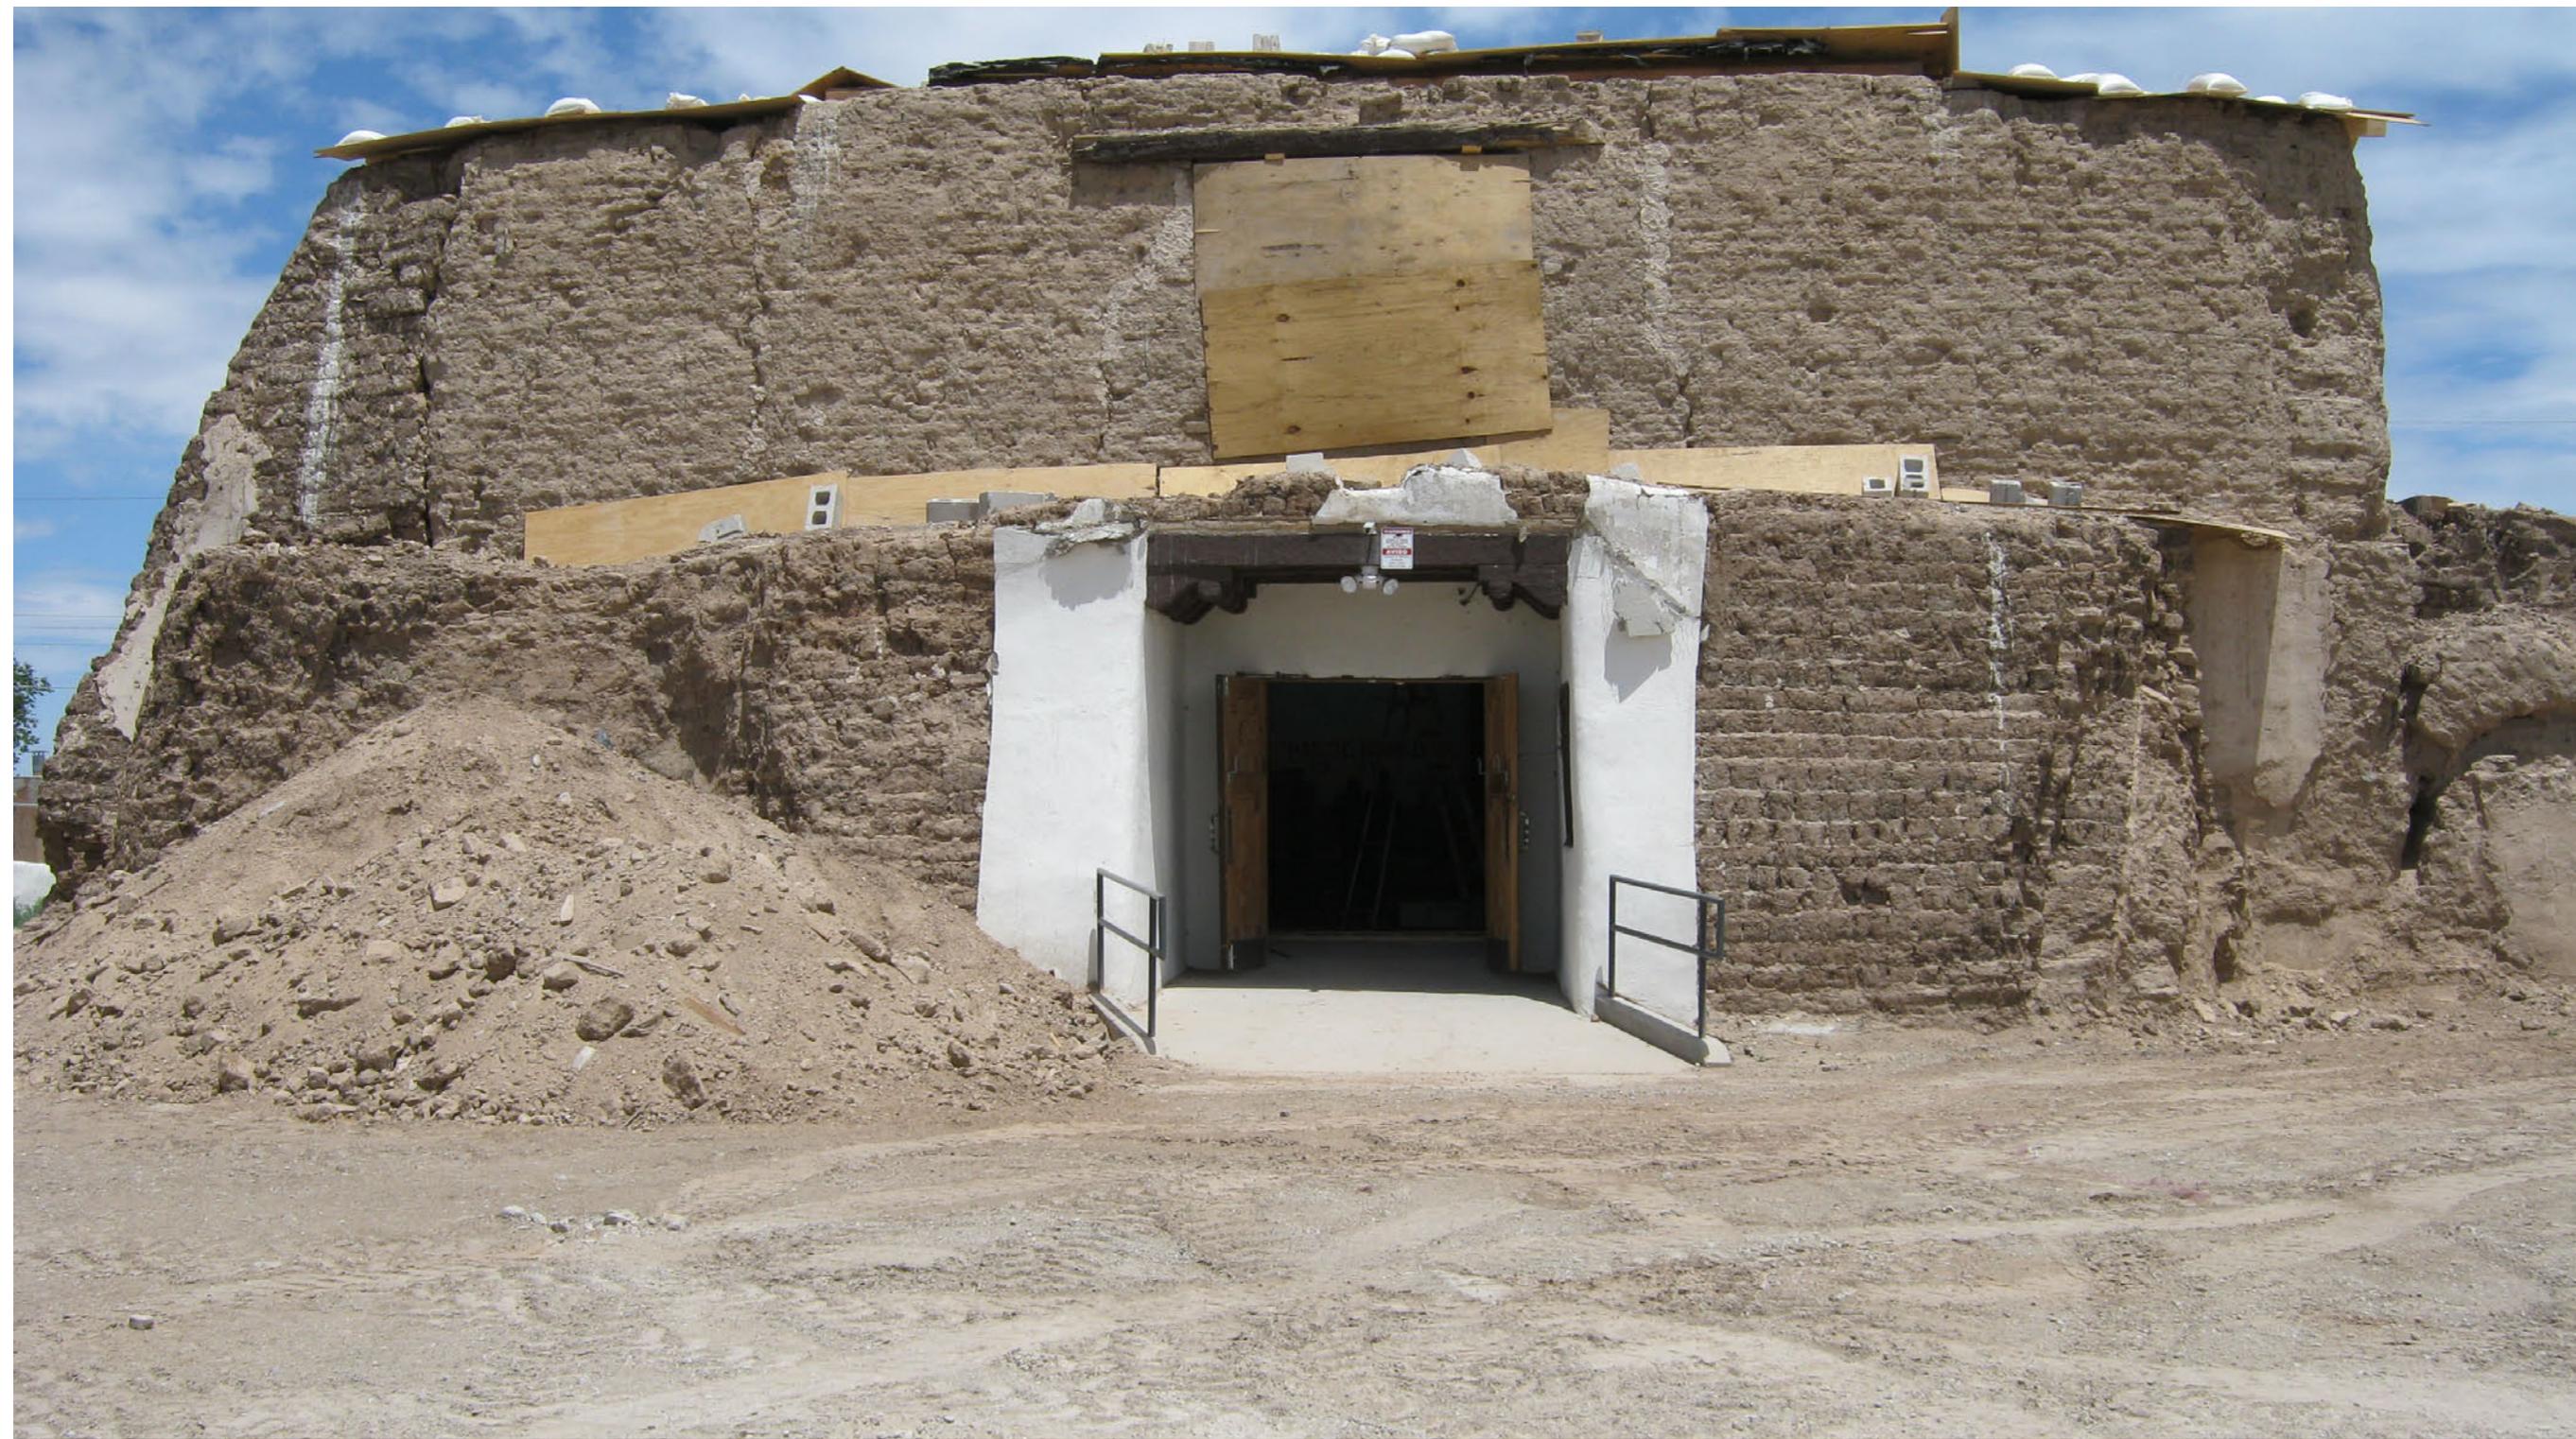
A 1959 remodeling campaign left the building tightly encased in Portland cement, including plasters that in places were seven inches thick. The belfries were constructed of concrete masonry blocks. The first job was to remove the non-permeable and inappropriate materials. As illustrated here, vast areas of damage were discovered, as were many surprises.

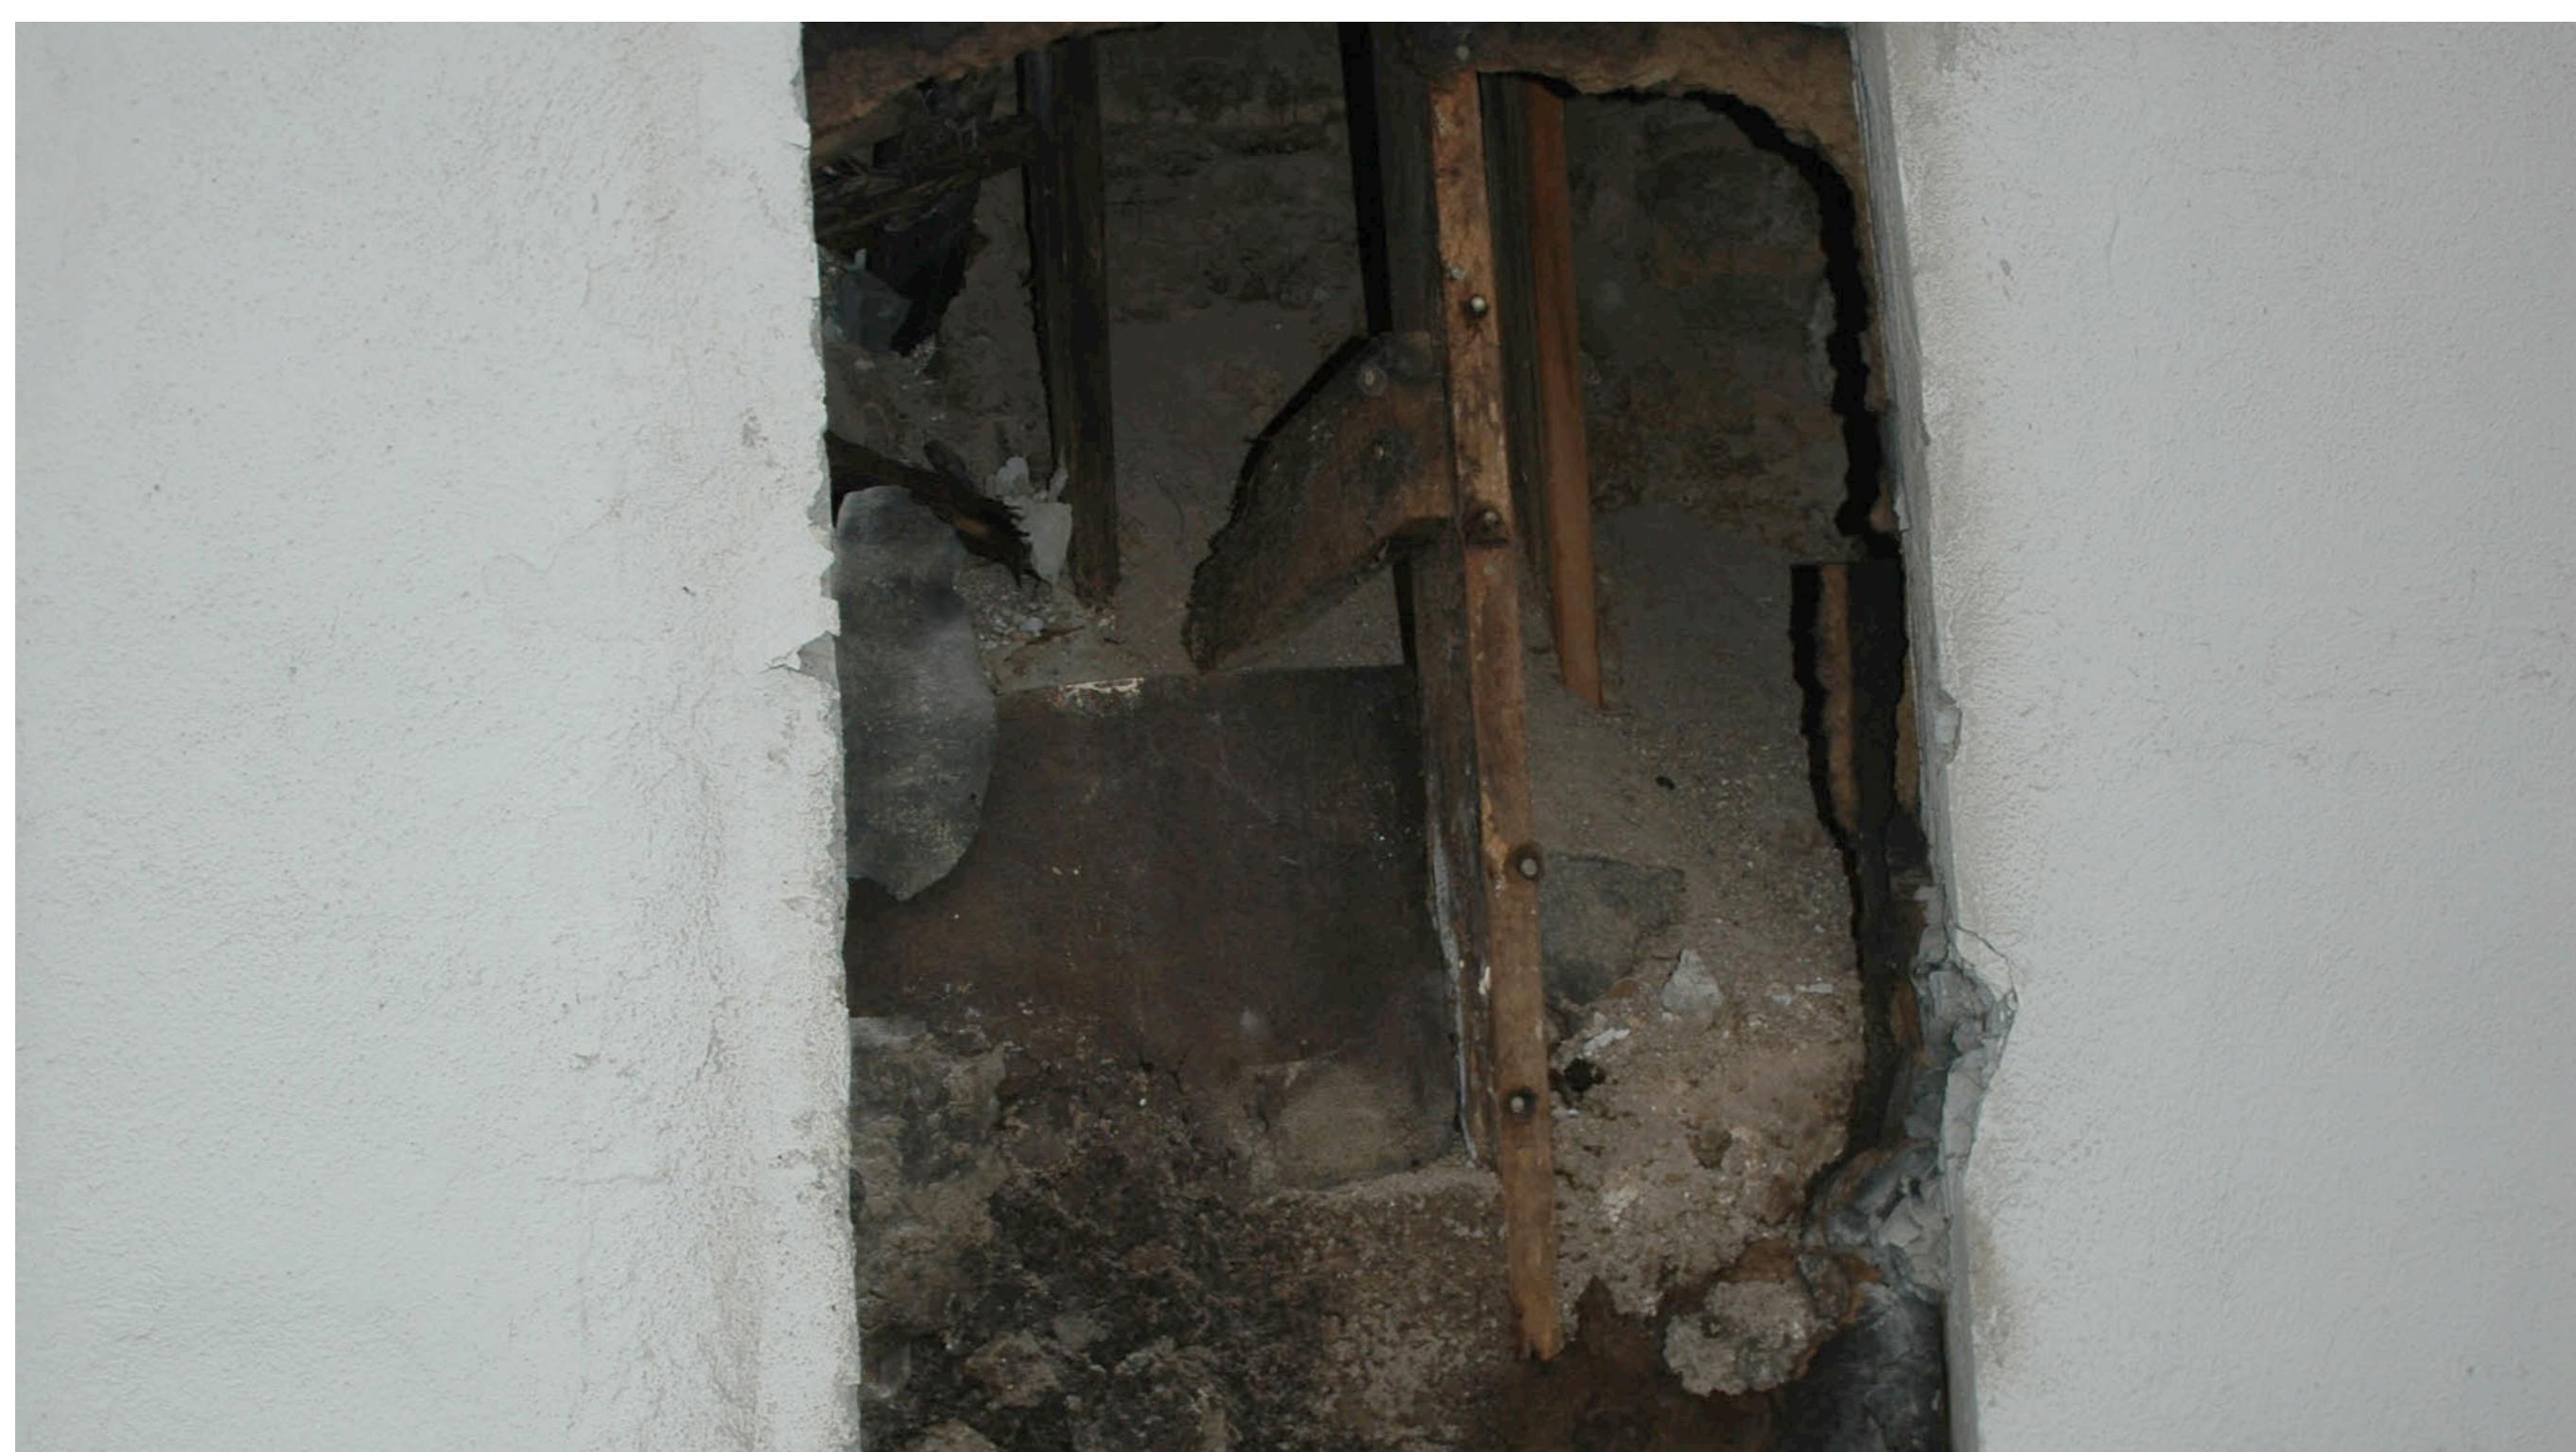
Among the more disturbing revelations was that some of the major features of the building had been “restored” in 1959 using wood frame construction. Coupled with the impermeable plaster, the damage to both the wood and adobe was extreme. This is the north side of the east buttress, where free water was found in the voids.

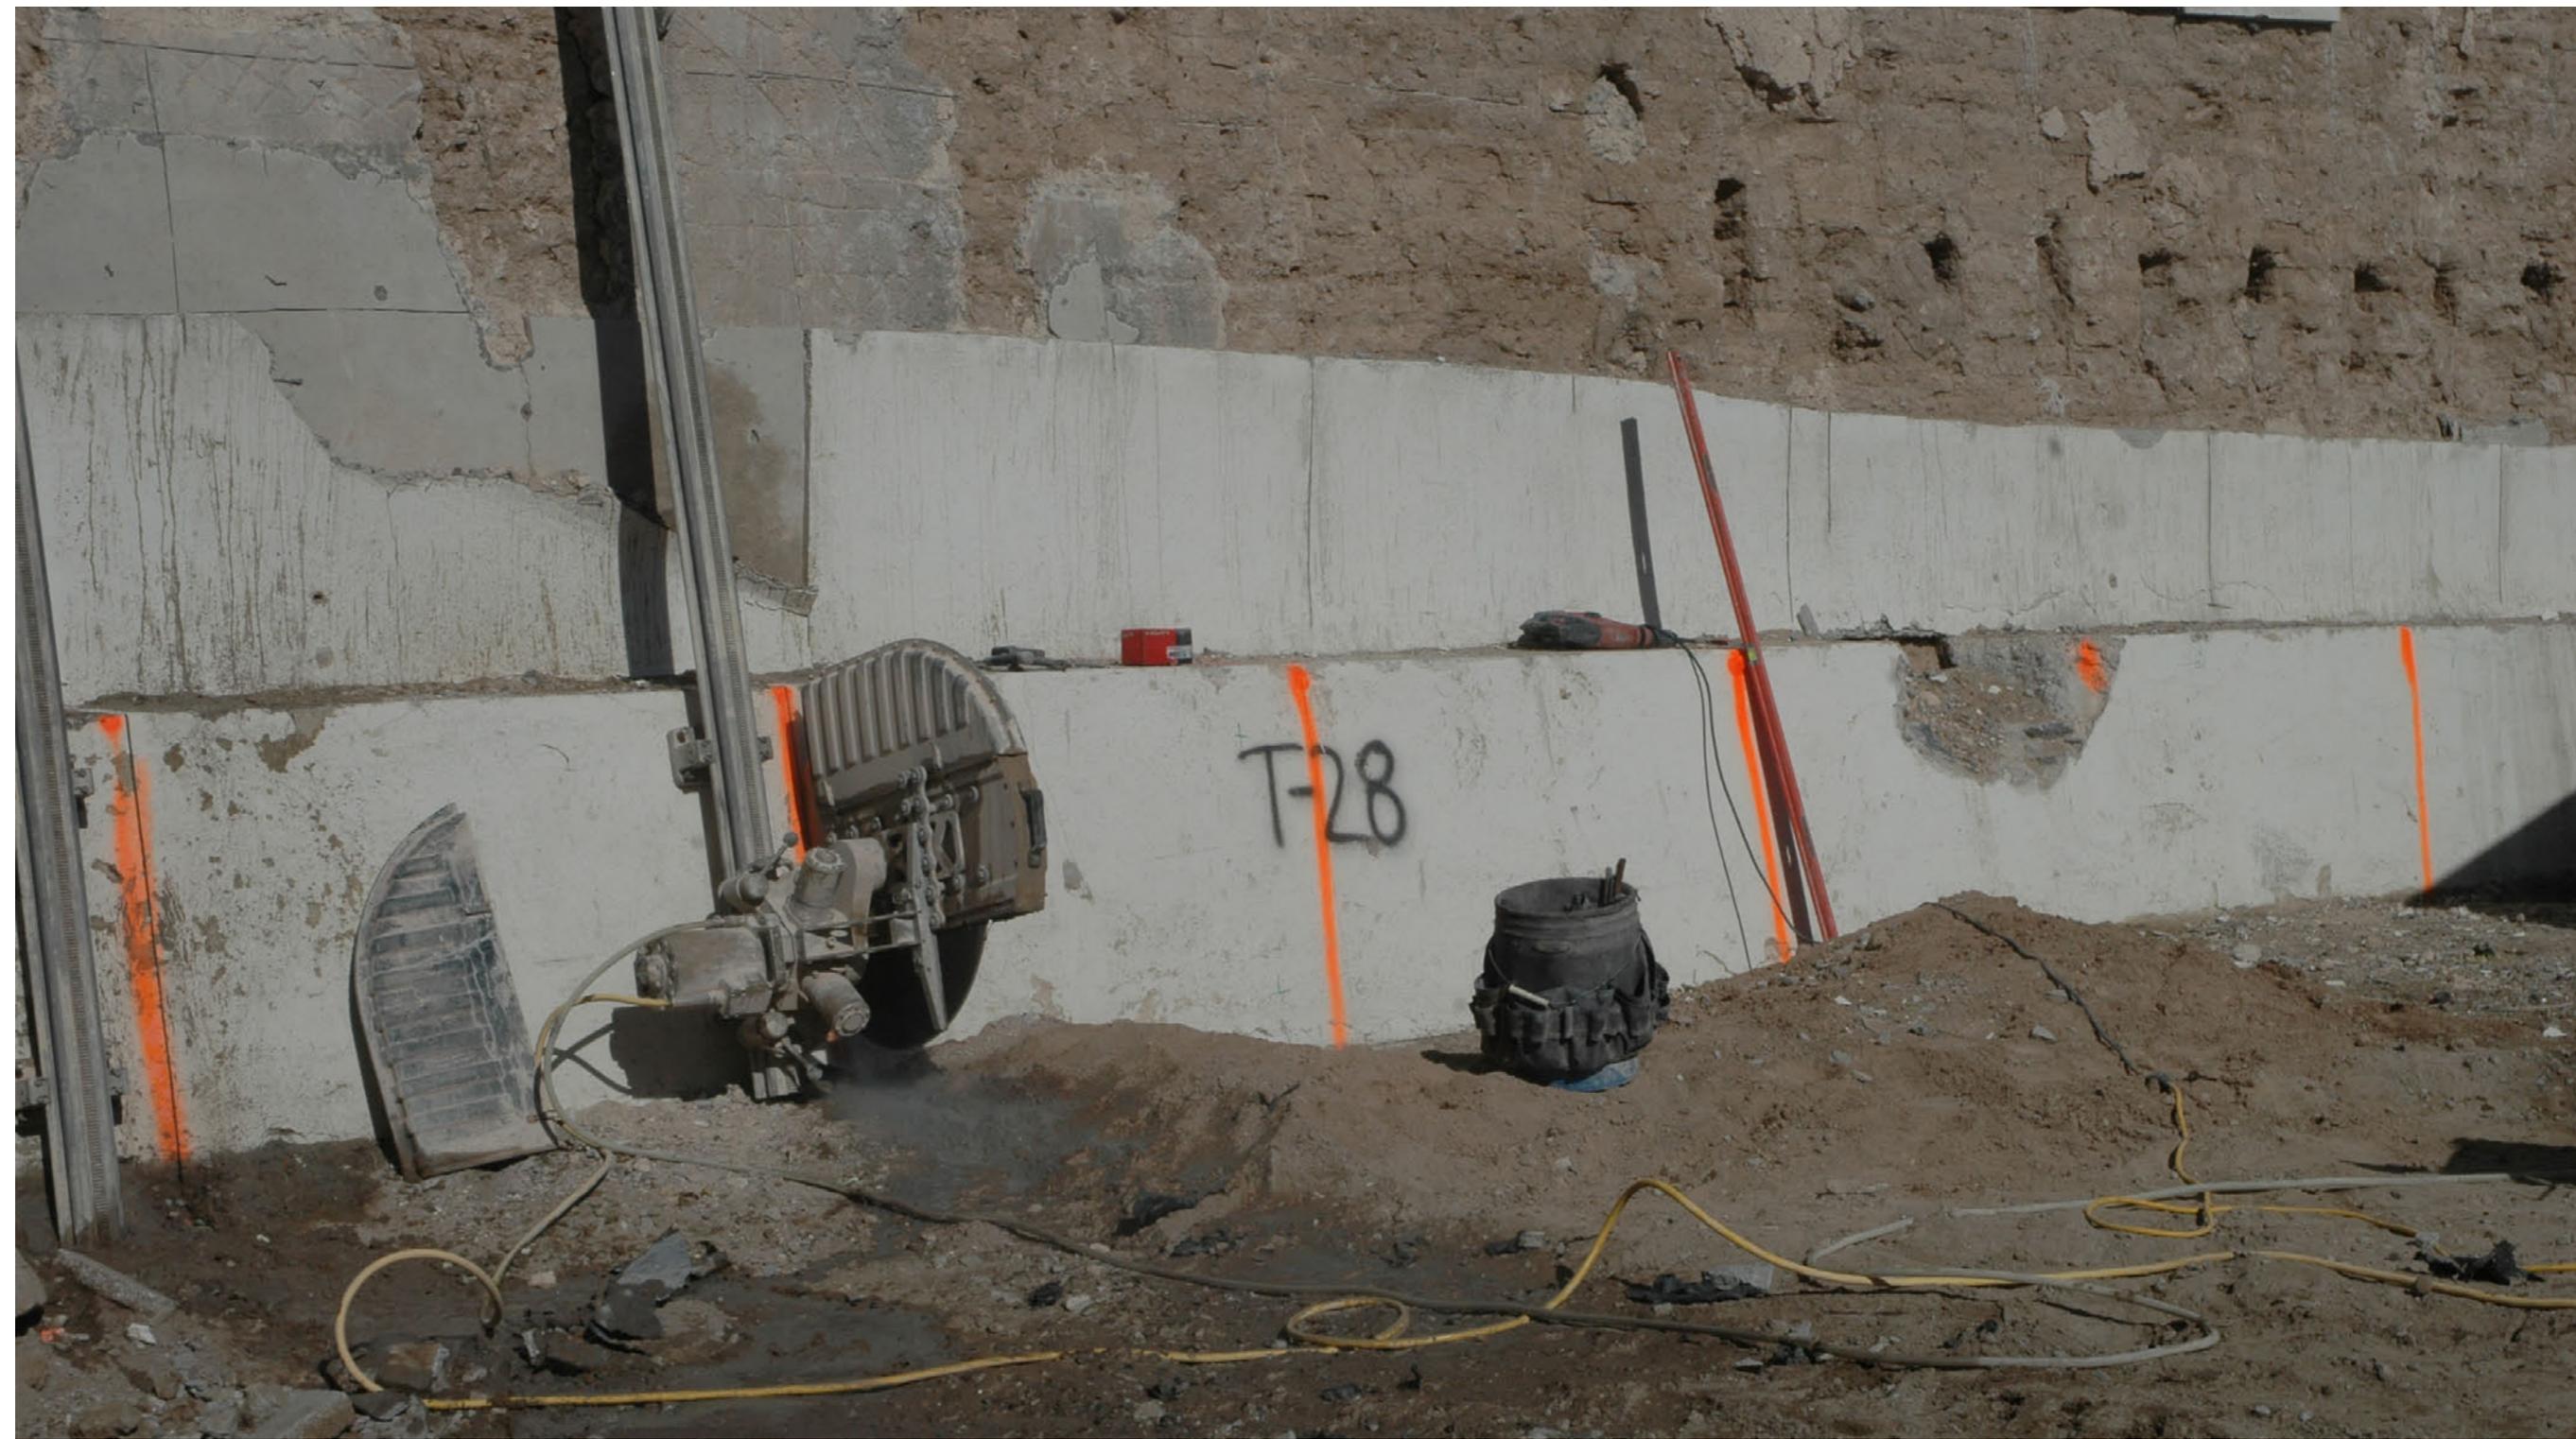
Among the 1959 interventions was the installation of a massive concrete *contrapared*, or gradebeam, that in places extended more than two and half feet below grade. The only safe way to remove the concrete was to saw it into manageable sections.

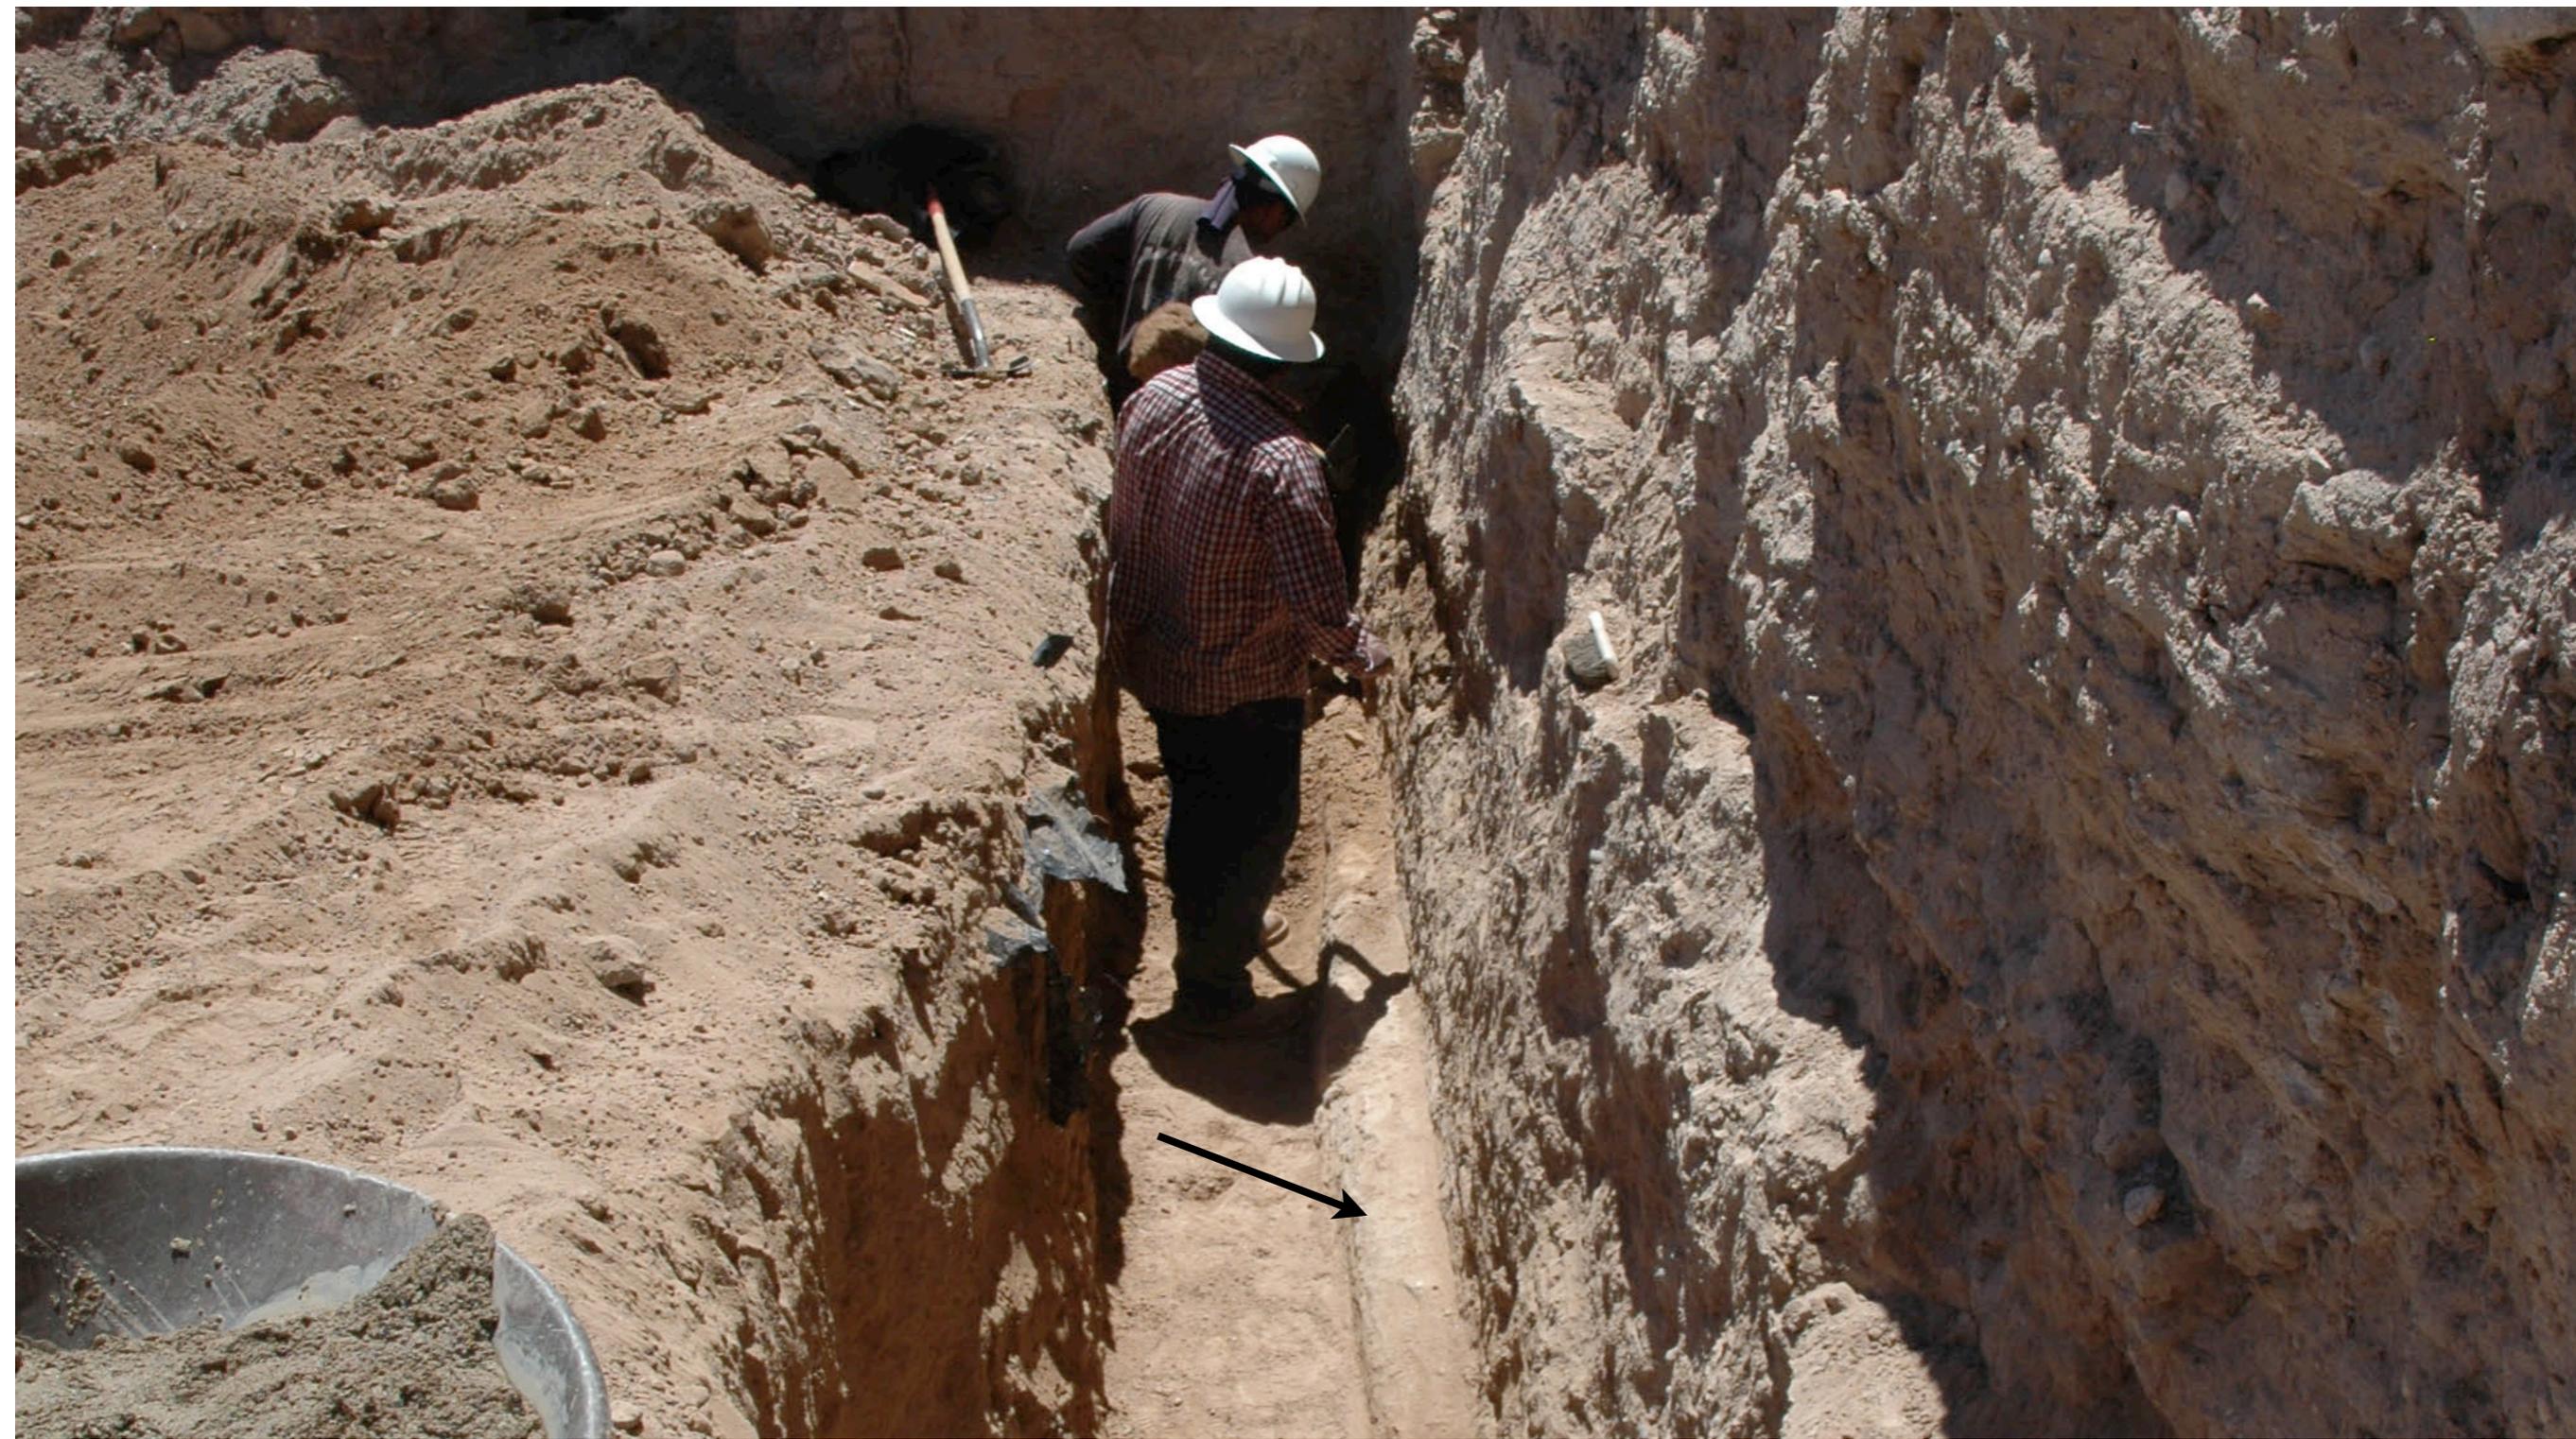
Once the *contrapared* had been removed, the engineered fill was excavated down to the wall base. There we discovered a narrow adobe plinth, indicated here, that marked the junction between the basalt-in-mud footing and the adobe walls. Restoration of the walls began at that point. Note the level of moisture damage to the walls that were behind the concrete.

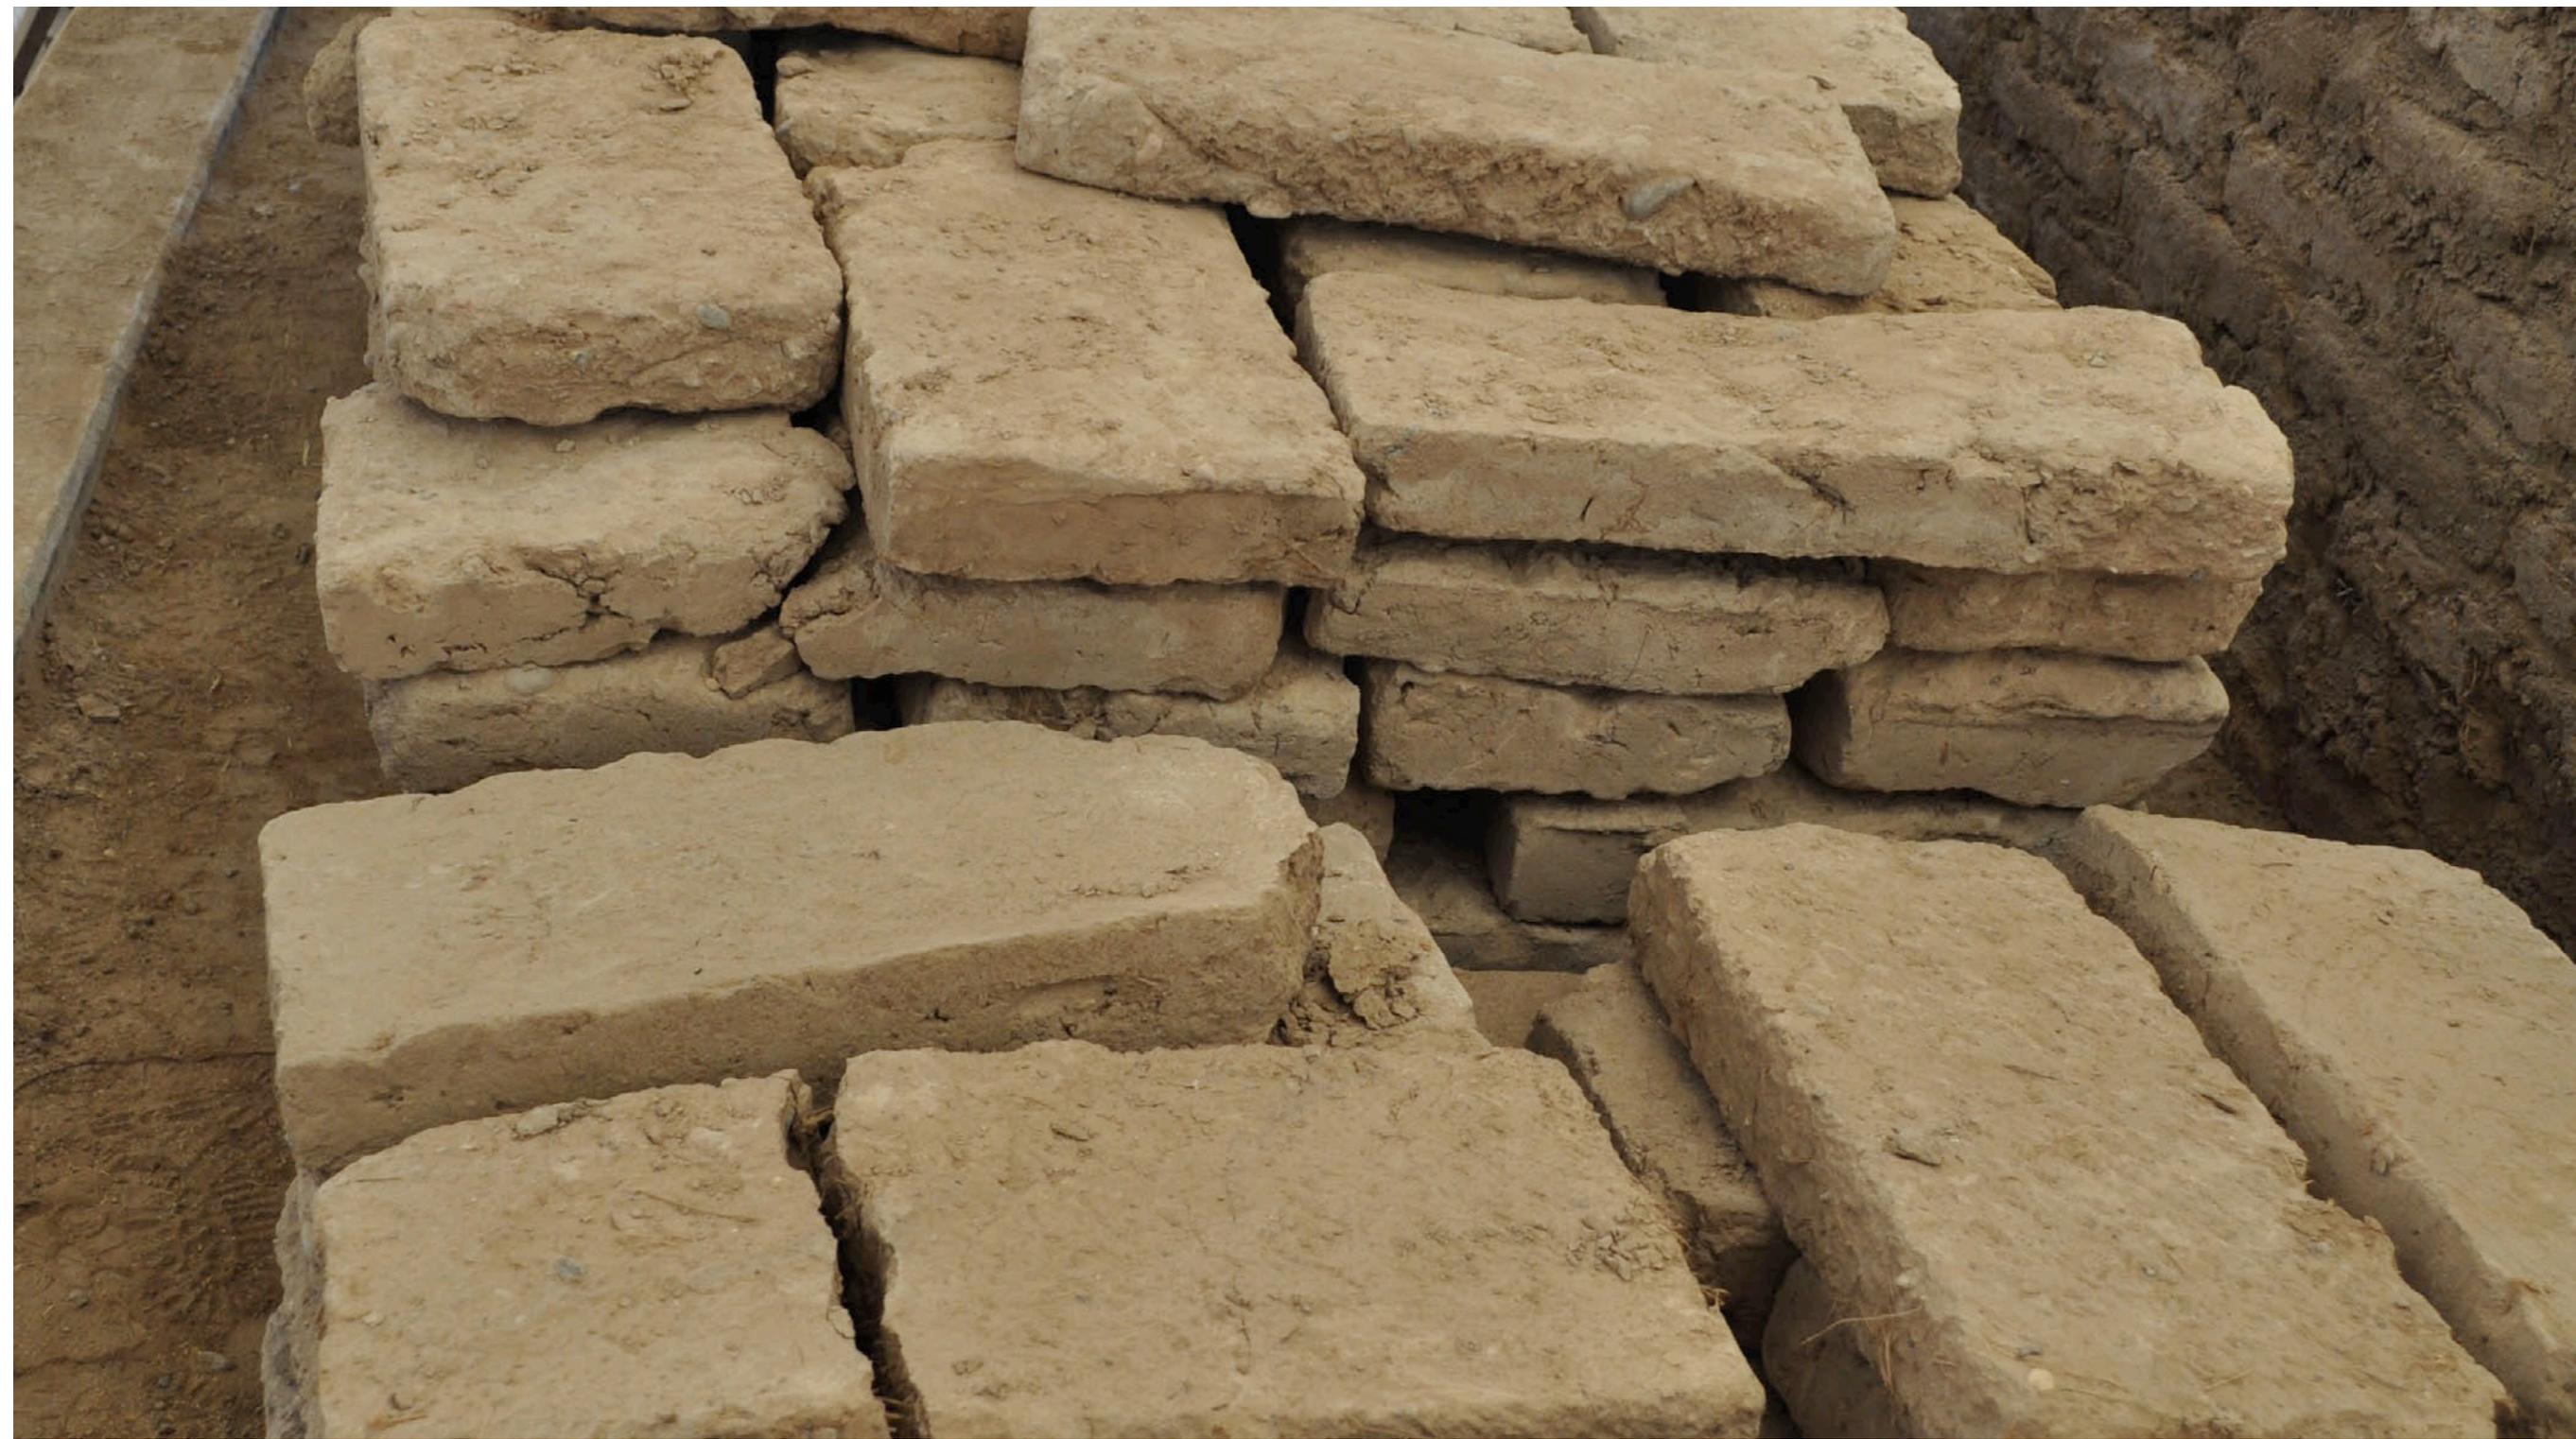
The Isleta adobes were roughly 10 x 23 x 2-1/4" and are exceptionally durable; many were salvaged and re-used. The *terrones*, on the other hand, were weak to begin with and many had to be replaced.

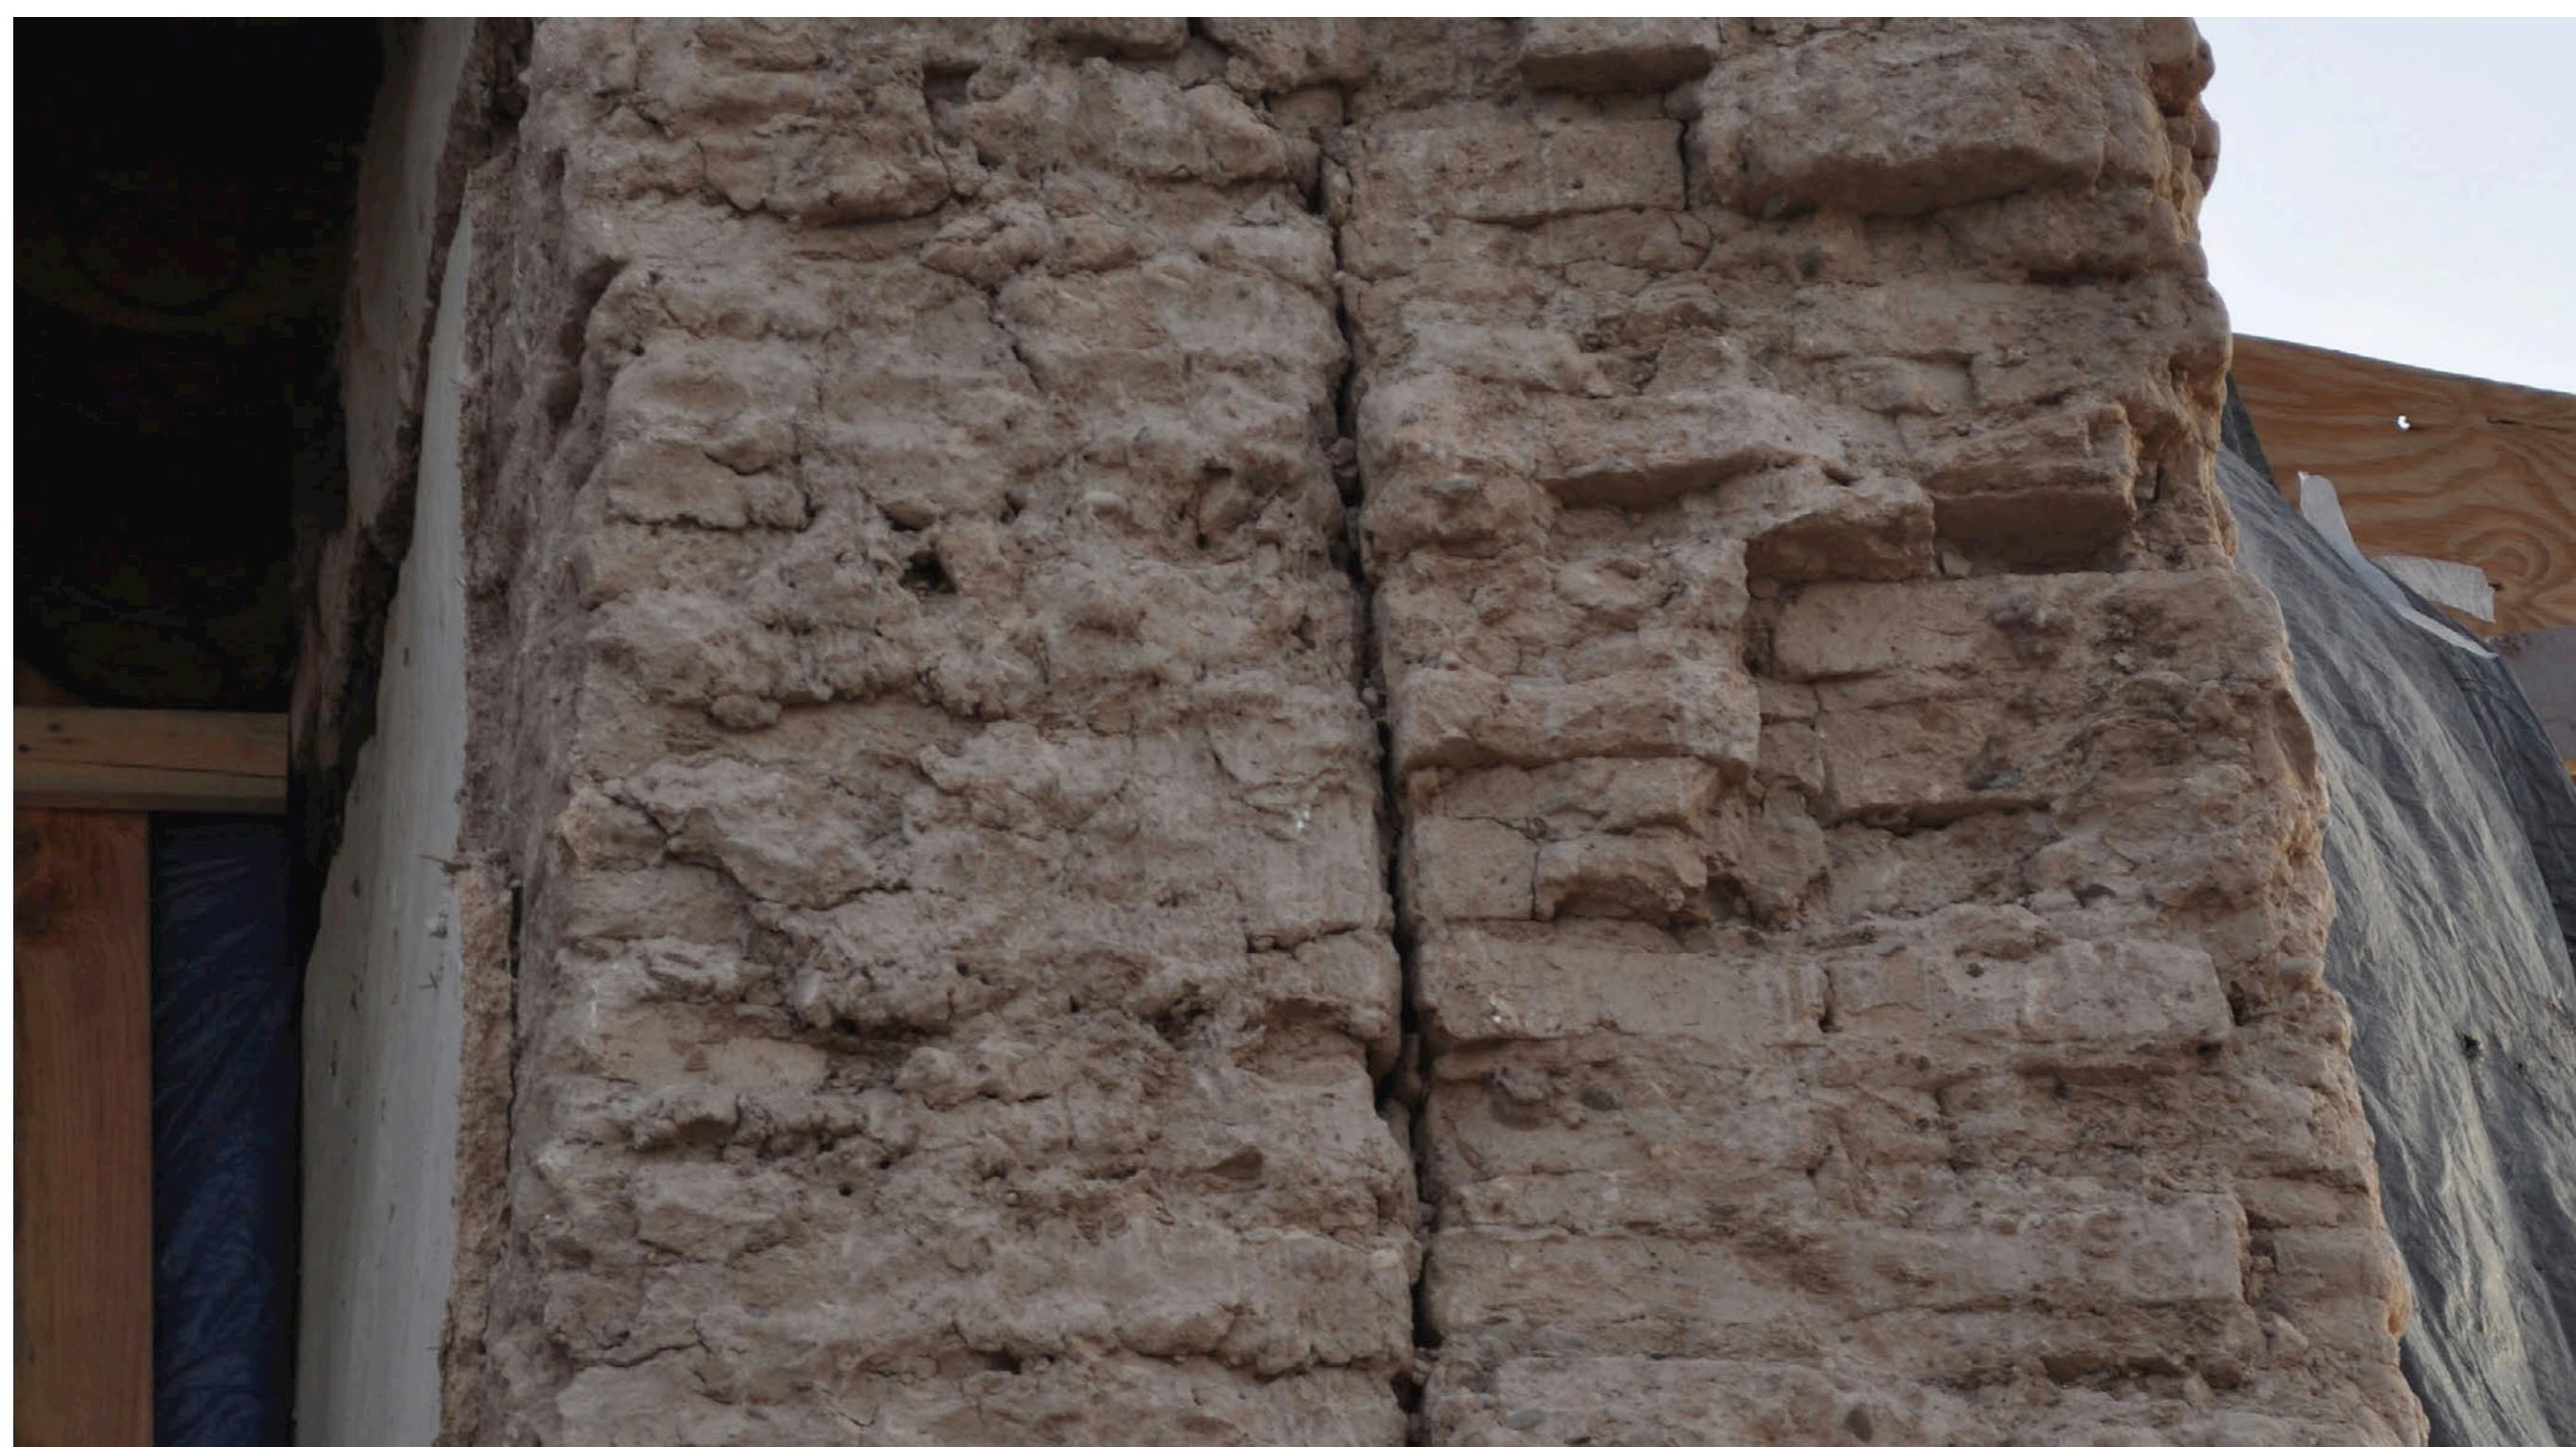
Another unsettling discovery was that the core building had been built during two campaigns. The outside wythe was first and either failed or was expected to. An additional inner wythe, essentially a veneer, was installed. The walls were independent of each other and basically free-standing. Our solution was to retrofit wall ties using treated wood where possible, and steel through-bolts where necessary.
