# The Resurrection of St. Augustine

The story of a hundred-year fix

The mission St. Augustine at Isleta Pueblo, NM was built in 1613 and has, over the centuries, undergone many modifications. This image shows the building as it appeared in 2005, as the Pueblo began its drive to restore the historic church. In 2010 Crocker Ltd was selected as the contractor and Neil Carter Associates was the project manager.

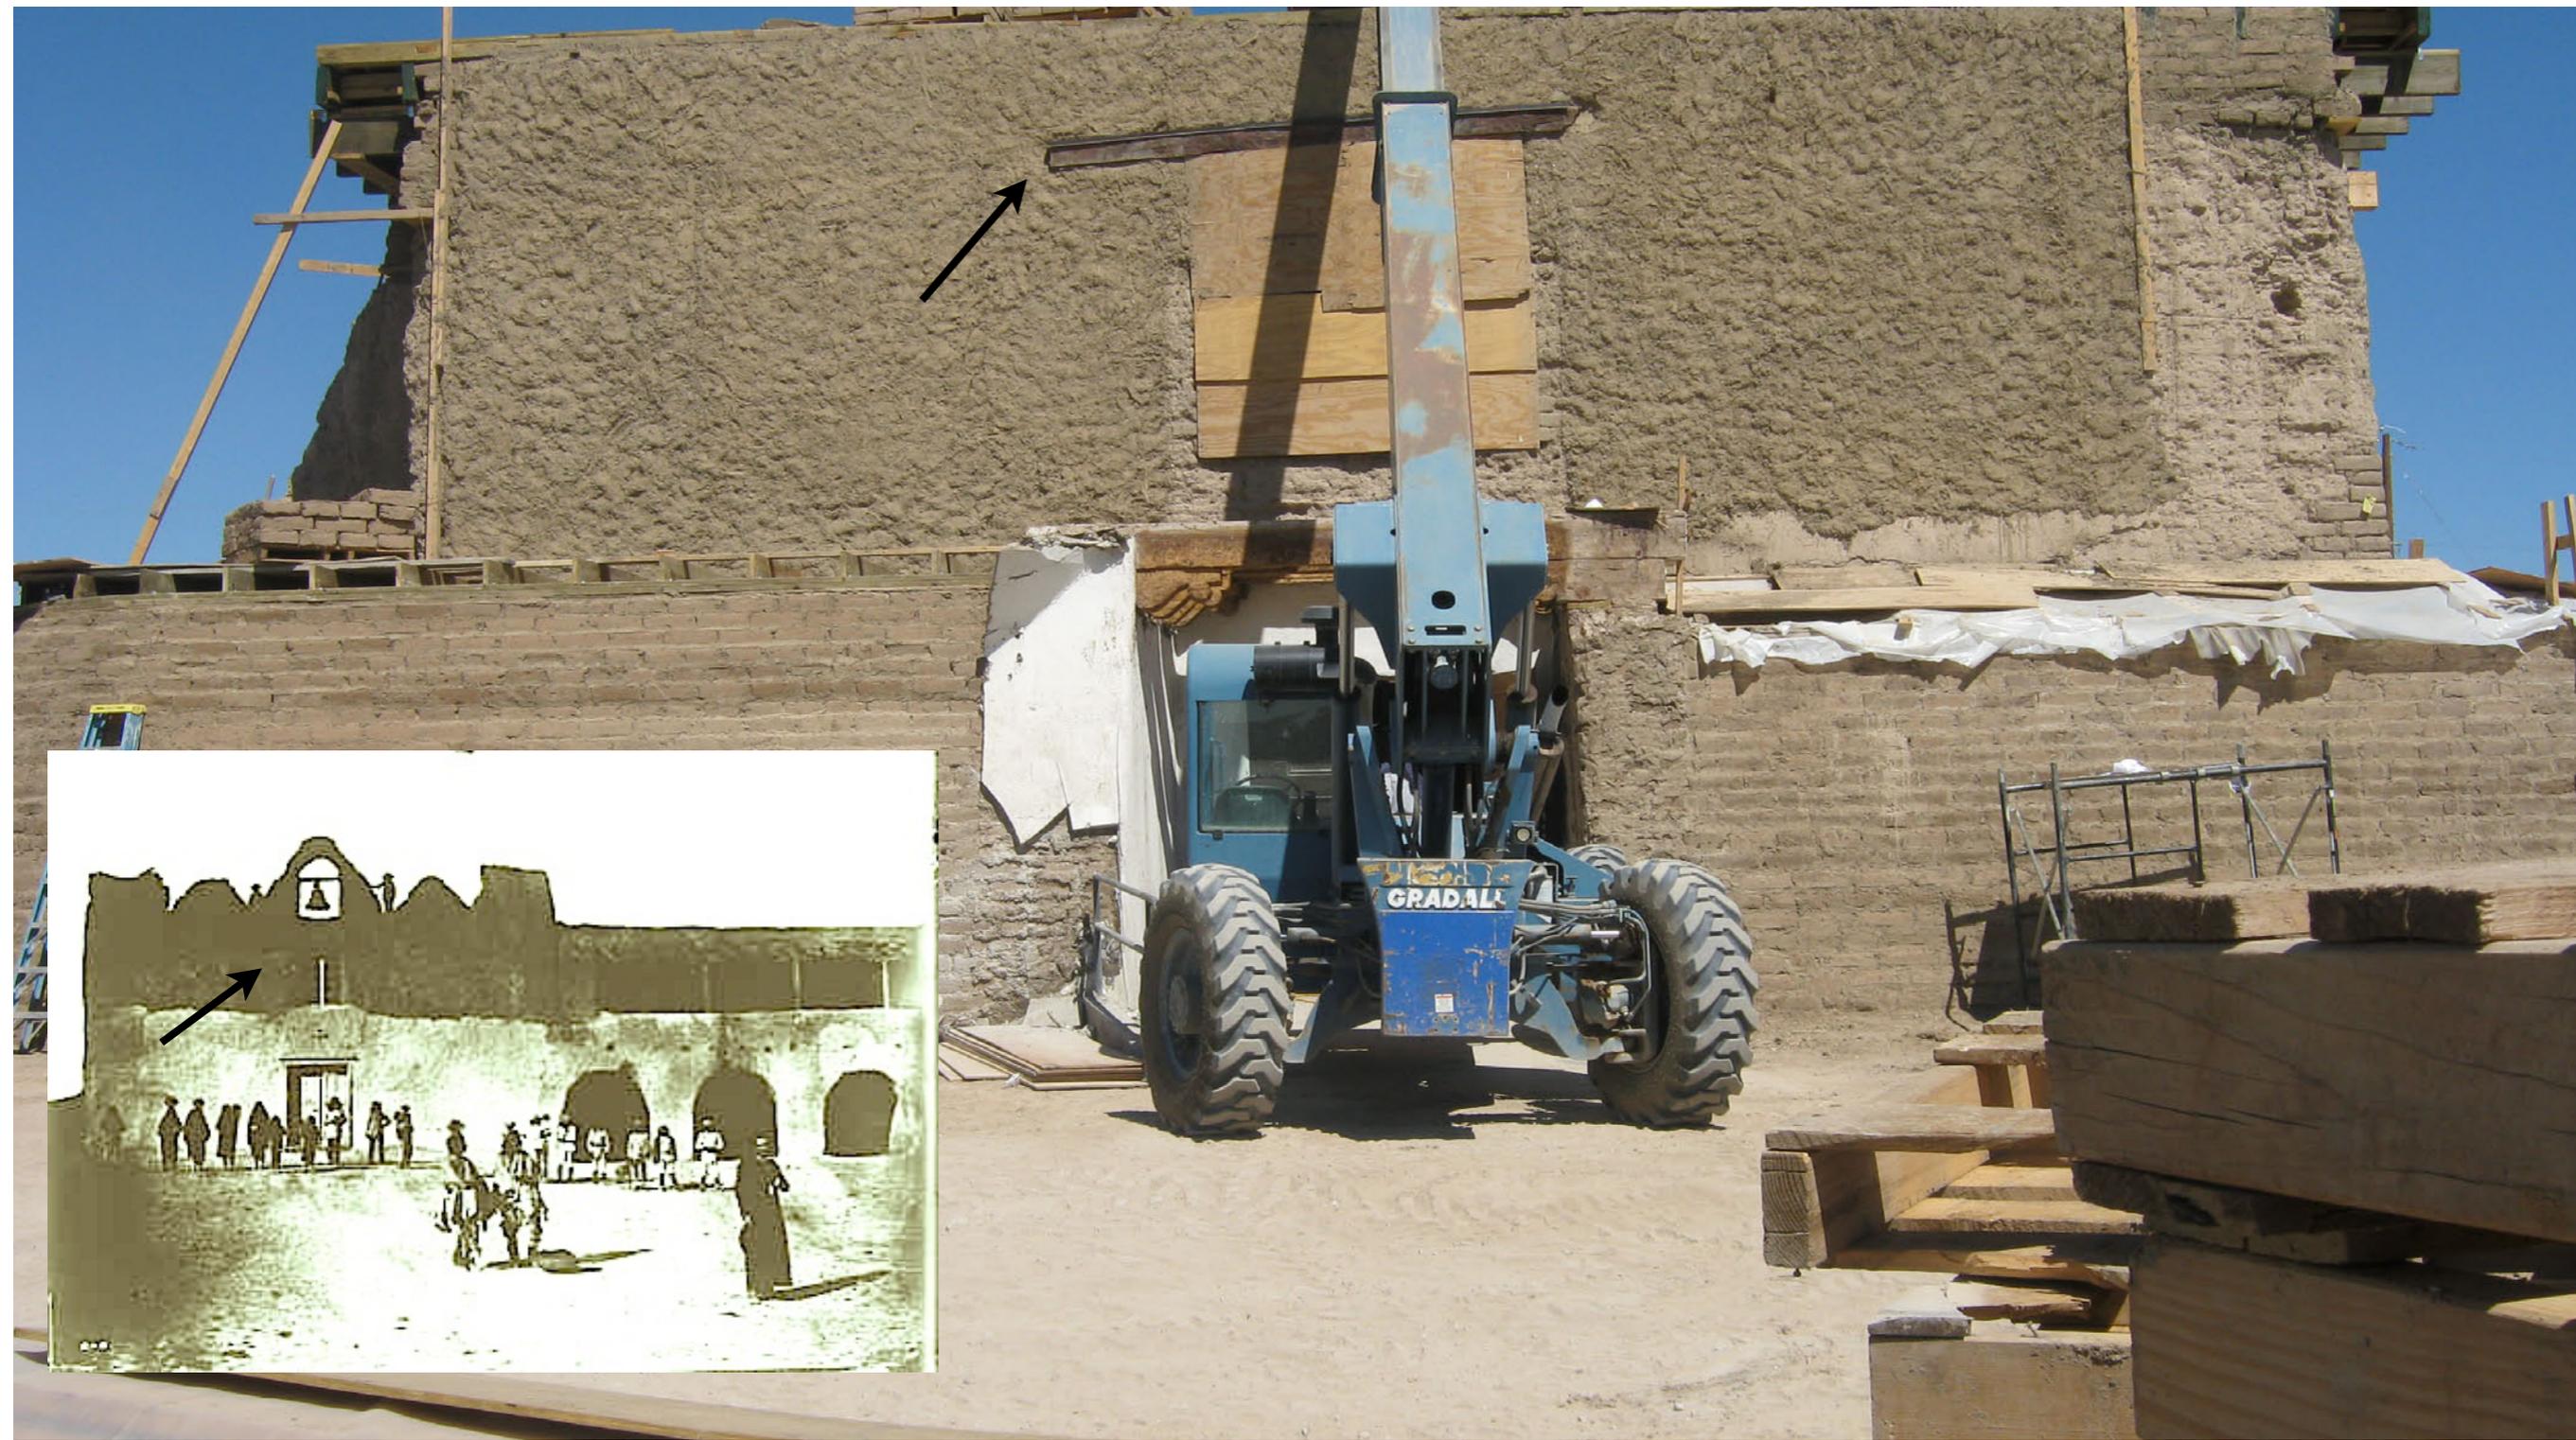
The south facade after stabilization and a mud leveling coat on the upper walls. Note the beam over the choir window. It appears in the first known photo of the mission, *ca.* 1867. As one of the earliest visible features, it was stabilized and replaced in its asymmetric location.

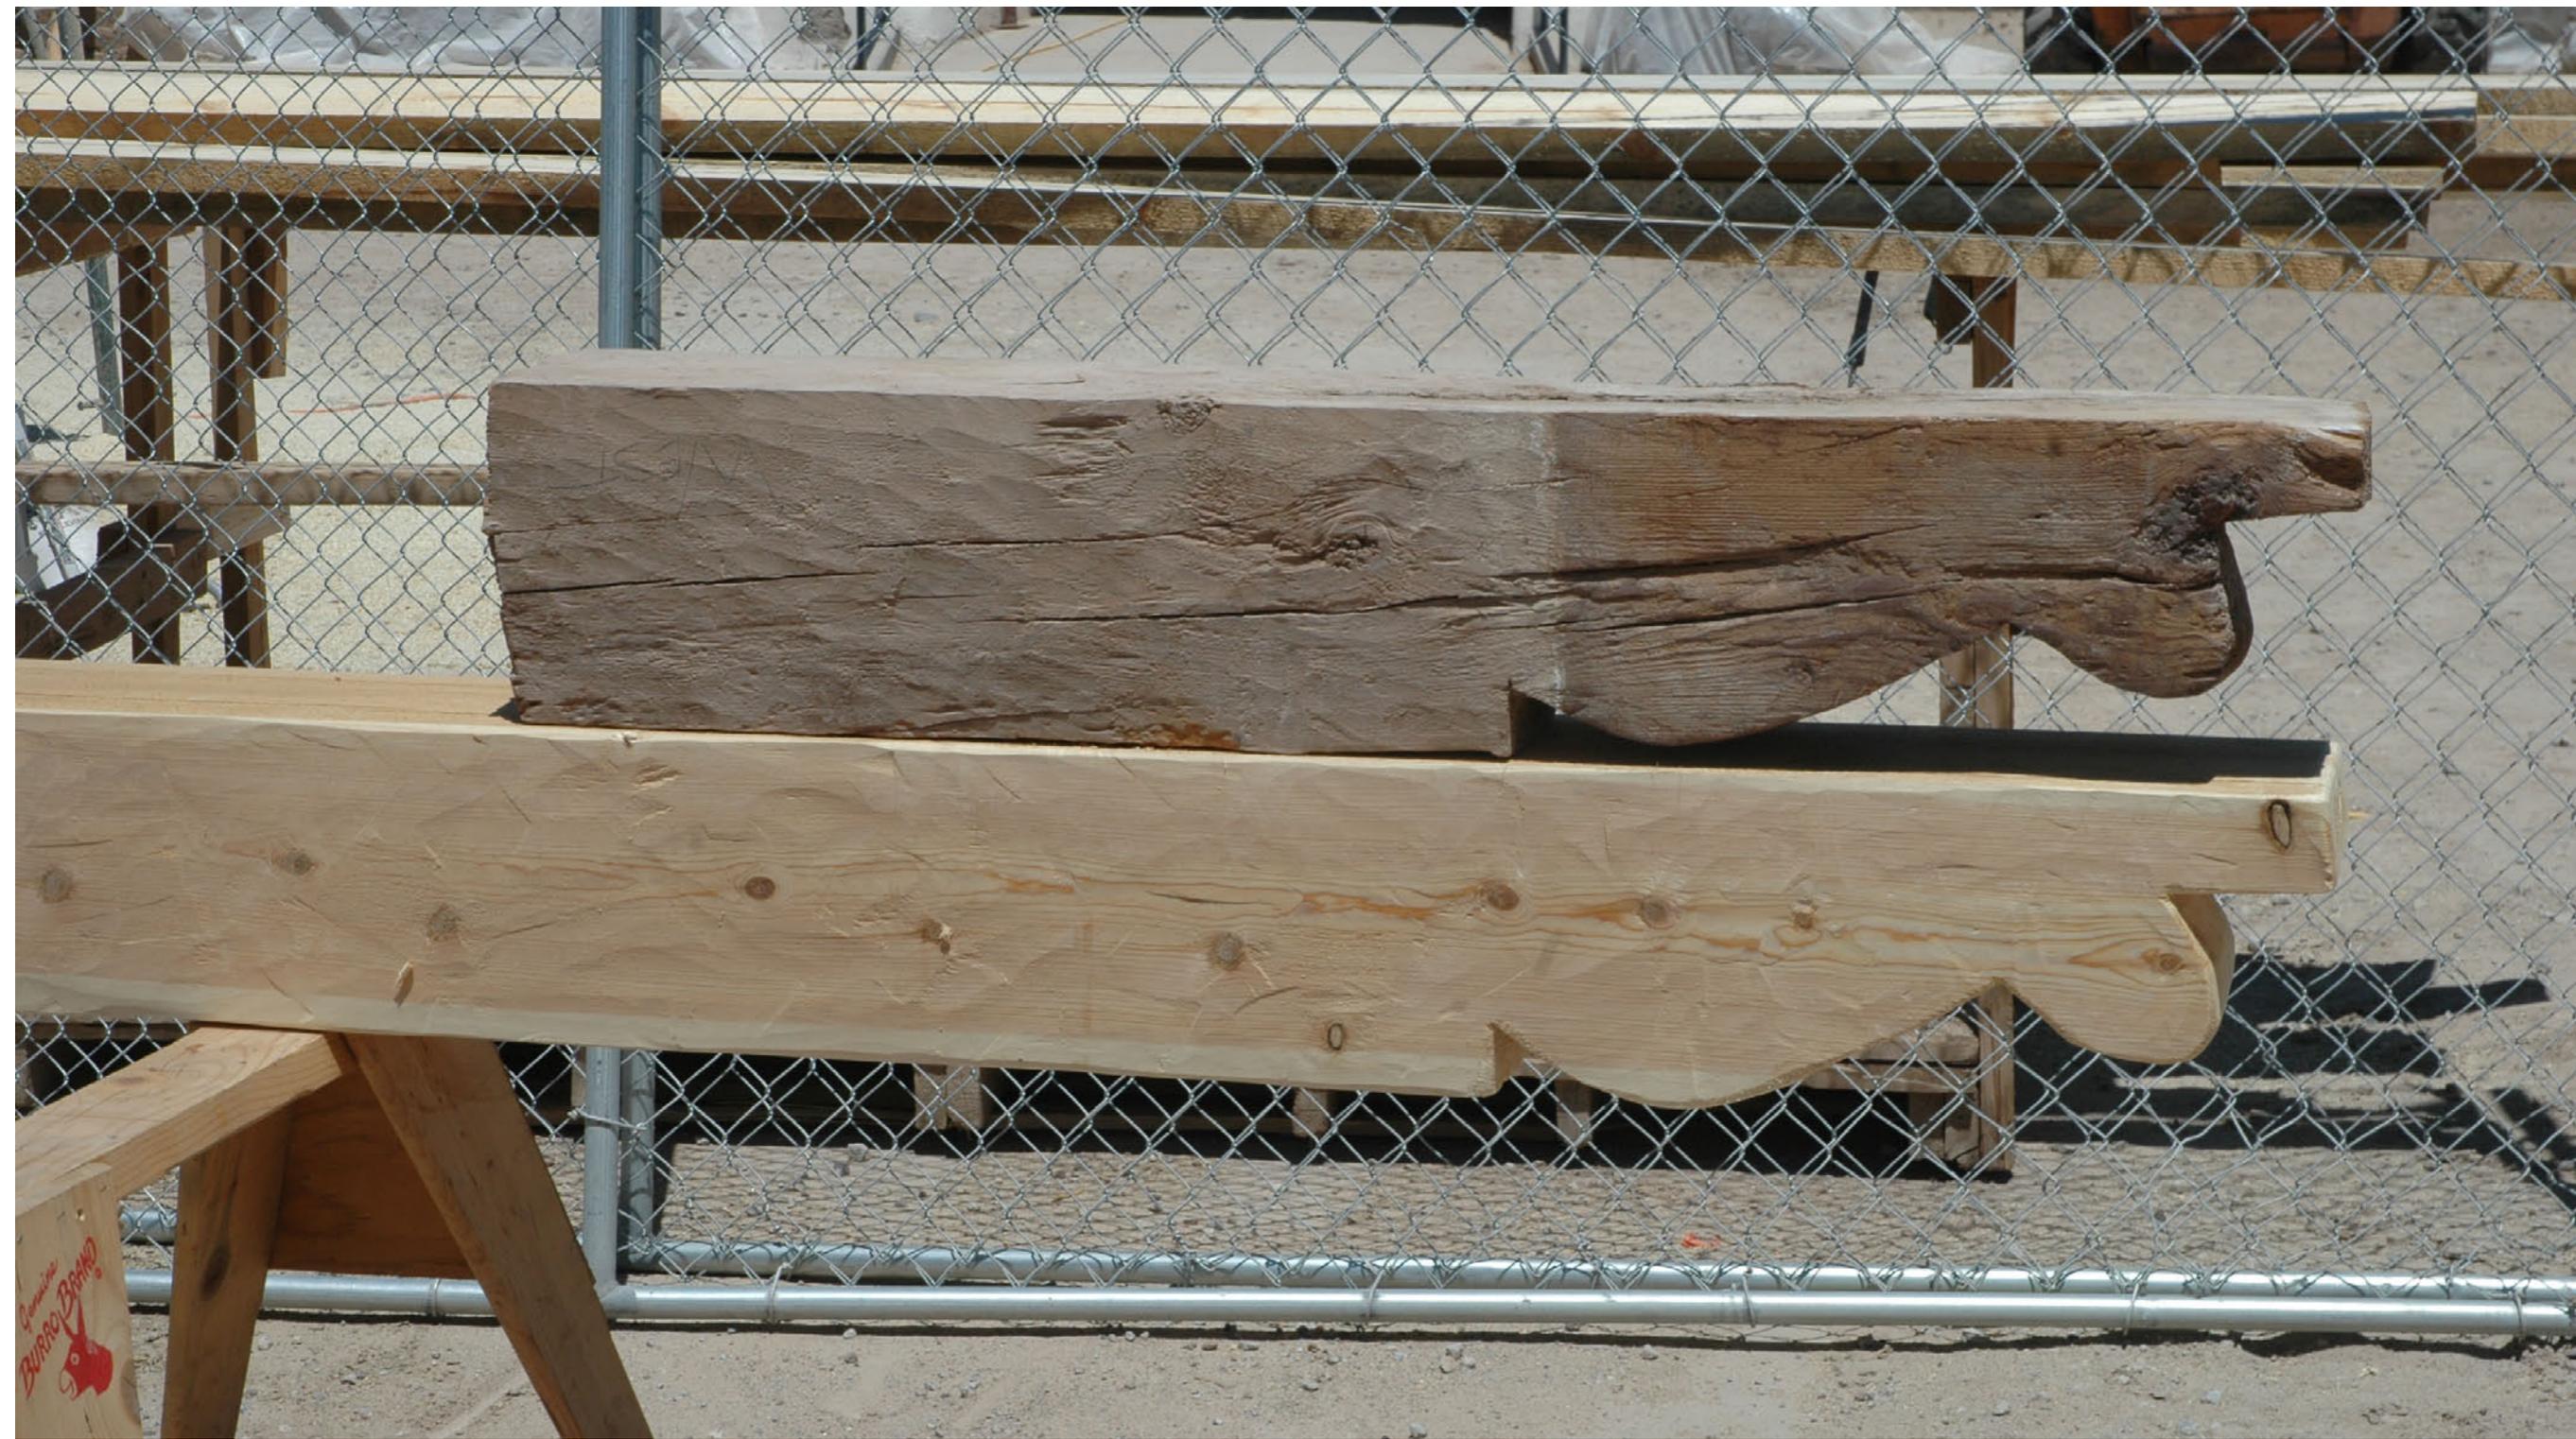
A late 20th century fire in the narthex left the underside of the choir loft largely destroyed and a reconstruction at the time was not true to the original. The restoration committee opted to completely restore the choir loft. Here, the carved beams are being prepared using one of the remnants as a template.

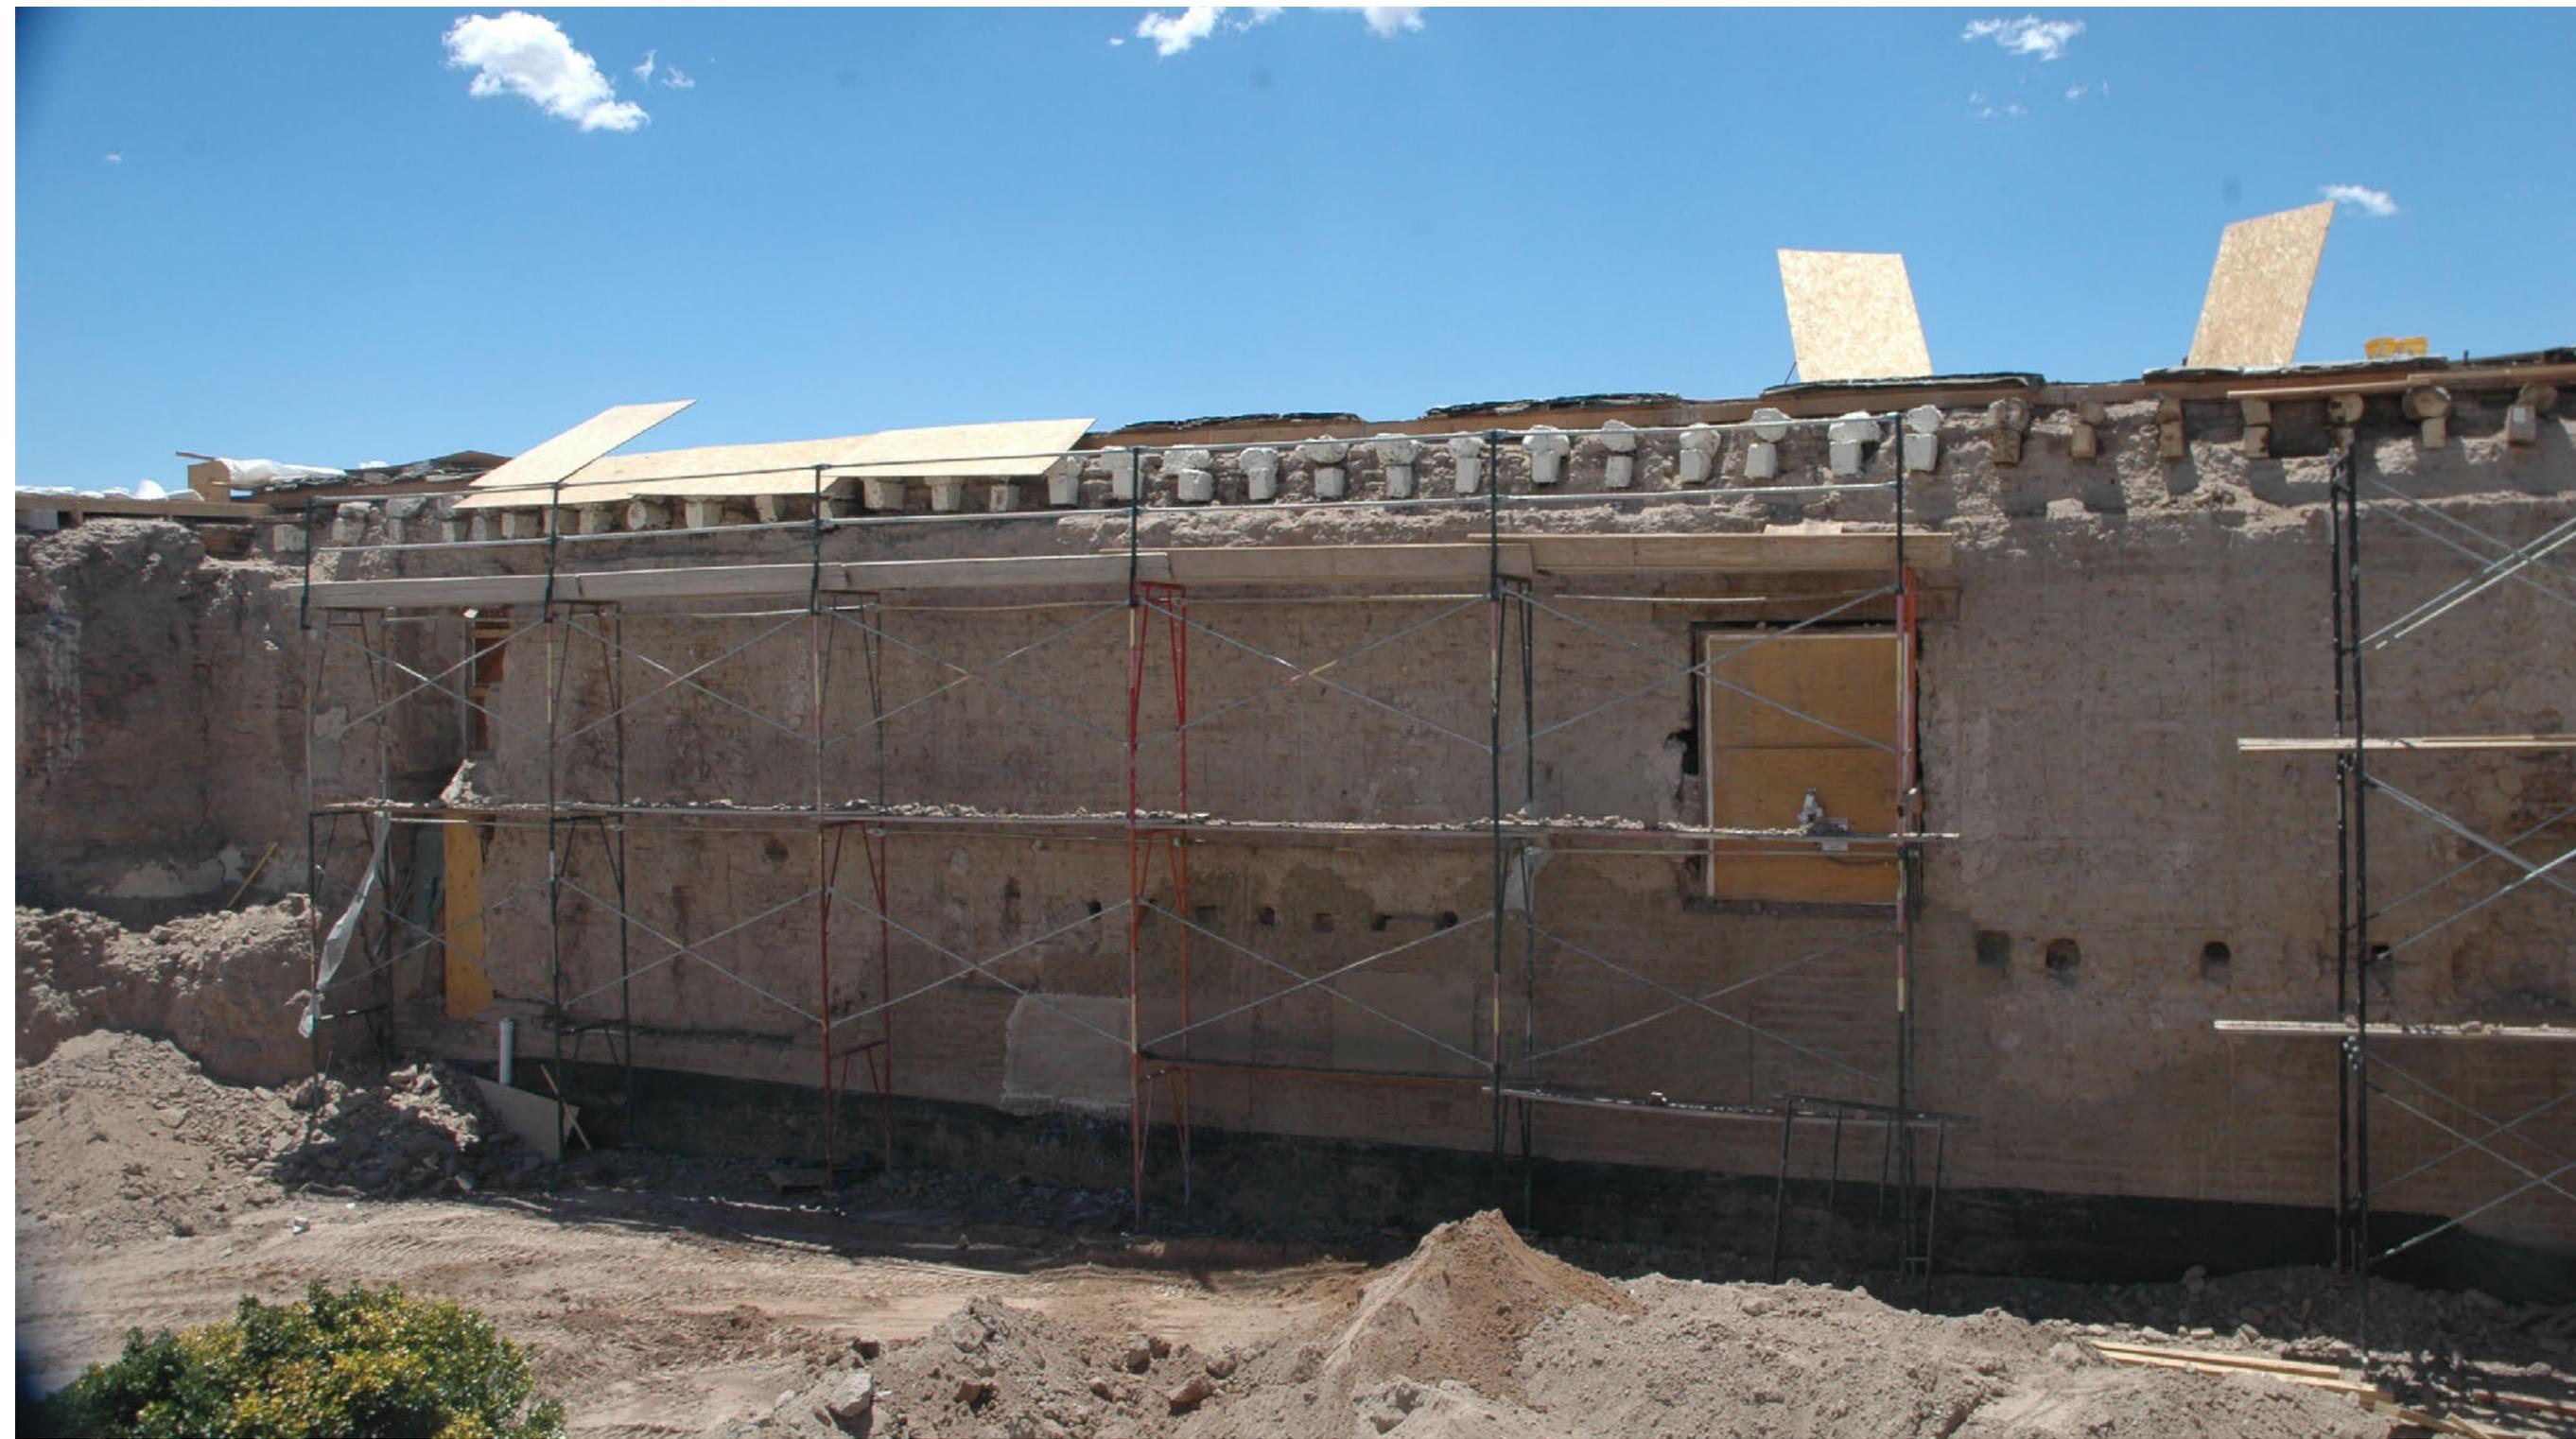
The east facade after being stripped and in the early stages of restoration. Note the beam sockets, remnants of the *convento* that has long since been demolished. Rectified photos of all elevations were part of the documentation.

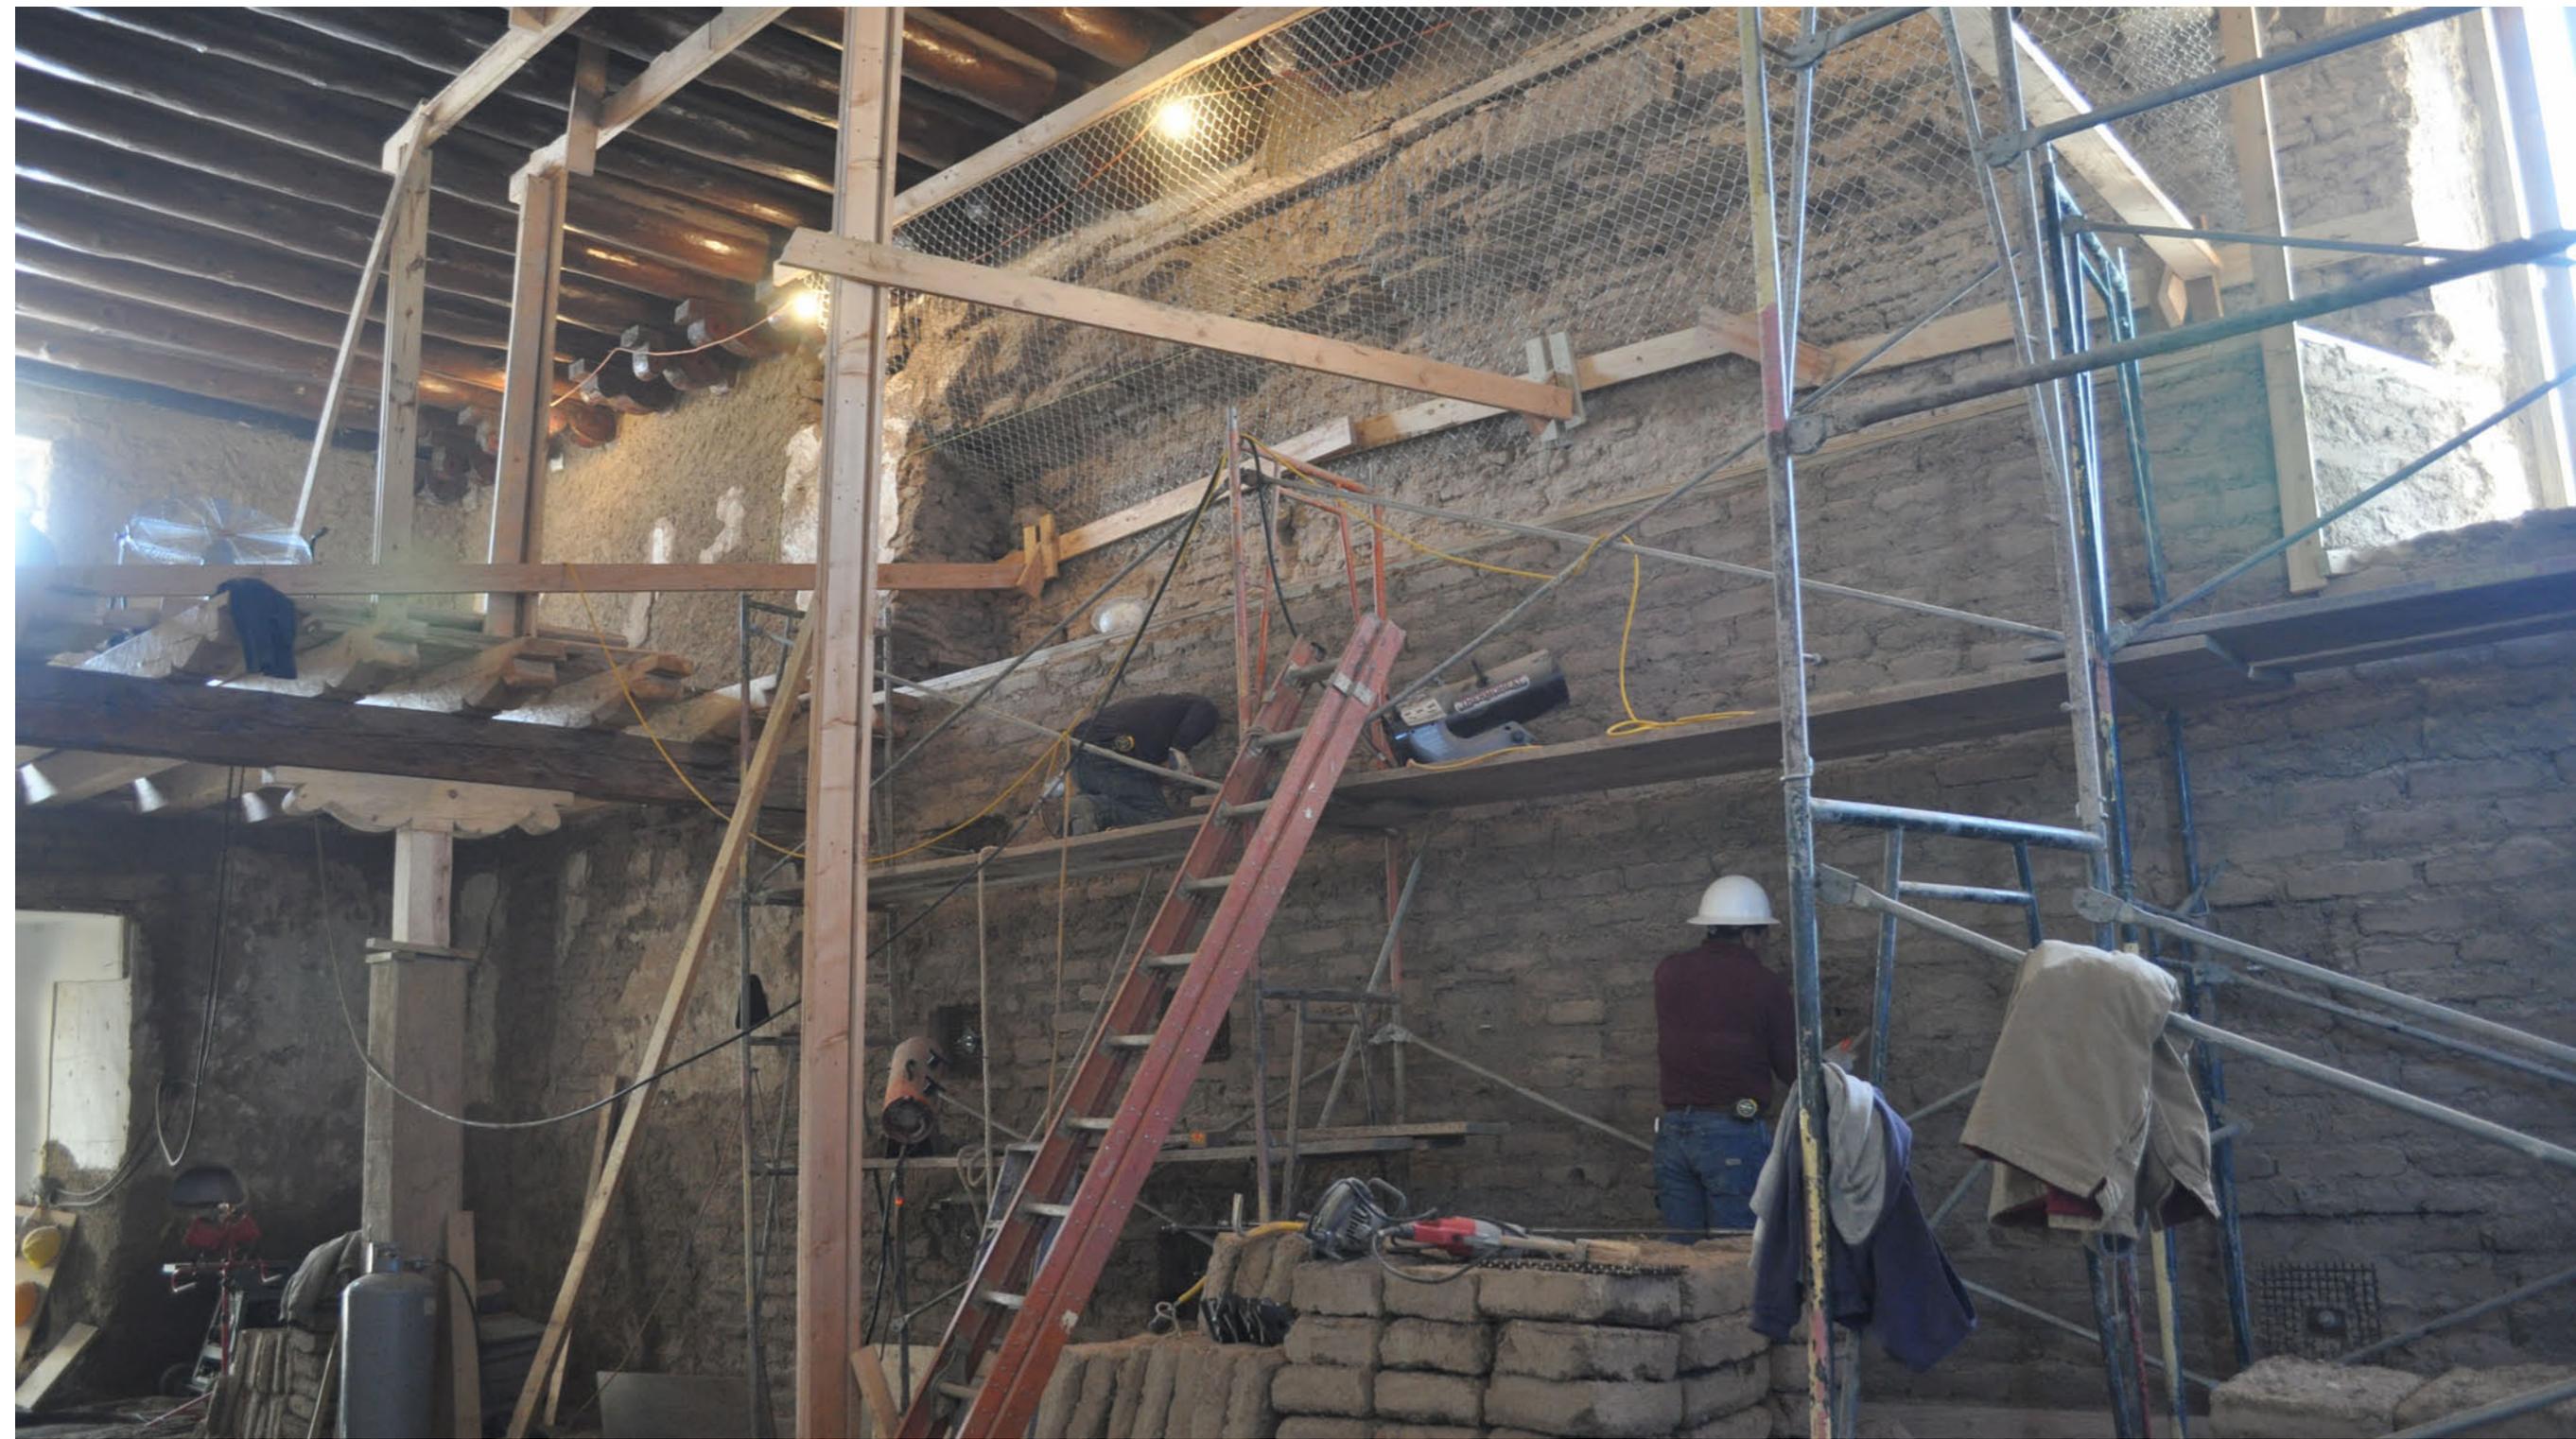
The interior west wall suffered a partial collapse of the veneer. Here the rebuilding of that wall is roughly 50% complete. More than 75,000 new, unamended adobes were used overall to complement the thousands that were recycled.
