# PAINTED KIVA CORONADO STATE MONUMENT

The restored kiva in the Pueblo of Kuaua (*ca.* 1300) contains now-historic replicas of painted murals, the originals of which are widely considered to be among the finest examples of pre-contact art in North America. The New Mexico Office of Cultural Affairs contracted with Crocker & Associates to perform a comprehensive assessment and present an outline strategy for treatment.

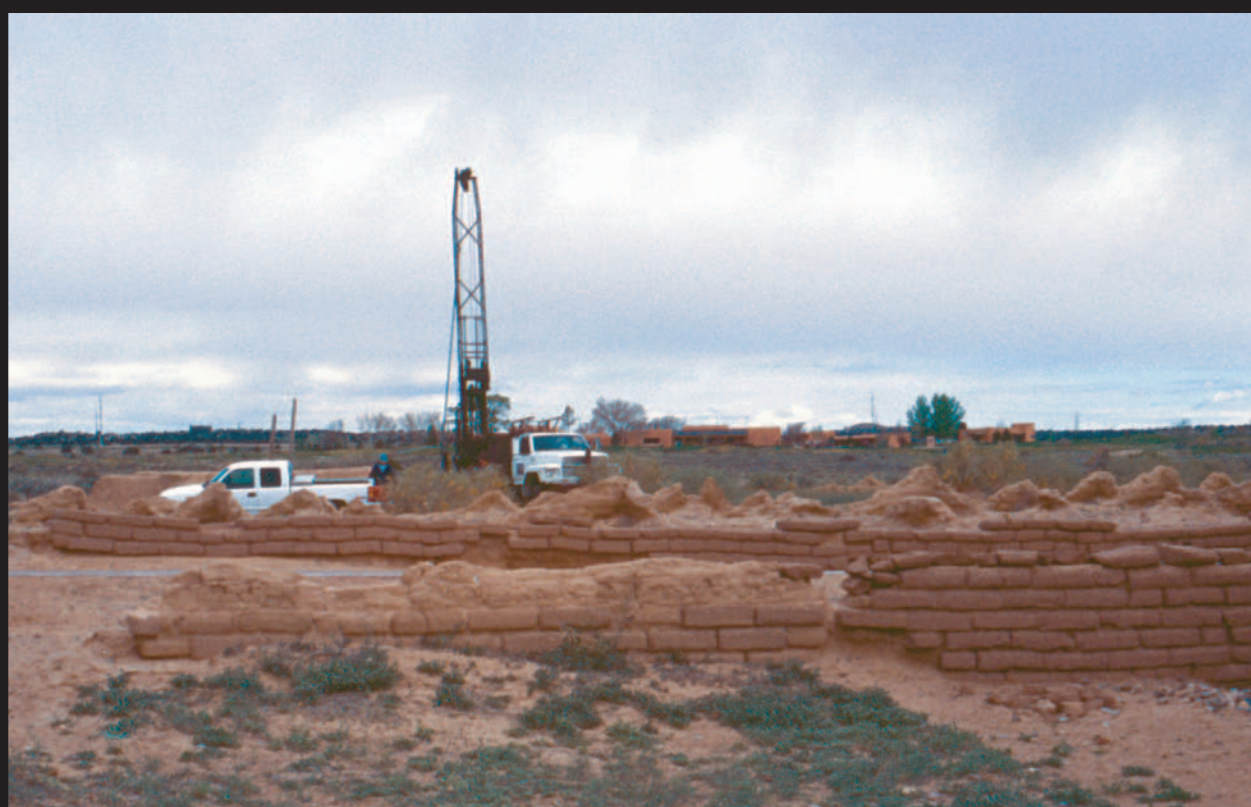
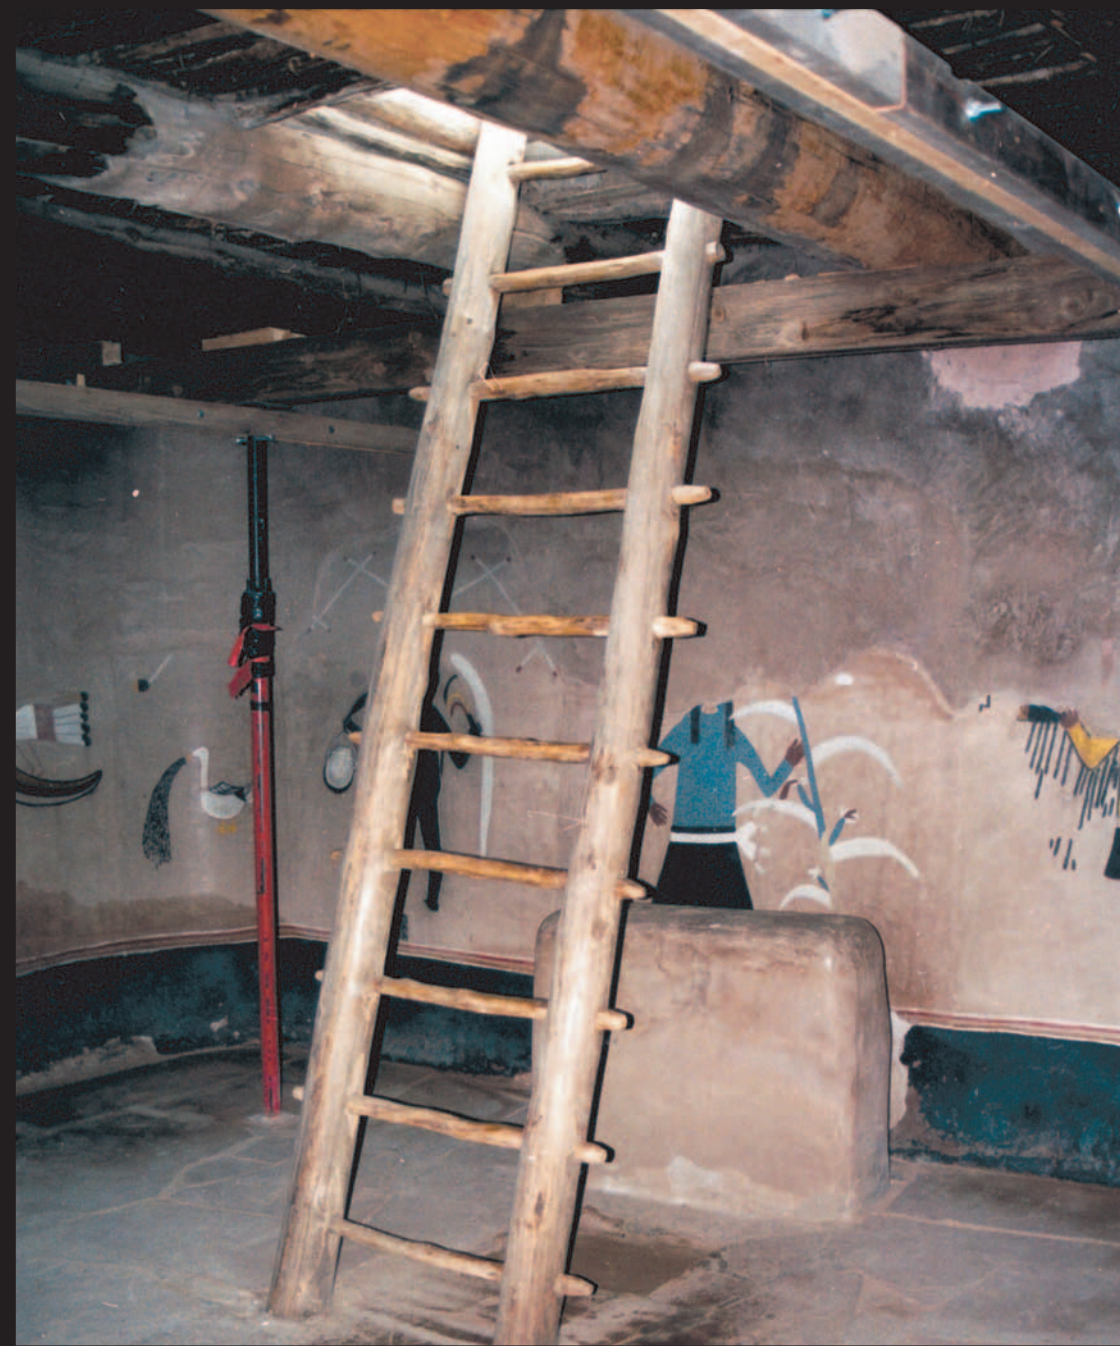
A cast concrete roof, impermeable plasters and flagstone floor had retained moisture, causing considerable damage to the murals, as well as structural damage to the earthen walls and supporting vigas.

The assessment included an analysis of the surrounding soils, characterization of the plasters and paint, and a structural evaluation of all elements in the kiva. Recommendations included installing a redundant interceptor drain and non-invasive underpinning of the failed walls.
