# The Resurrection of St. Augustine

The story of a hundred-year fix

The mission St. Augustine at Isleta Pueblo, NM was built in 1613 and has, over the centuries, undergone many modifications. This image shows the building as it appeared in 2005, as the Pueblo began its drive to restore the historic church. In 2010 Crocker Ltd was selected as the contractor and Neil Carter Associates was the project manager.

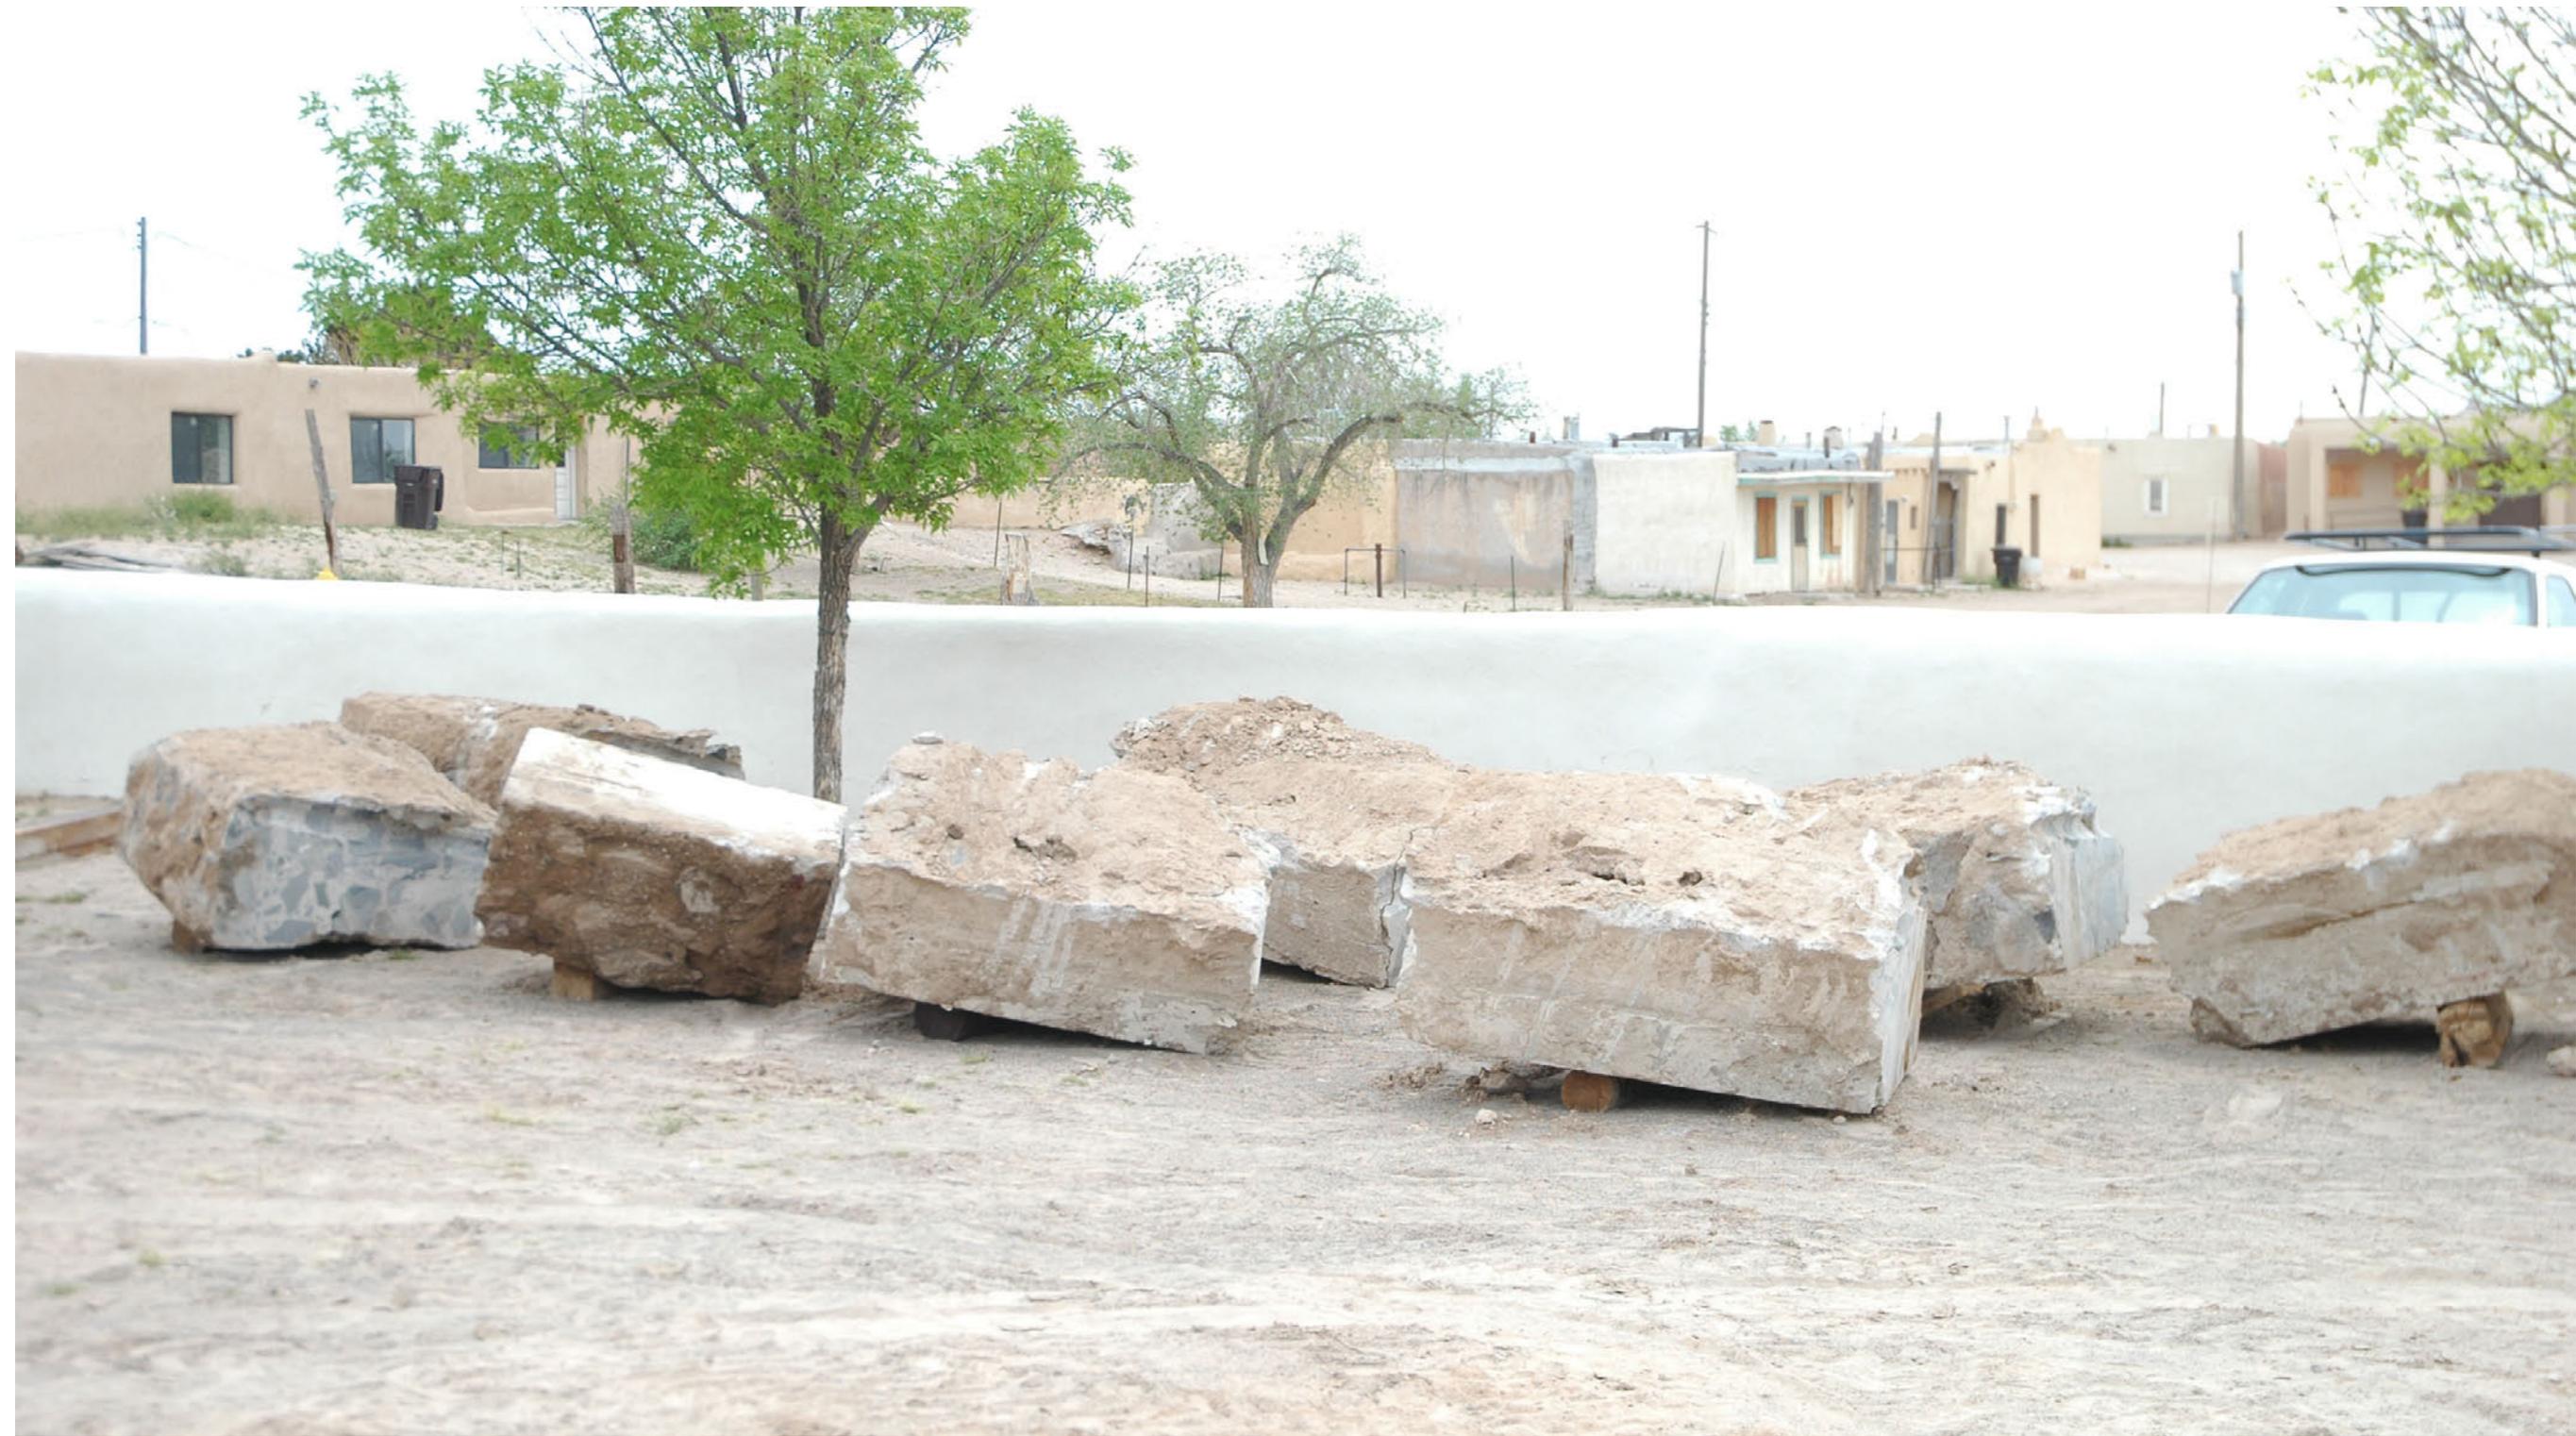
More than 375 tons of concrete were removed from the church.

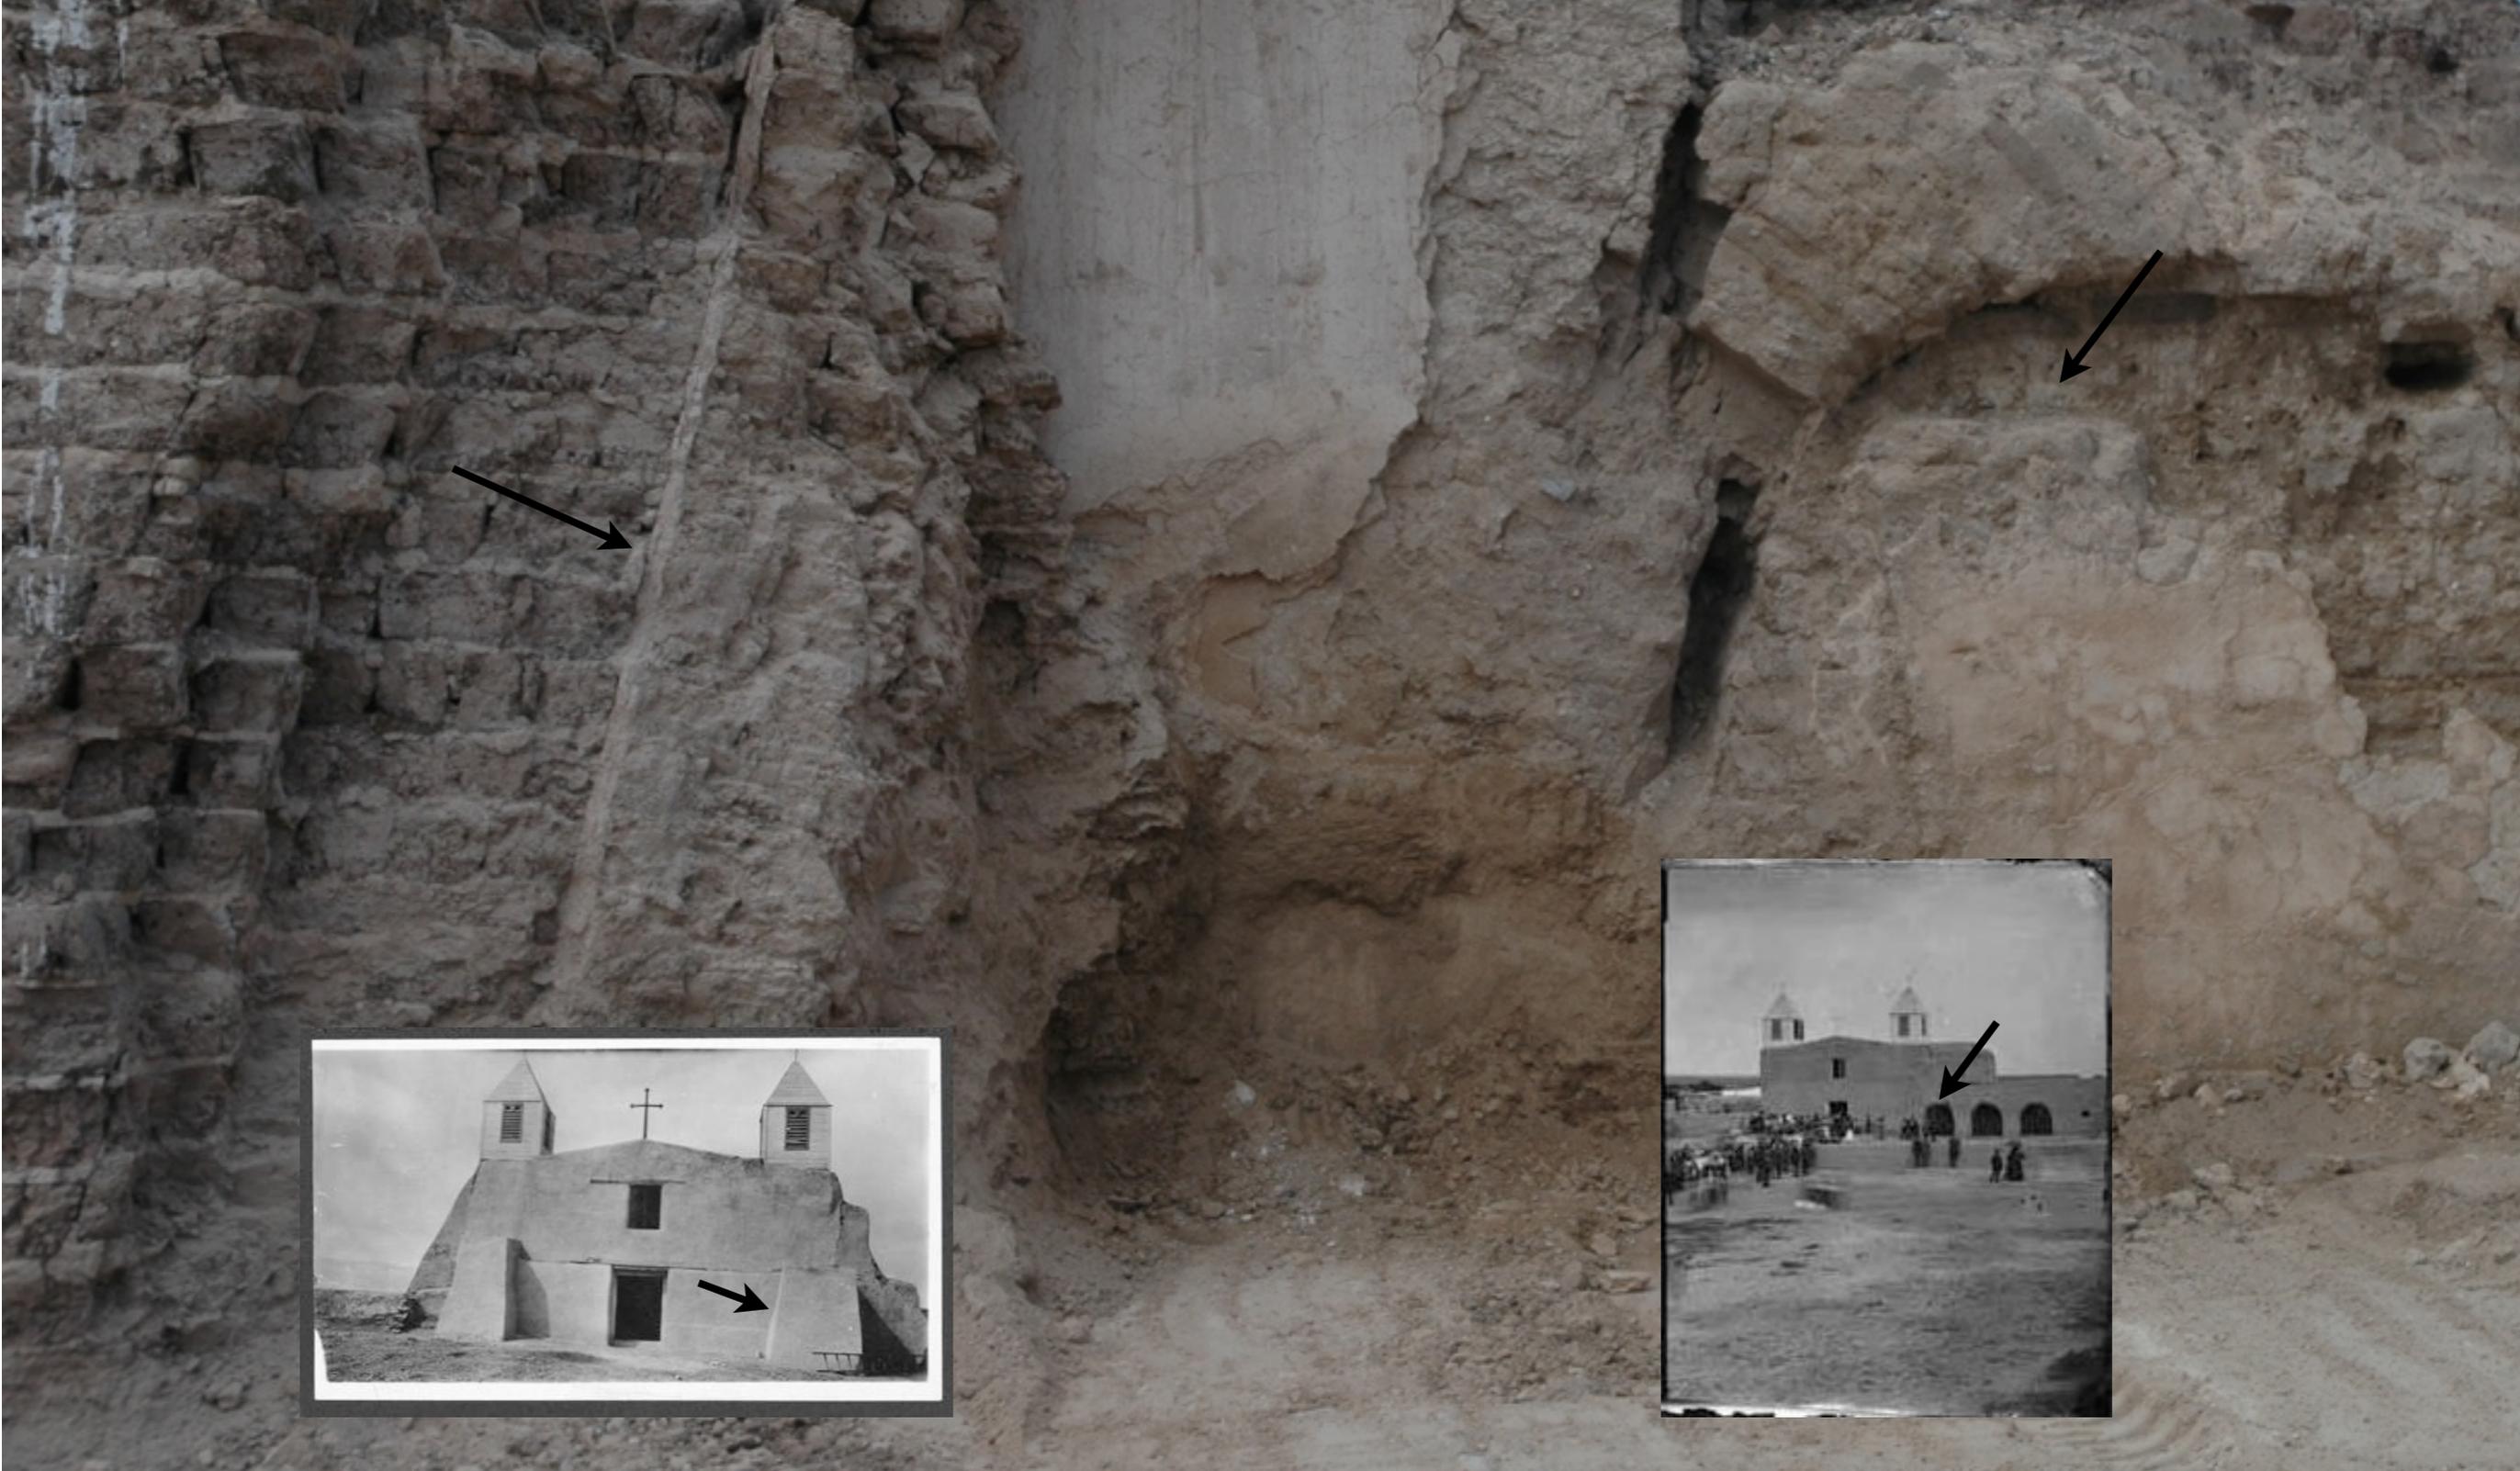
With the cement disguise removed, many architectural features were exposed. The near vertical line on the left indicates the edge of one of two trapezoidal buttresses from one of the church's many reconfigurations (photo *ca.* 1920). On the right can be seen the last vestige of the adobe arches that comprised a two story arcade (photo *ca.* 1880).

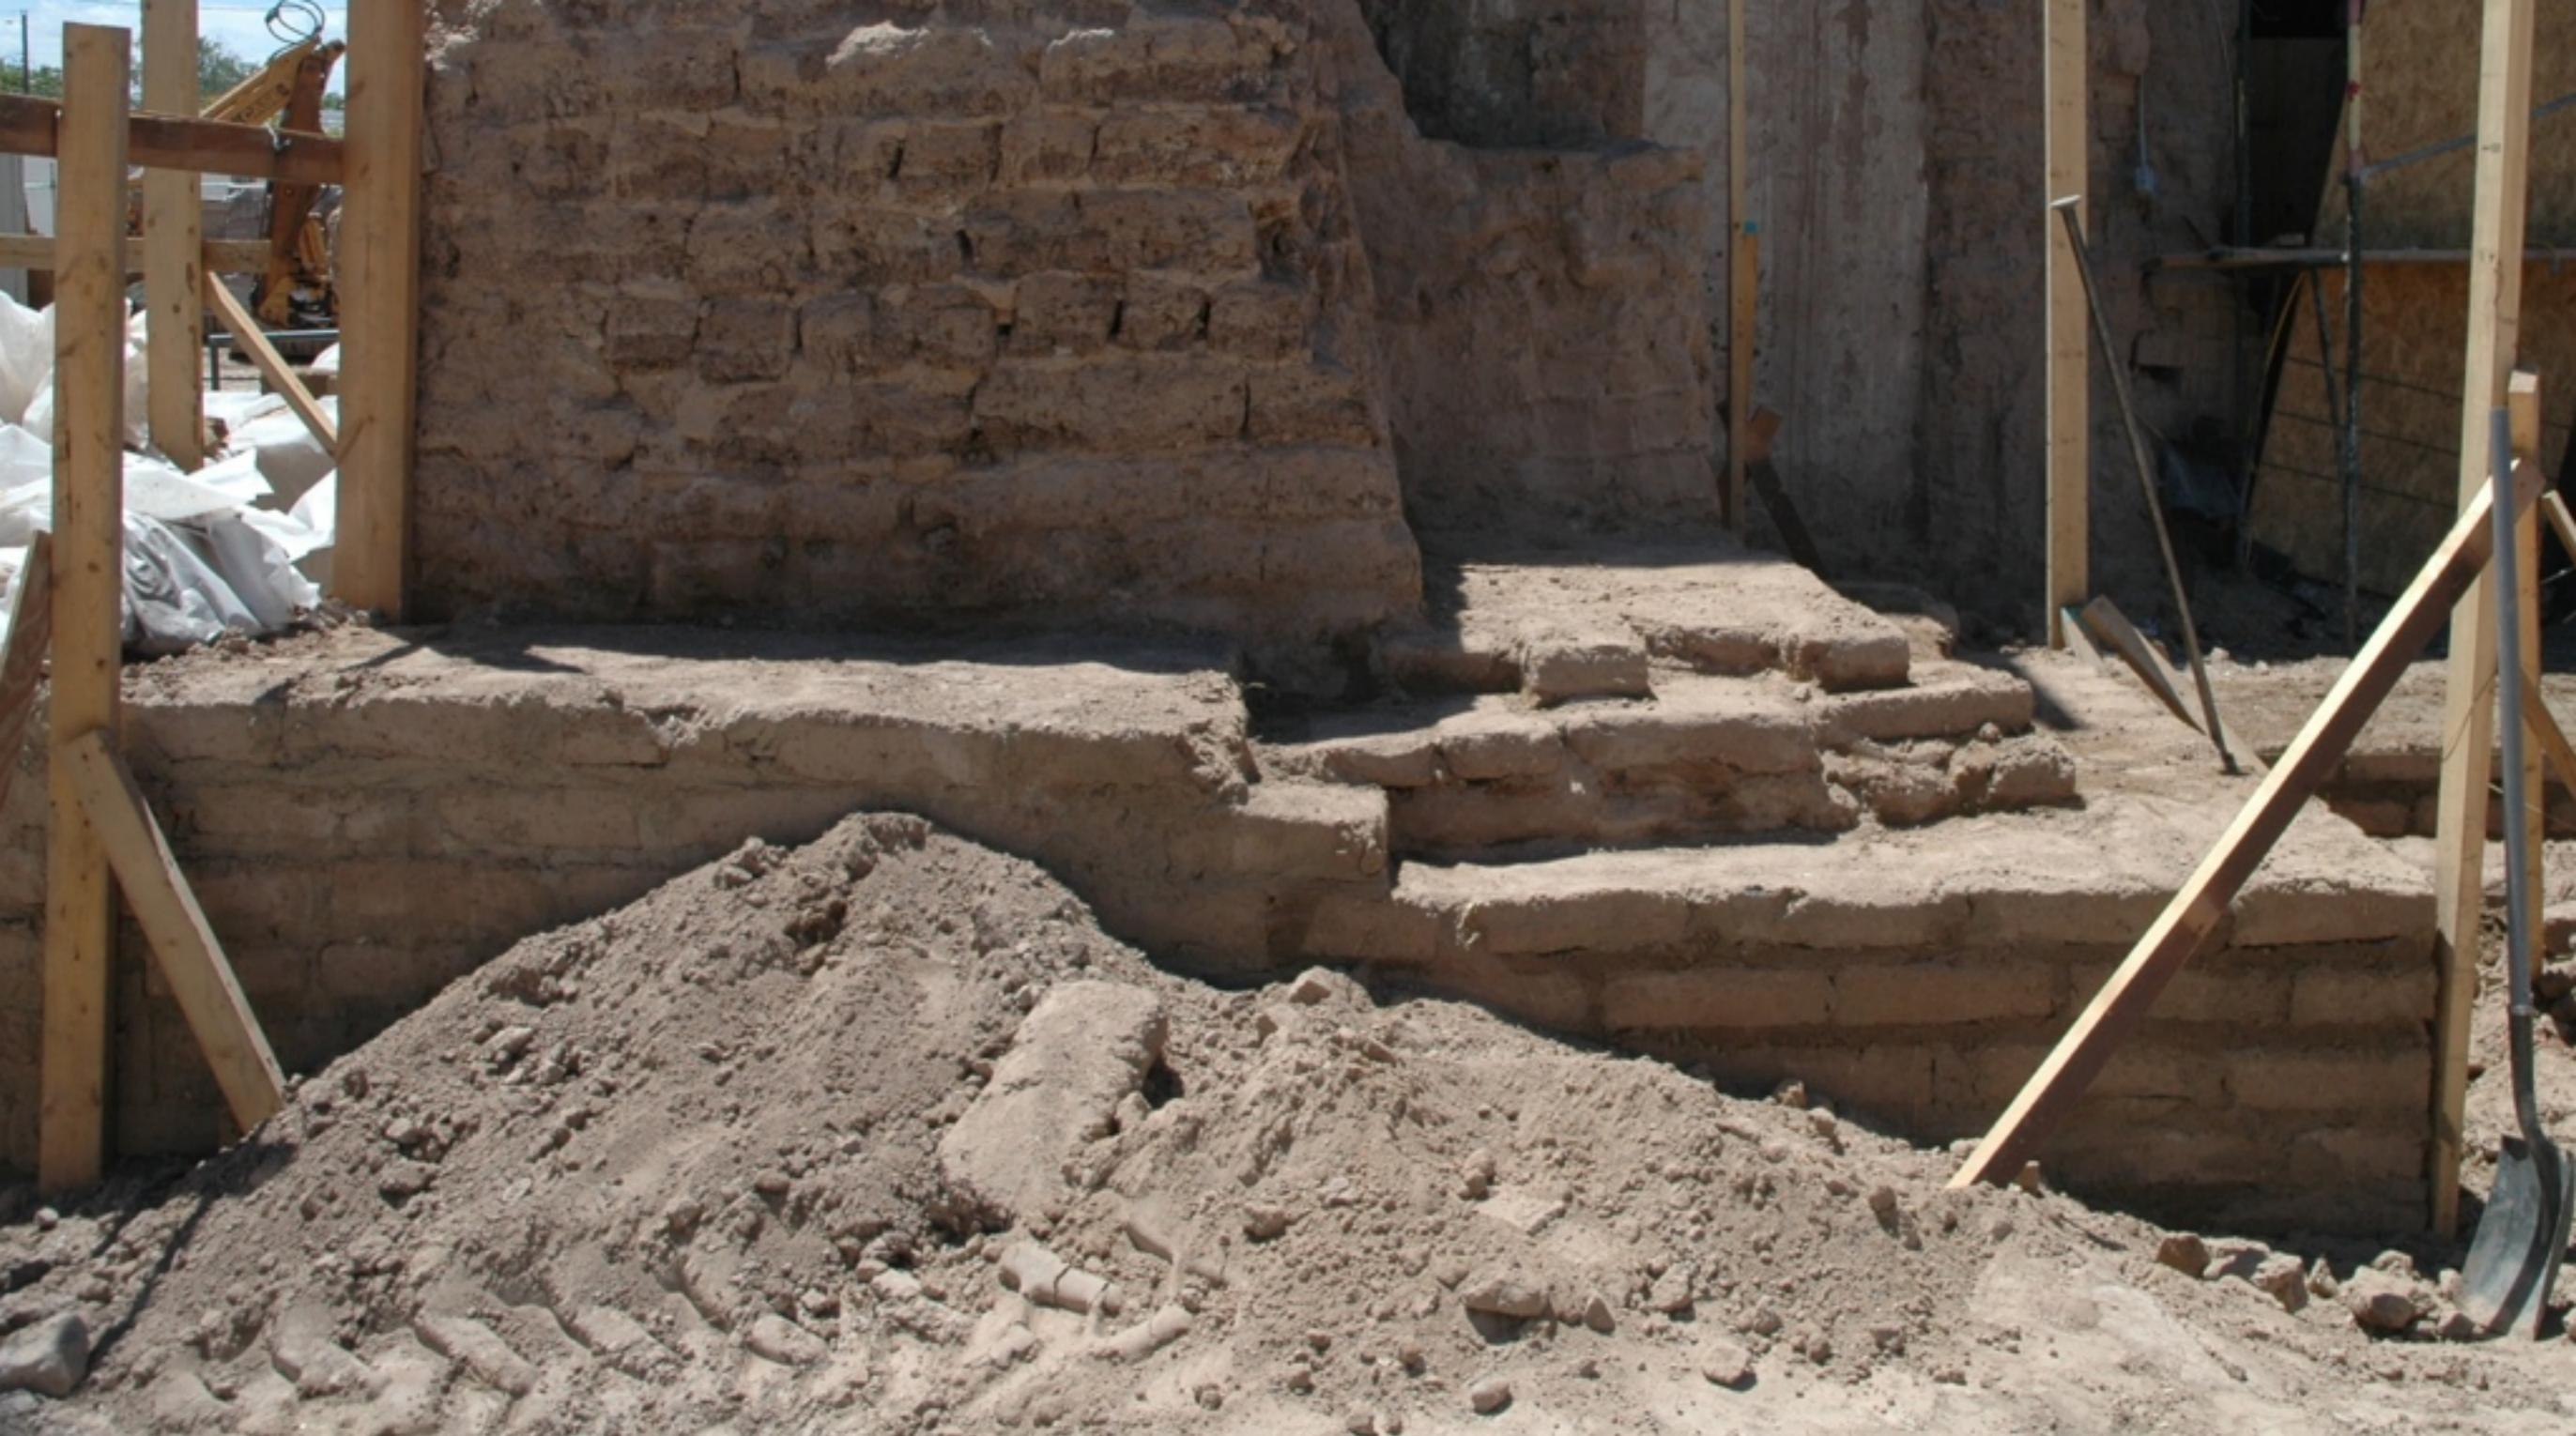
The original adobe and *terron* was left in place and incorporated in the restoration as much as possible. This is a view of the SE corner of the building where a *convento* was once attached.

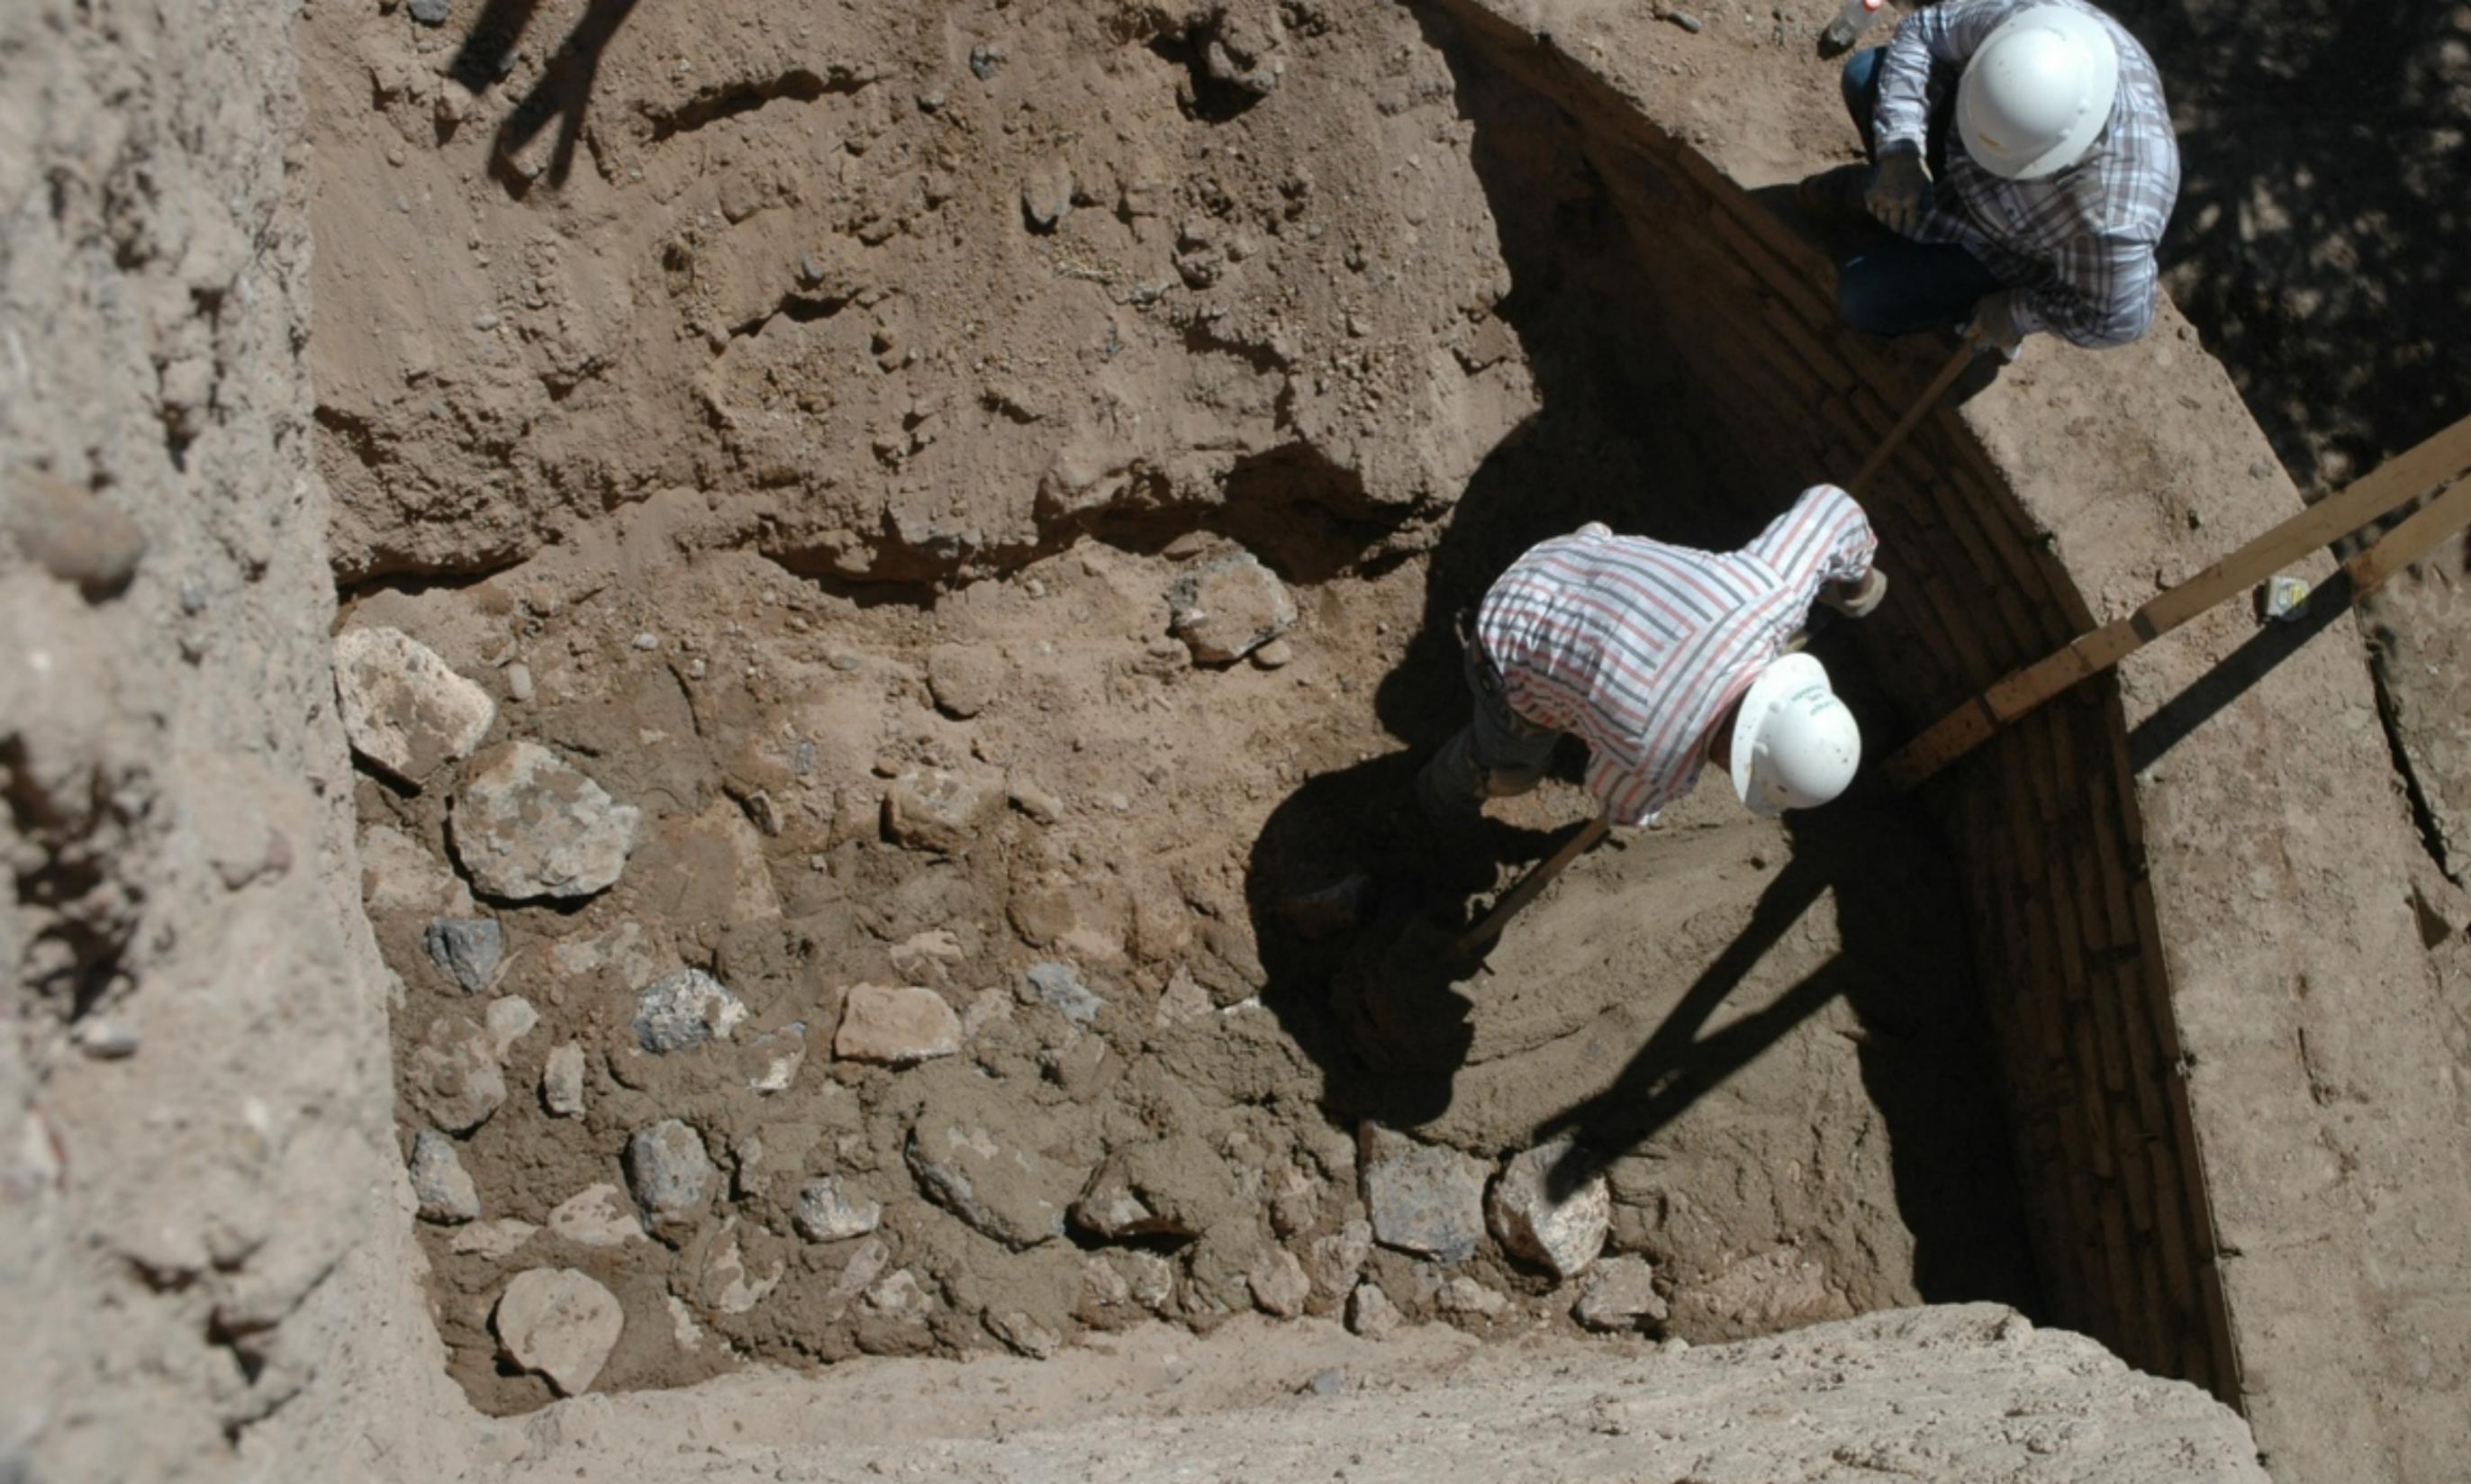
While demolition of the concrete sheathing continued, restoration began in select areas. Here the footing is being laid for the SW buttress.

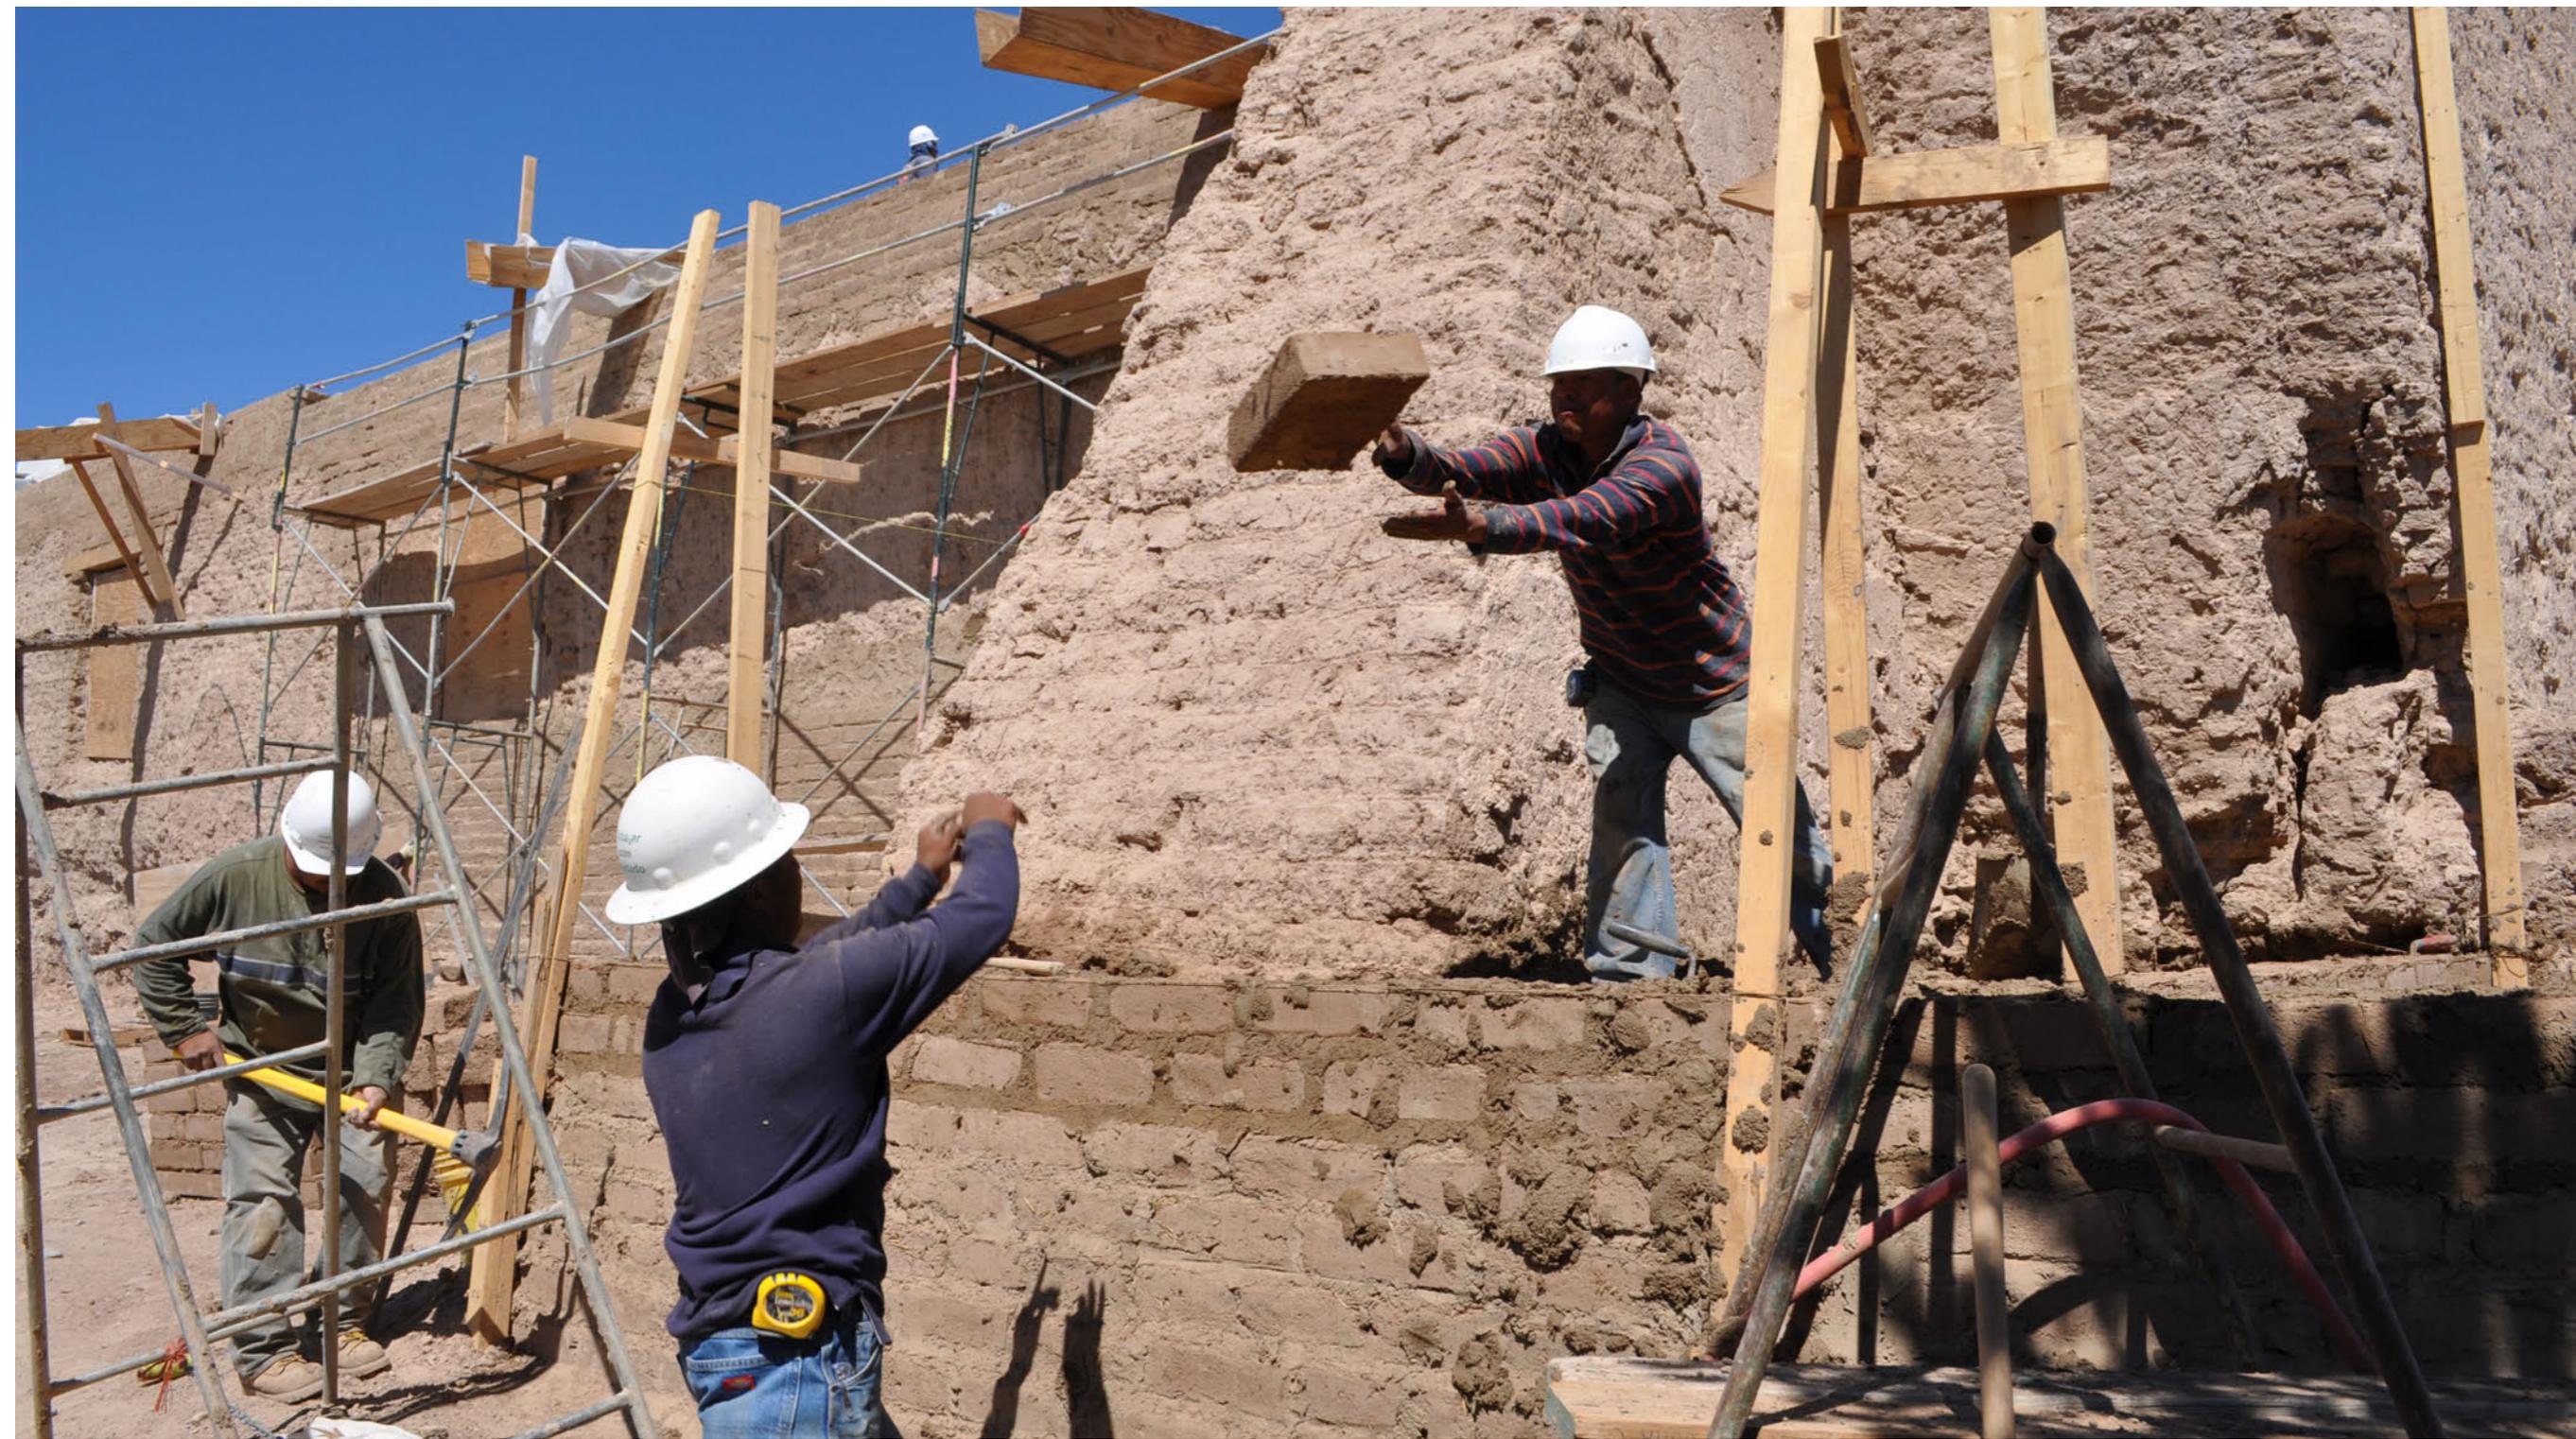
Here, the first courses of adobe are being laid for the interior mass of the SW buttress. The west parapet was nearing completion.

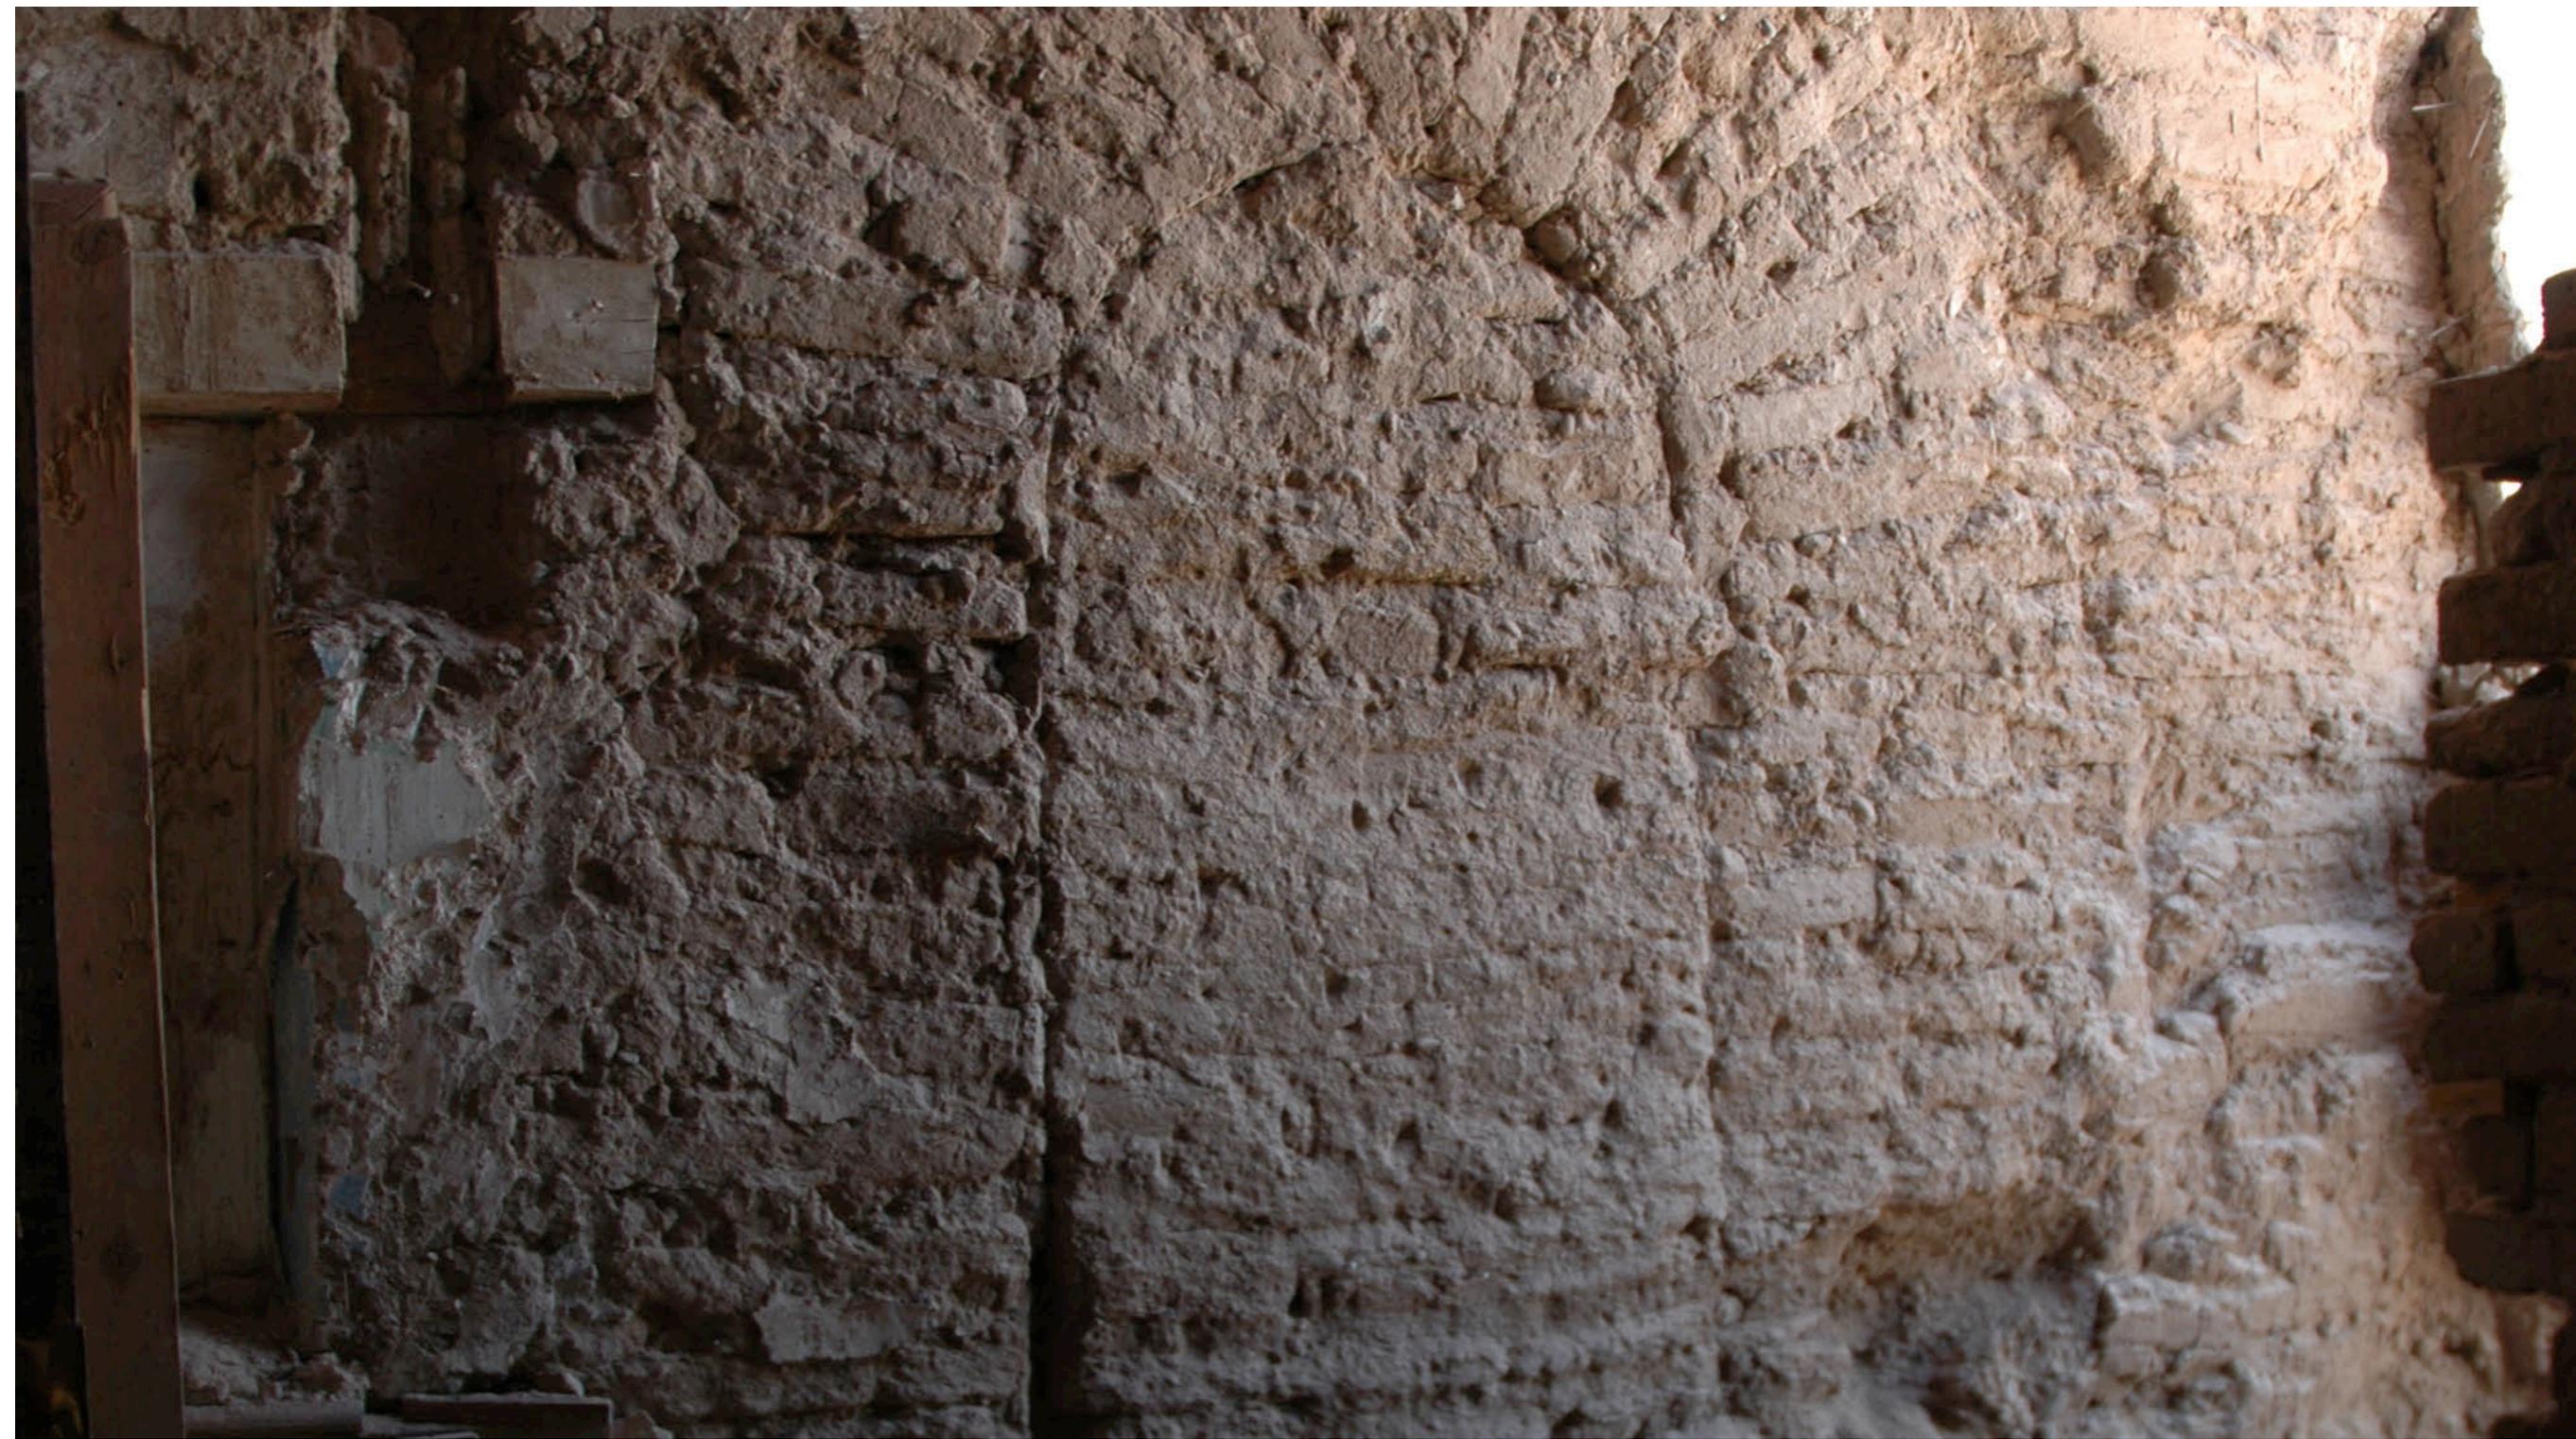
With the interior plaster removed from the sacristy, a sealed doorway to the sanctuary was revealed. This feature is now protected behind a furred-out wall in the new mechanical area.
