# The Resurrection of St. Augustine

The story of a hundred-year fix

The mission St. Augustine at Isleta Pueblo, NM was built in 1613 and has, over the centuries, undergone many modifications. This image shows the building as it appeared in 2005, as the Pueblo began its drive to restore the historic church. In 2010 Crocker Ltd was selected as the contractor and Neil Carter Associates was the project manager.

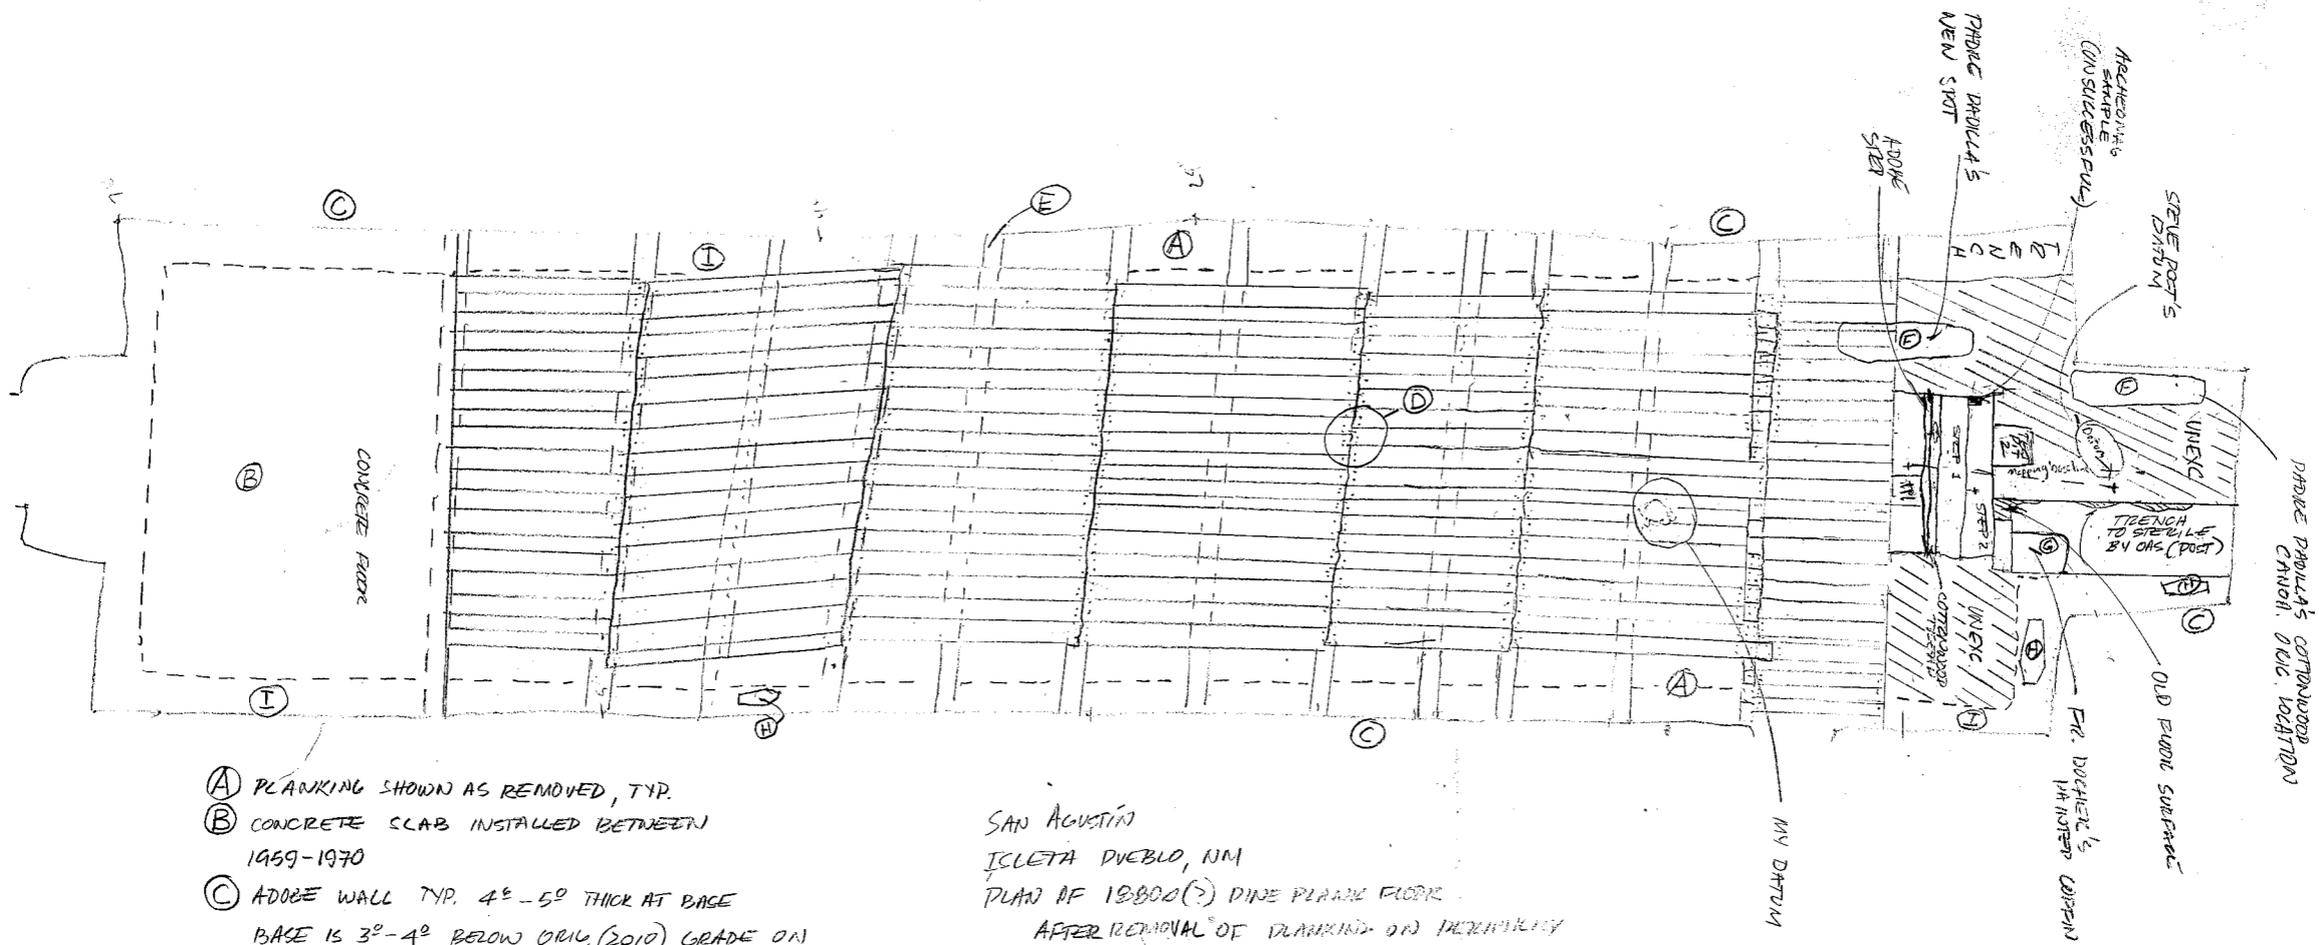
SAN AGUSTIN  
 ISLETA DUEBLO, NM  
 PLAN OF 1880(?) DINE PLANK FLOOR  
 AFTER REMOVAL OF PLANKING ON INTERIORITY  
 FOR BASAL WALL REPAIRS.  
 JUNE, 2010 SCALE 3/16" = 1'  
 E. CROCKER: ALIDADE & PLANE TABLE  
 (ADDITIONS JULY, SEPT., 2010  
 AND MARCH 2011)

- (A) PLANKING SHOWN AS REMOVED, TYP.
- (B) CONCRETE SLAB INSTALLED BETWEEN 1959-1970
- (C) ADobe WALL TYP. 4" - 5" THICK AT BASE  
BASE IS 3" - 4" BELOW ORIG. (2010) GRADE ON EAST, 3" - 4" BELOW 2010 GRADE ON WEST
- (D) DINE PLANKING, RANDOM WIDTHS ATTACHED TO SLEEPERS (E) WITH CUT NAILS
- (E) 6x8 SLEEPER, HAND HEWN, WALL TO WALL BUT NOT EMBEDDED, RESTING ON LOOSE UNDIFFERENTIATED FILL RICH IN HUMAN REMAINS
- (F) HOLLOWED OUT COTTONWOOD "CANOA" COFFIN CONTAINING PR. PADILLA. MOVED TO NEW LOCATION DUE TO COLLAPSE OF WEST ADobe WALL.
- (G) PR. DOCHER'S PAINTED COFFIN PARTIALLY REVEALED
- (H) CHILDREN'S COFFINS REMOVED/REPLACED AFTER REPAIRS
- (I) DOTTED LINE INDICATES TRENCH EXC FOR BASE WALL REPAIR. SUBSEQUENTLY STABILIZED WITH FLOWTABLE FILL (LETAO PORTLAND) AND UTILIZED FOR HVAC CHASE

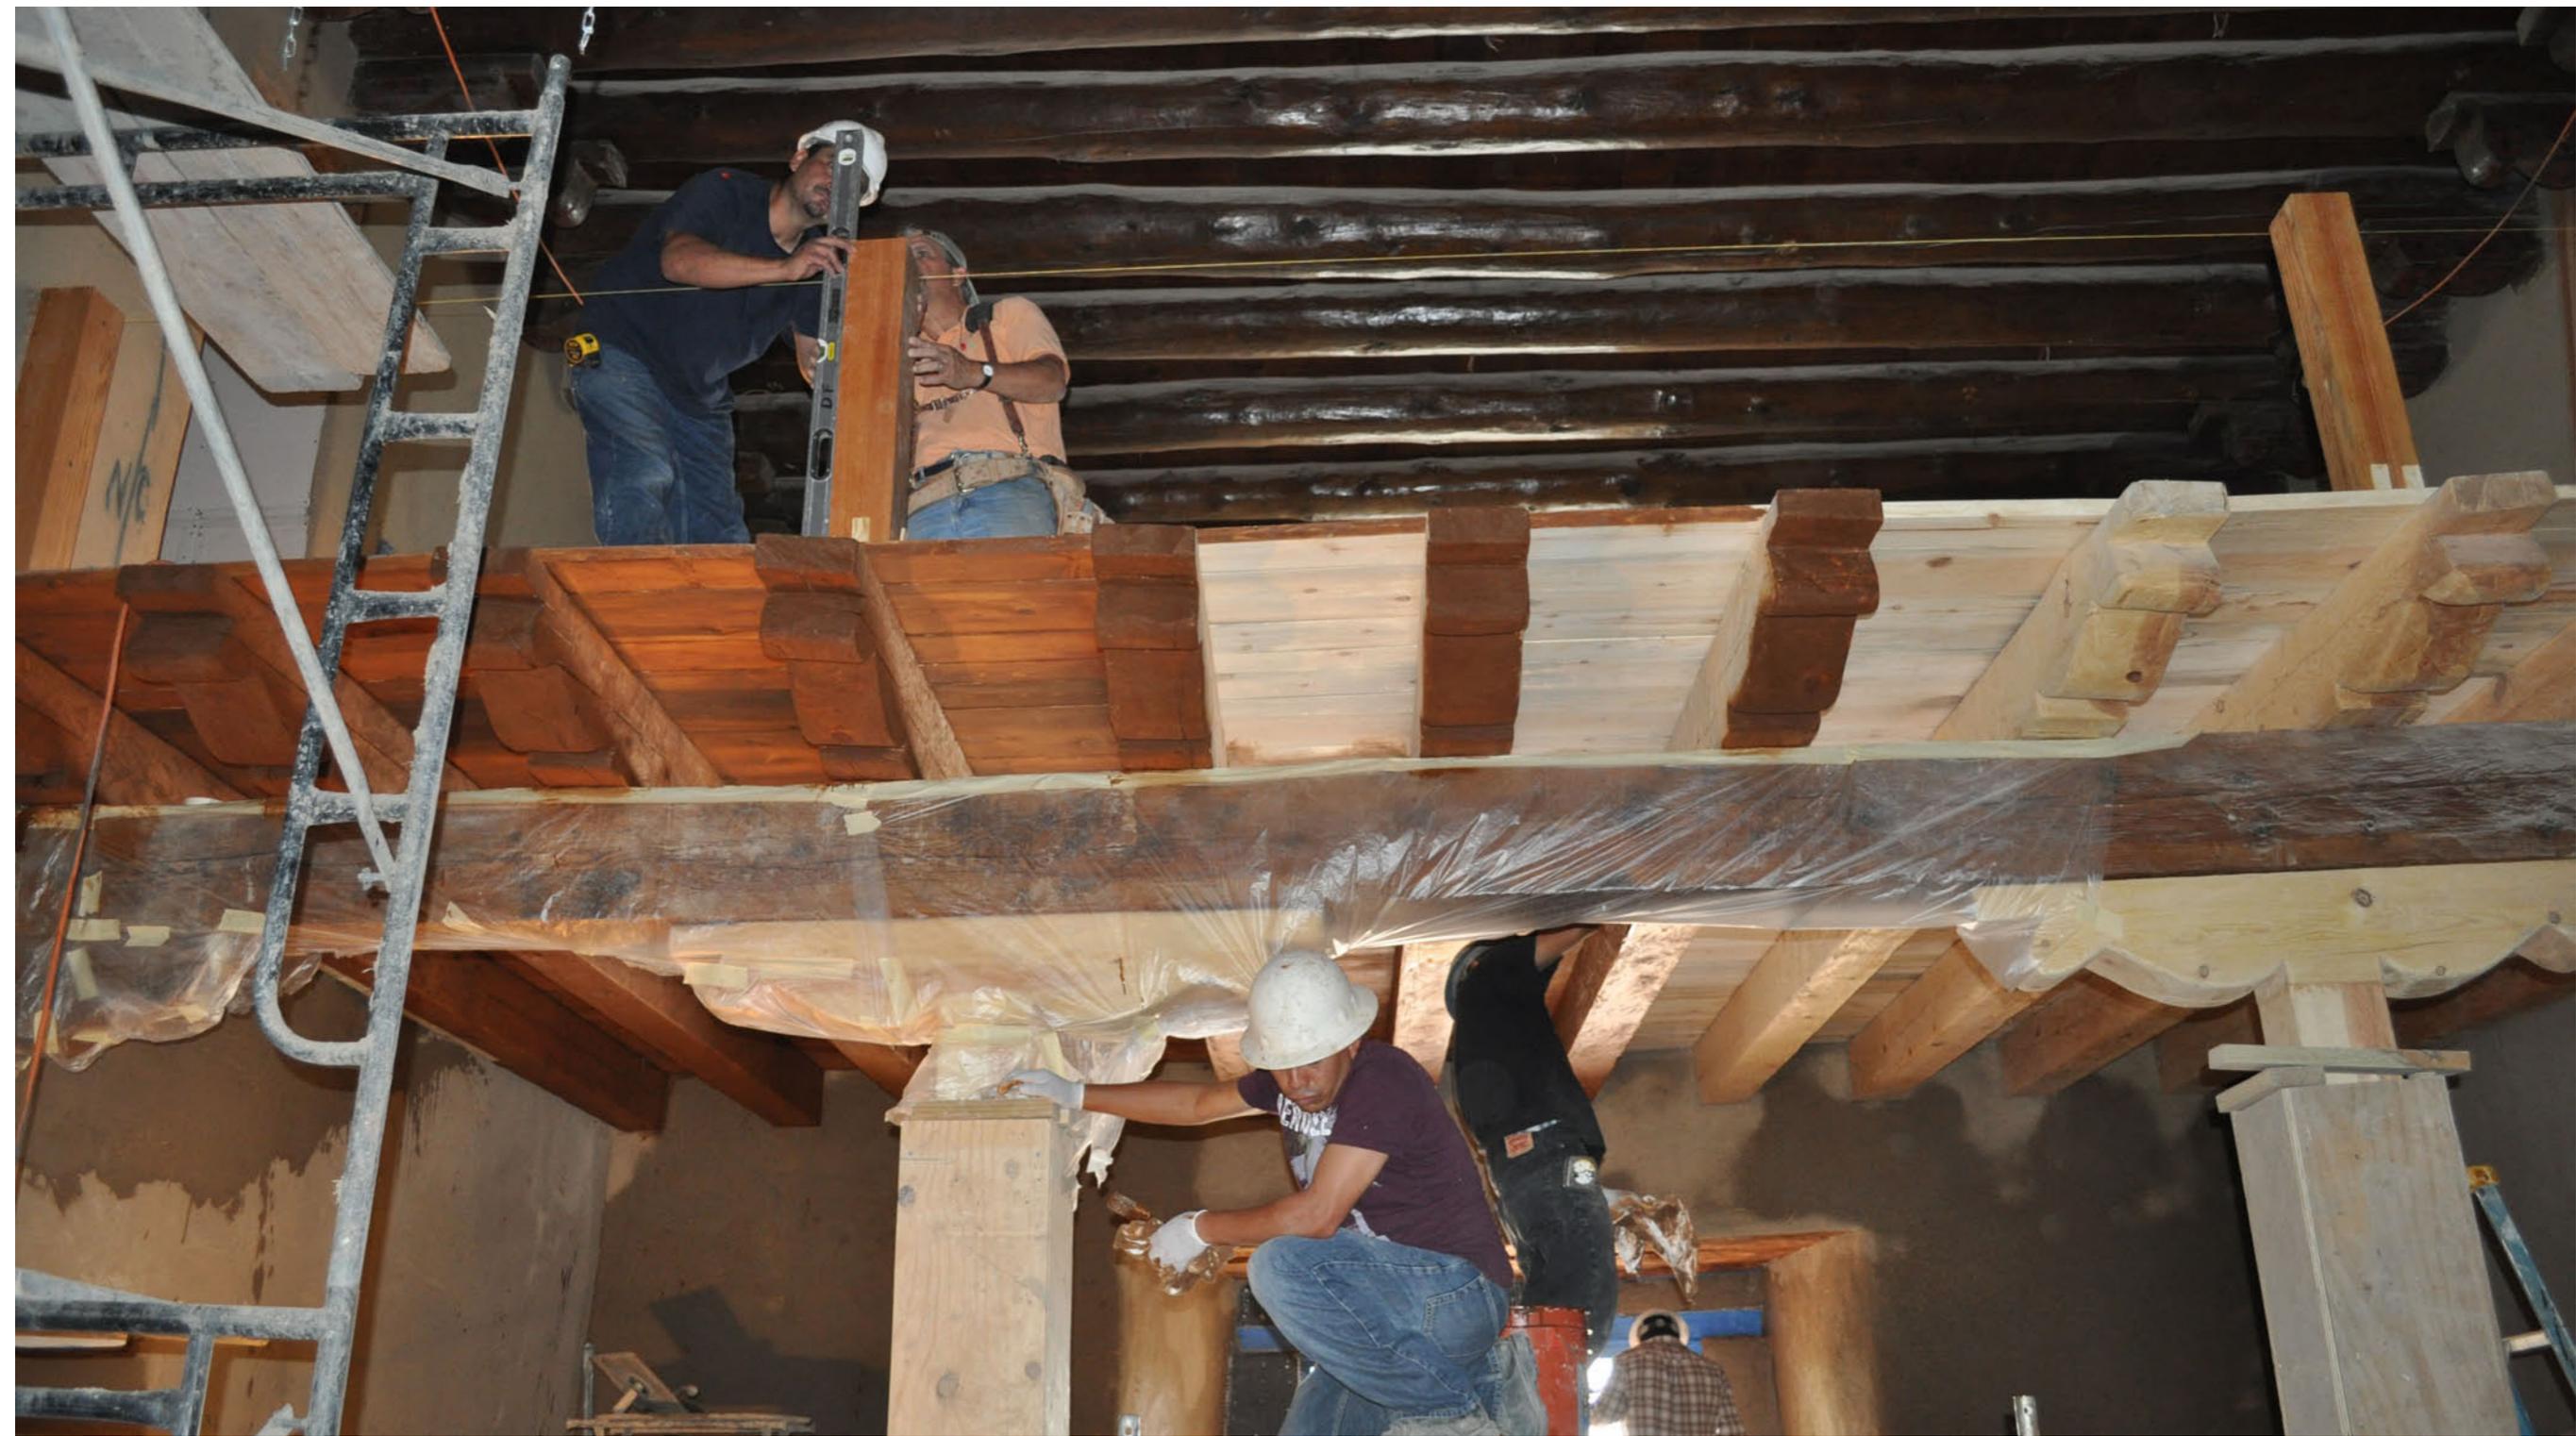
Re-assembly of the choir loft.

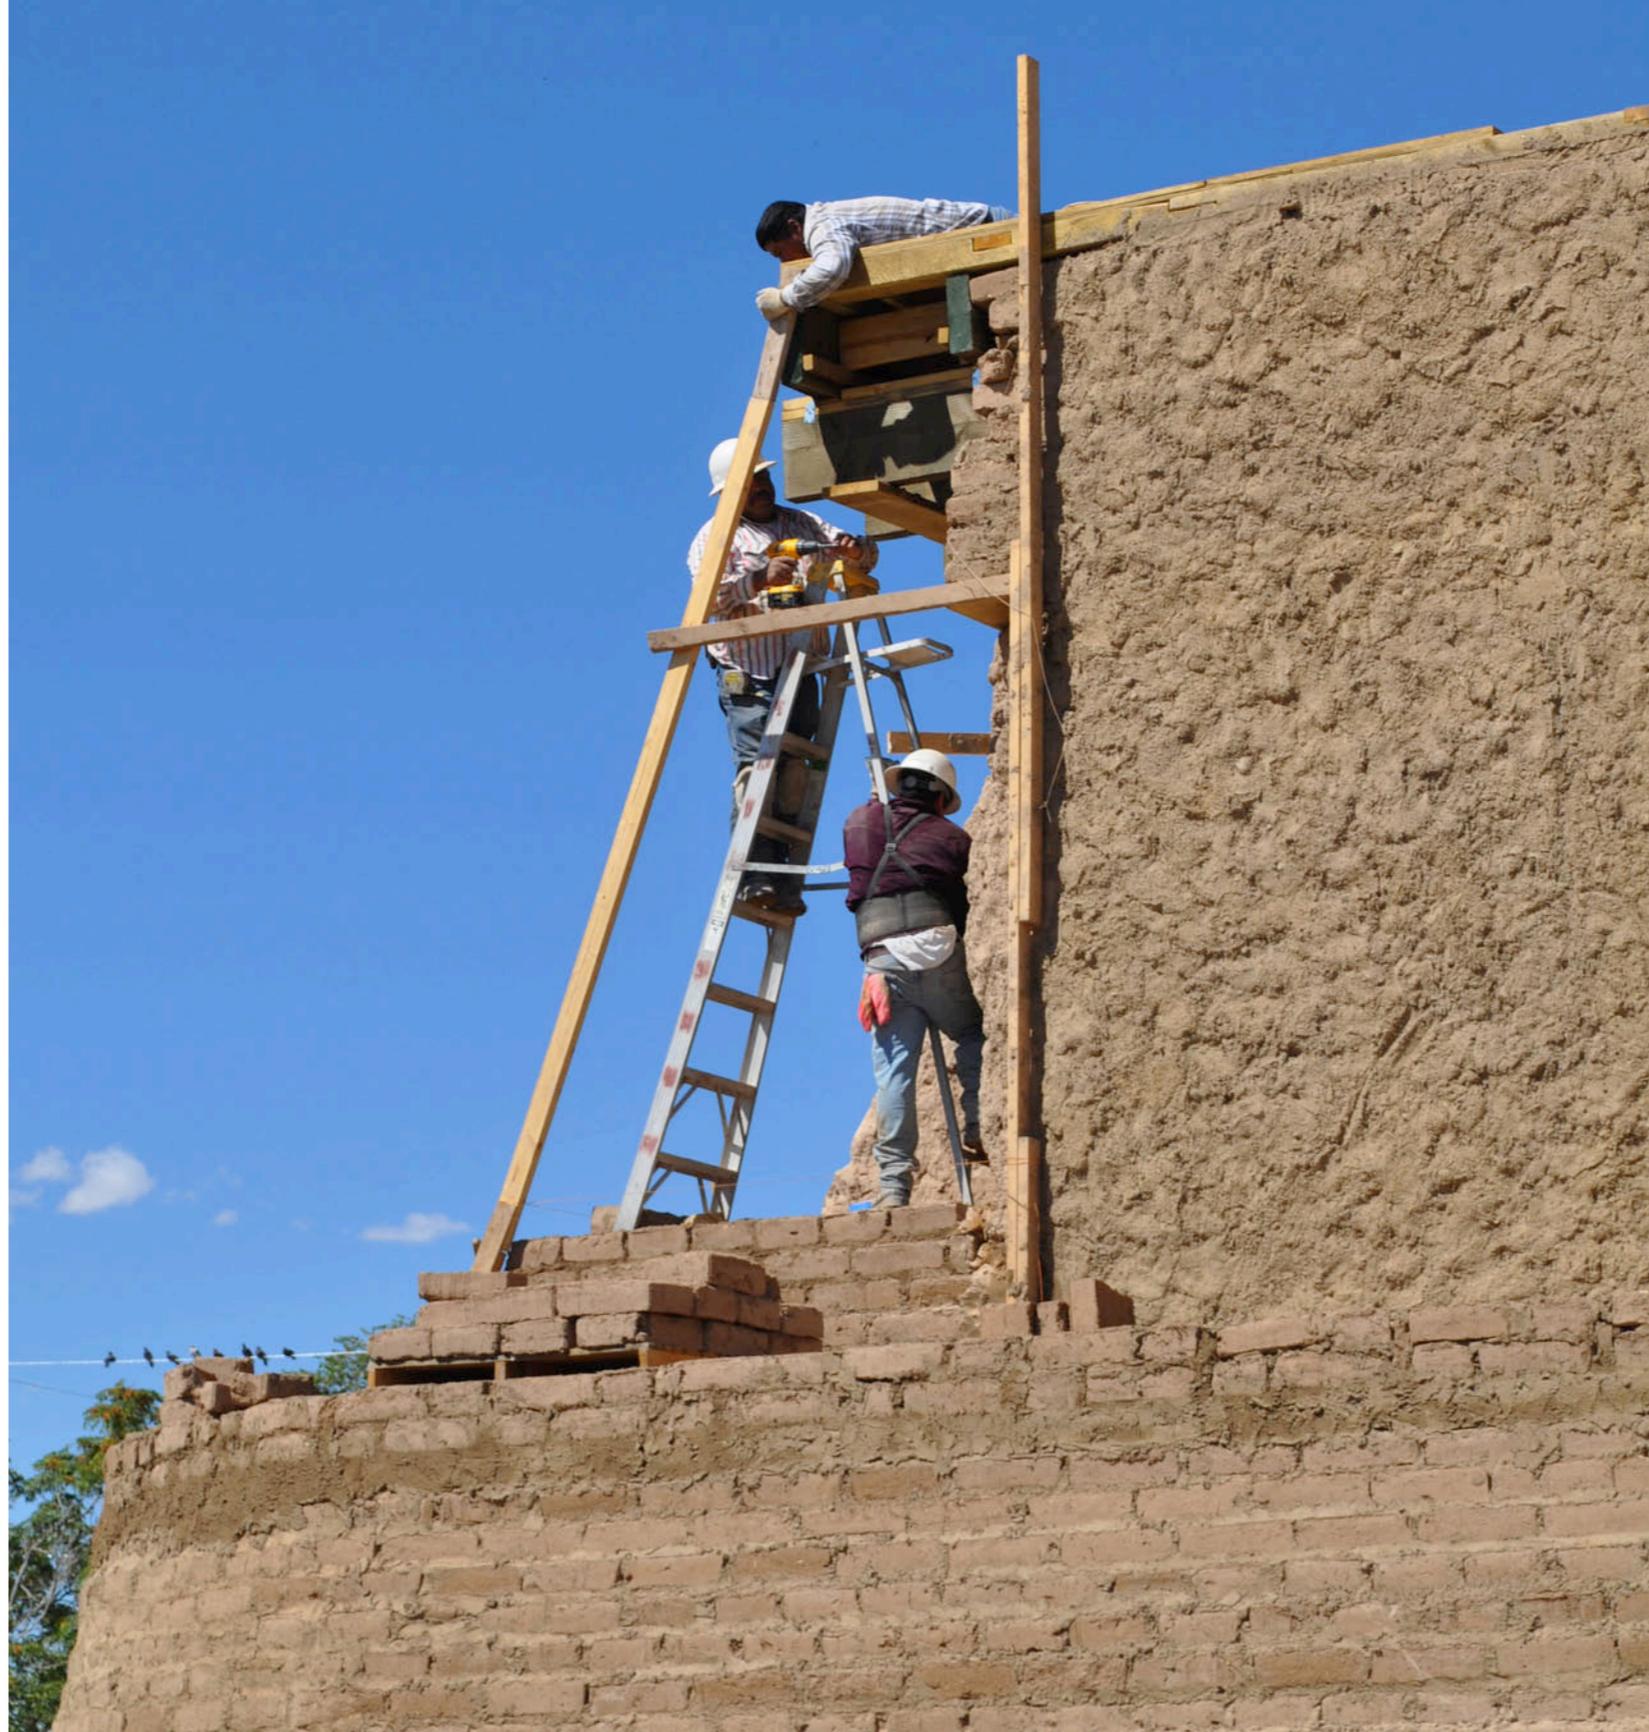
Here, the SW corner is being laid out and reconstructed to bear the new belfry.

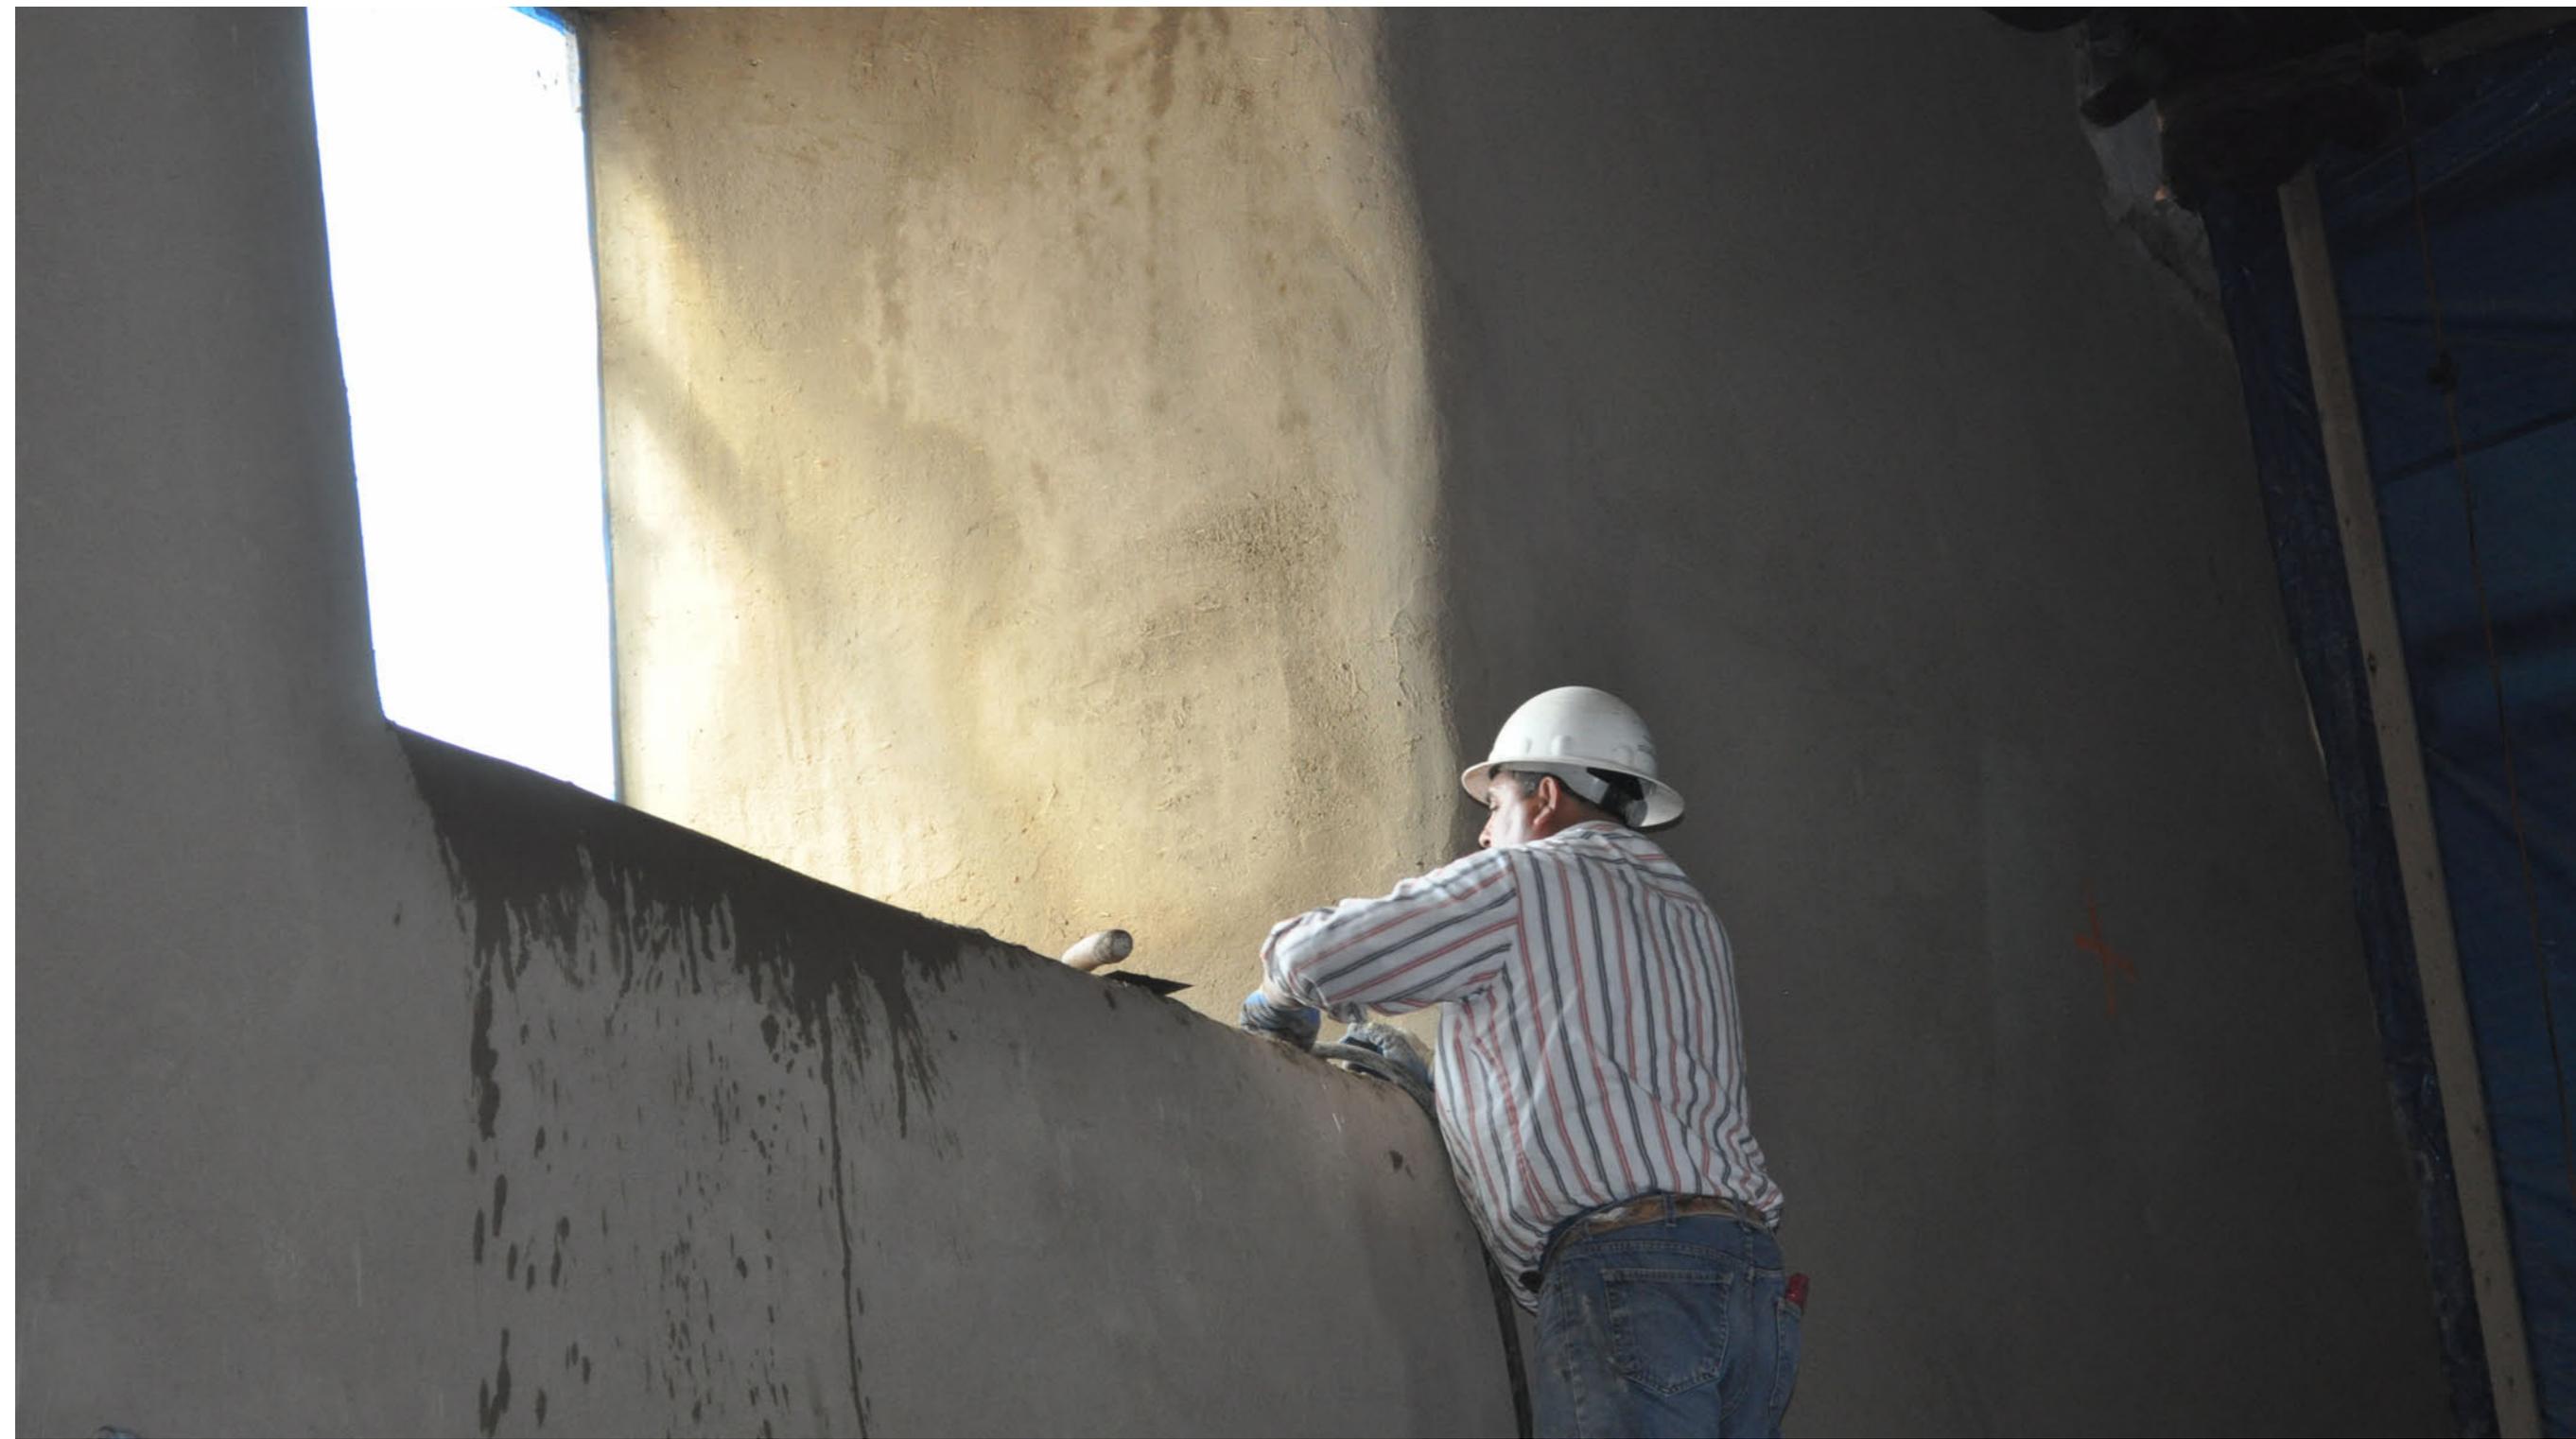
An interior mud leveling coat was applied.

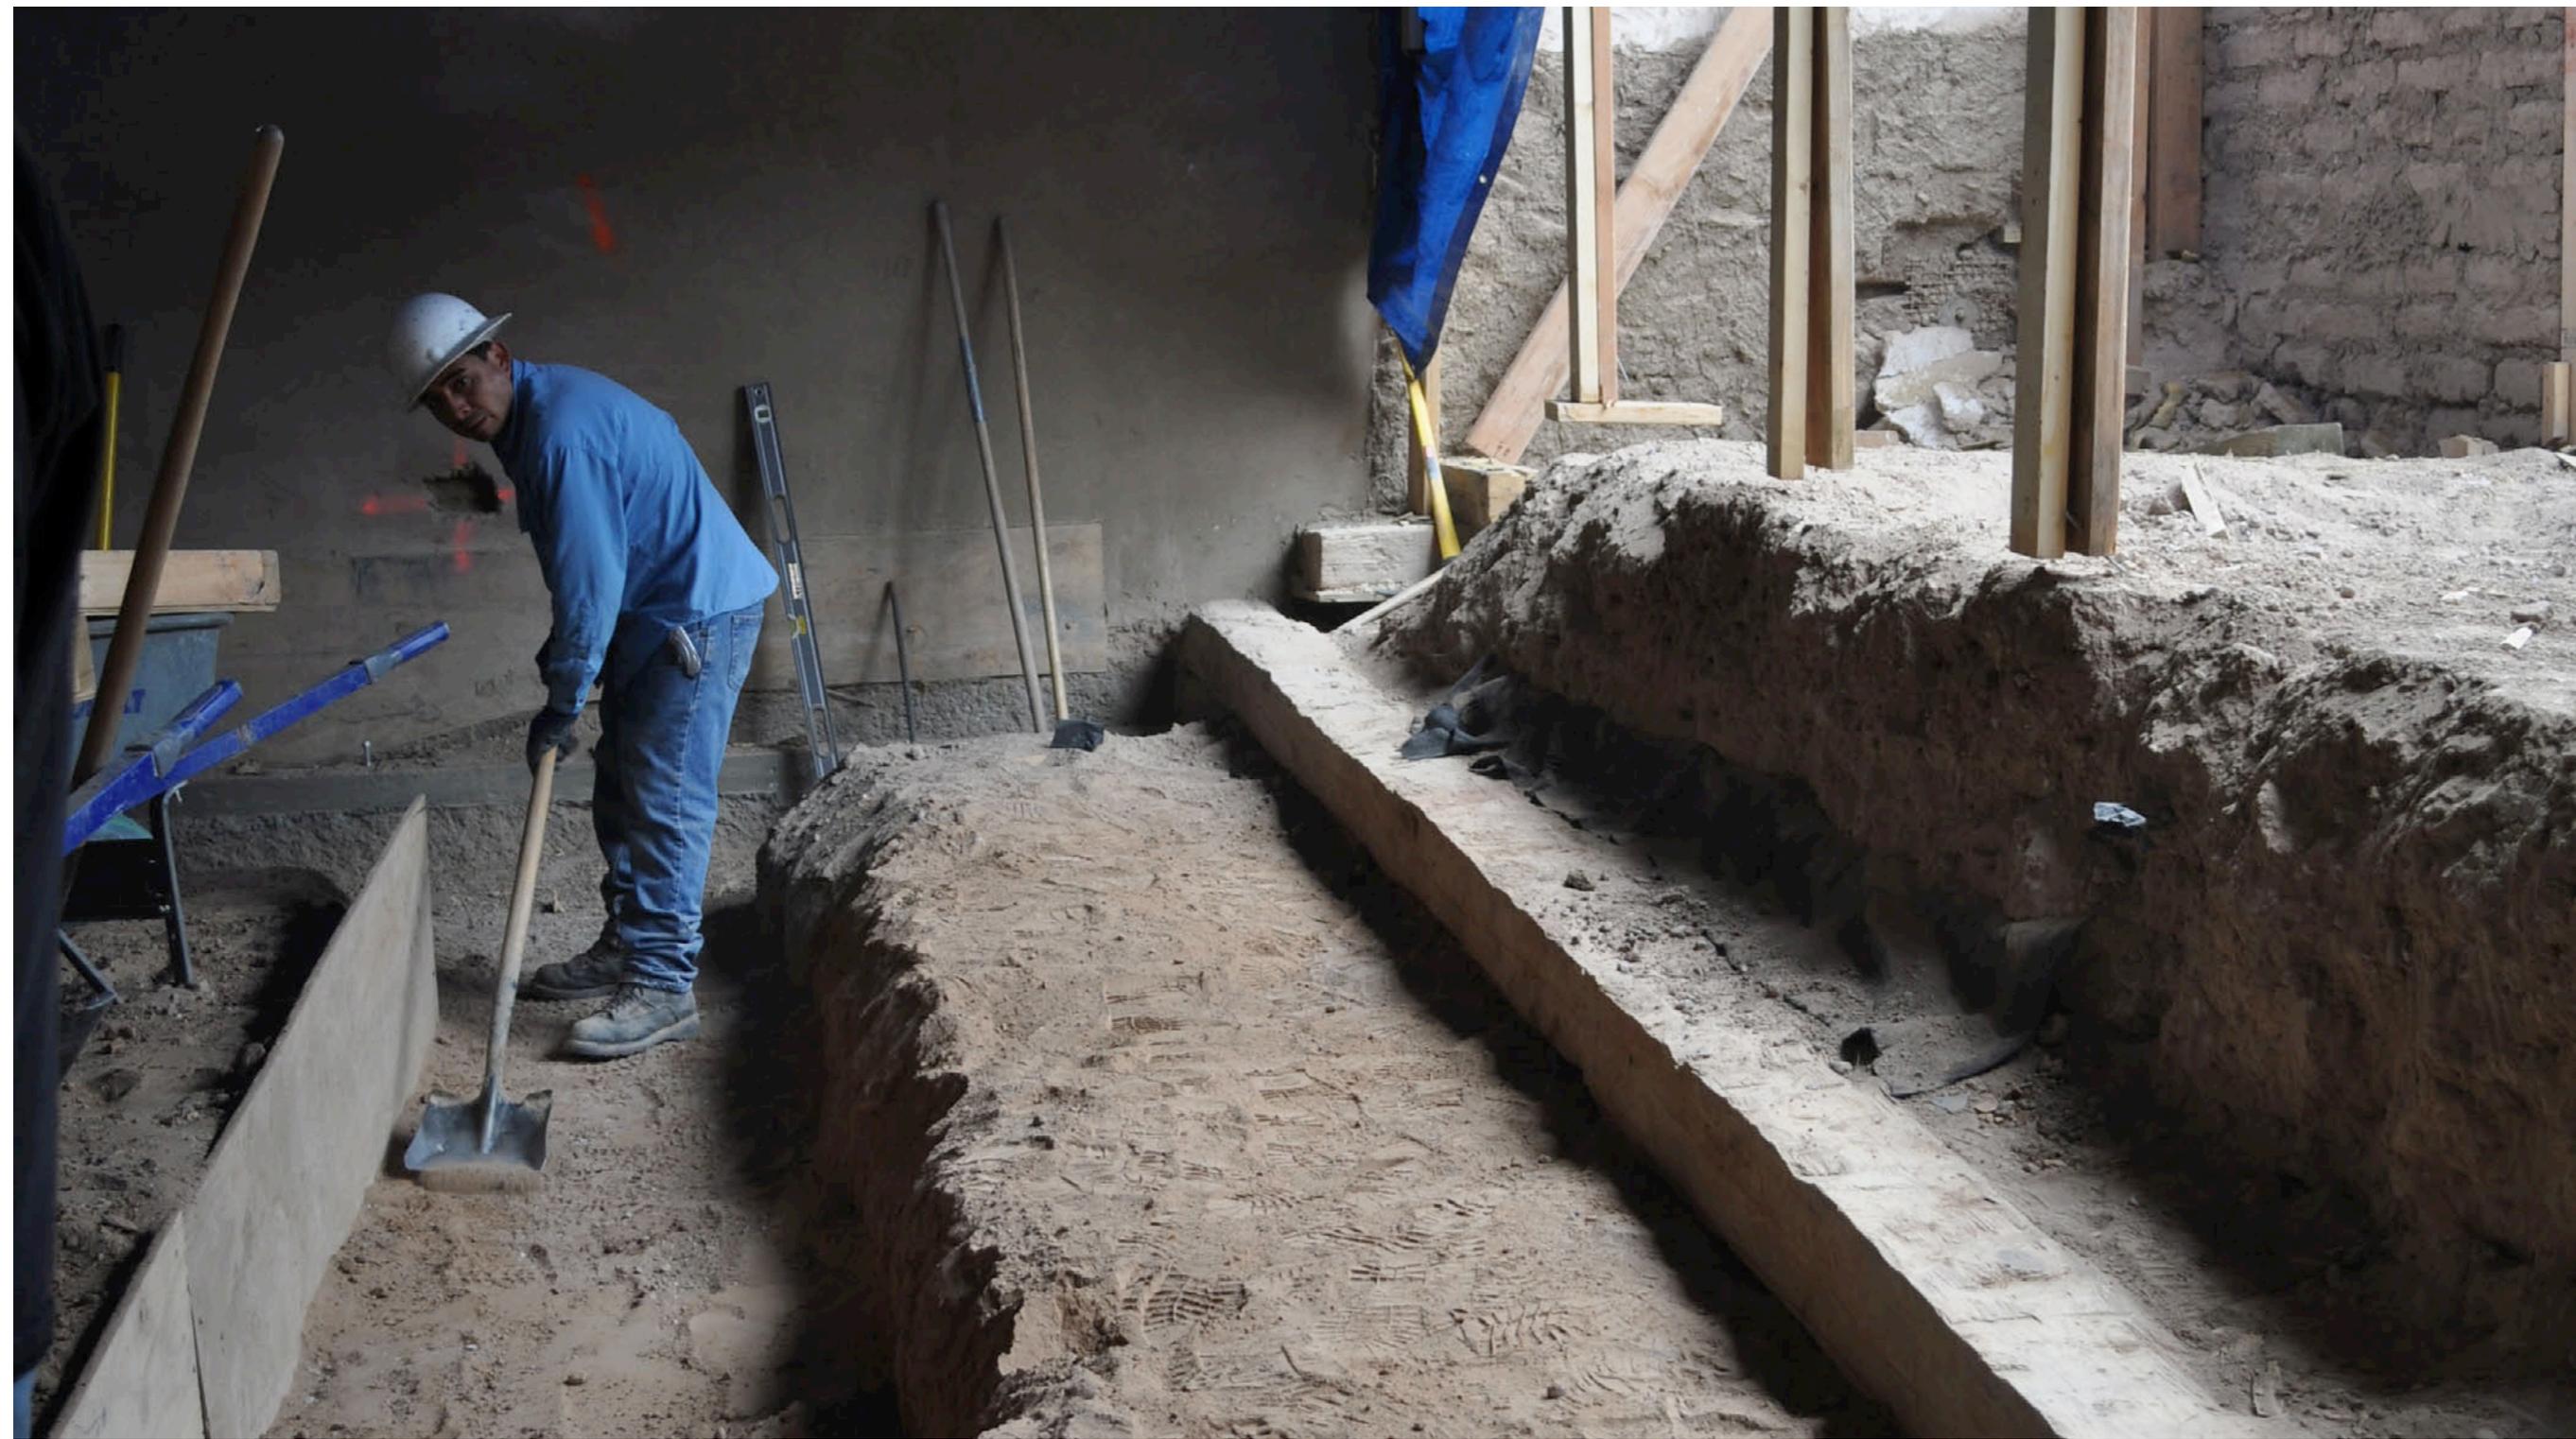
A shallow trench was excavated to accommodate stainless steel ducting for heating and air conditioning.
